FINAL REPORT

AIRBUS A380, REGISTRATION 9V-SKT RUNWAY EXCURSION AT SINGAPORE CHANGI AIRPORT ON 14 FEBRUARY 2013

AIB/AAI/CAS.089

**Transport Safety Investigation Bureau
Ministry of Transport
Singapore**

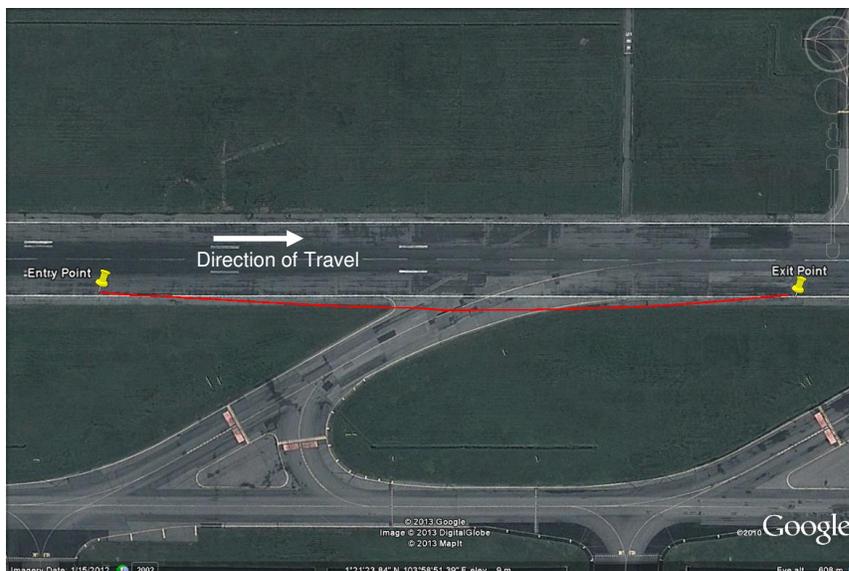
1.1.4 Flight data recorder (FDR) data showed that there was a right roll input from the PIC's side stick input when the flare was initiated. The right roll input resulted in the aircraft moving to the right. The aircraft touched down at about 650 m from Runway 02L's threshold and 12 m from the runway centreline. The right main landing gear touched down near the right edge of the runway. The aircraft exited the runway (**Figures 1 and 2**) and rolled on the grass patch and across Taxiway W7 before re-entering the runway.

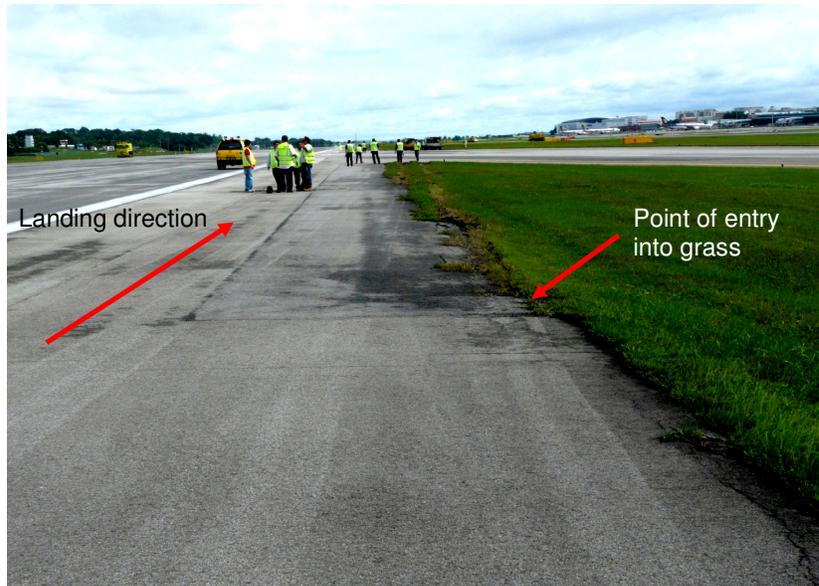
Figure 2: Wheel track of the right main

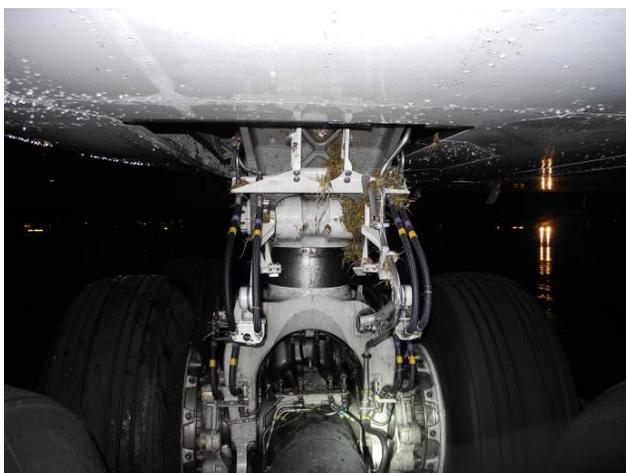
1.1.6 After the aircraft arrived at the gate, the flight crew informed the ground engineer that the aircraft might have scrubbed something during the landing. The ground engineer performed a post-flight walk check around the aircraft. He informed the flight crew that mud and grass were found on the right side of the aircraft and right main landing gears as well as in the wheel well area (**Figures 3, 4 and 5**).

Figure 3: Grass ingestion on the forward of the right main landing gear

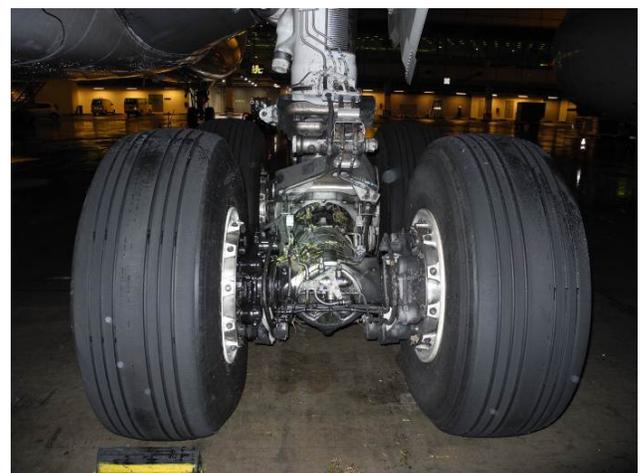
Figure 4: Grass ingestion on the aft of the right main landing gear

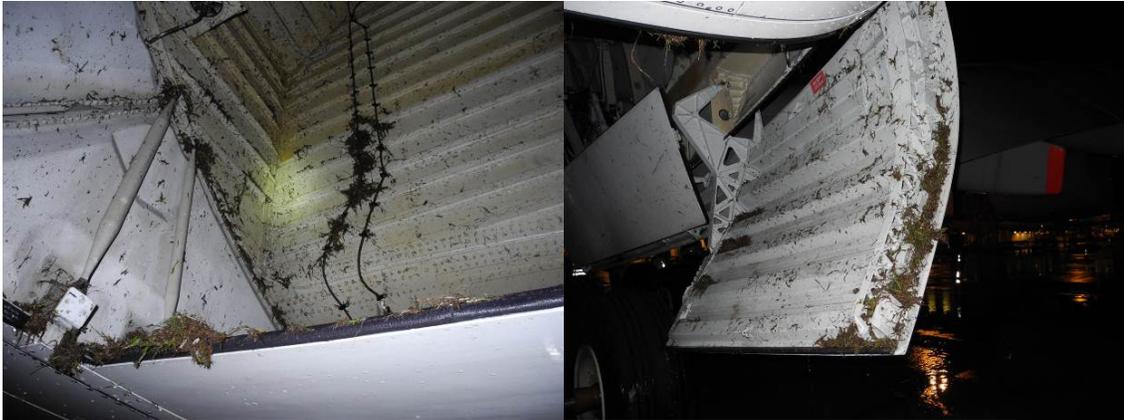
Figure 5: Grass found on the right main landing gear door

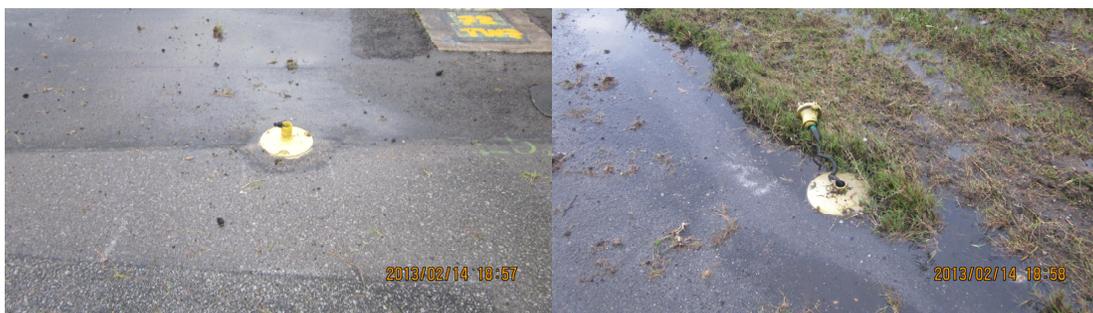
1.4.1. Five runway edge lights and four rapid exit taxiway edge lights along Runway 02L were damaged (**Figure 6**).

Figure 6: Damaged runway/taxiway lights
