# **Final Report**

## **SINKING OF TANKER SILVER SINCERE IN SINGAPORE TERRITORIAL WATERS ON 12 JANUARY 2025**

TIB/MAI/CAS.188

Transport Safety Investigation Bureau of Singapore  
Ministry of Transport  
Singapore

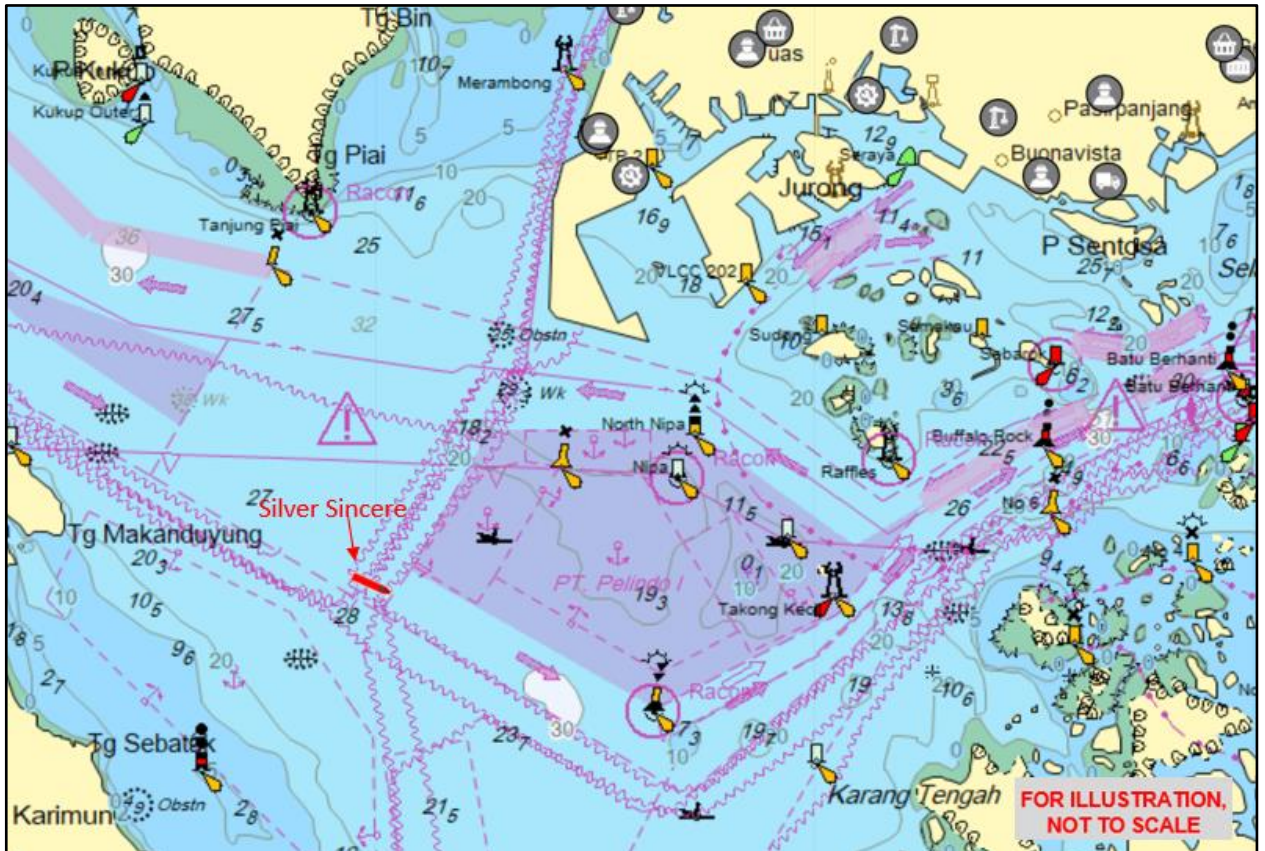
Figure 1 - Approximate location of SS (red annotation) when the first seawater ingress into engine room was reported (Source: MarineTraffic)

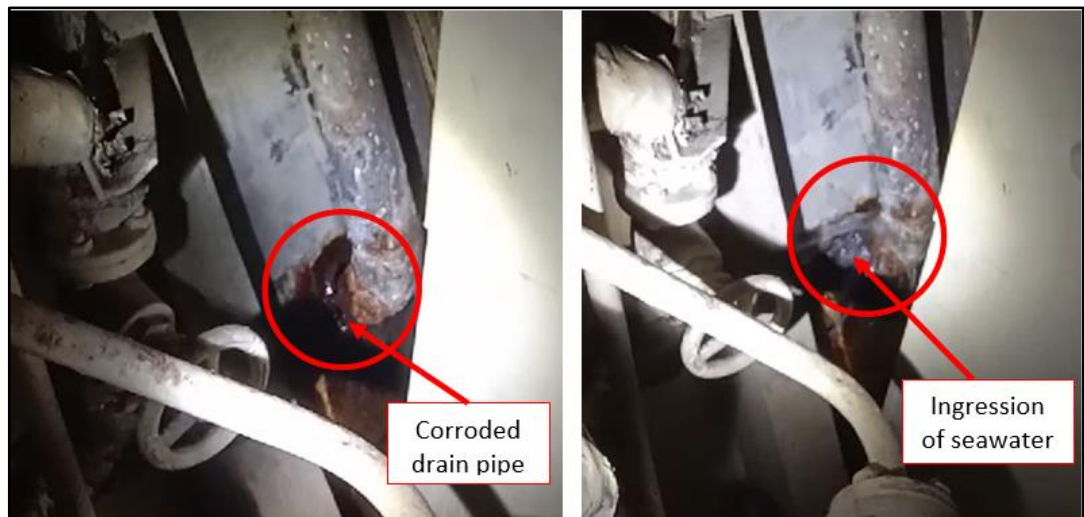
1.1.2 On 11 January 2025, at about 2015H, while SS was transiting the Sector 7 of the Singapore Strait (see **figure 1**), the Chief Engineer (CE) reported to the Master seawater ingressing intermittently into the engine room from a drain pipe<sup>4</sup> (see **figure 2**) located at the port side hull near the aft part of the engine room. The Master in turn informed the Company about the situation and was instructed to plug the leak using rags or wood materials to reduce the water ingress, and to use bilge pump and wilden pump<sup>5</sup> to cope with the situation. A wilden pump was deployed to clear the seawater from the engine room which was manageable and under control until the noon of 12 January 2025.

<sup>4</sup> The drain pipe was connected to a scupper on the main deck port side to drain water overboard through engine room. The leak was at the welded connection of the drain pipe to the scupper.

Figure 2 – Corroded drain pipe resulted in water ingress (Source: Video taken by the crew of SS, annotated by TSIB)

- 1.6 Additional information
  - 1.6.1 The leaking drain pipe discovered by the CE could not be temporarily clamped or welded due to its location. The engineers attempted to arrest the leak using rags but to no avail. The wilden pump was not able to cope with the continuous ingress of seawater and the situation was exacerbated by the further port listing.

- a) The corroded drain pipe was not addressed before the voyage commencement, which caused the engine room flooding. The Wilden pump could not cope with the continuous seawater ingress, and the leak from the corroded pipe could not be resolved temporarily by clamping or welding.
- b) Poor condition of the air vent head on port side deck, which was broken.
- c) Inoperative ballast pump which could not be used to adjust the ballast to correct the port listing.
- d) One of the two generators was under-performing and would trip when the electrical load was above 70% of its designed capacity. Though the other generator functioned normally and was capable of providing output of its designed capacity, it failed during the challenging voyage.

- 3.1 The contributing factors for the port listing and subsequent sinking of SS was mainly due to its low freeboard which caused seawater ingress into the port ballast tank (no.3 or no.4) through the broken air vent. The leak from the hole of a corroded drain pipe in the engine room had also caused seawater to ingress into the engine room.

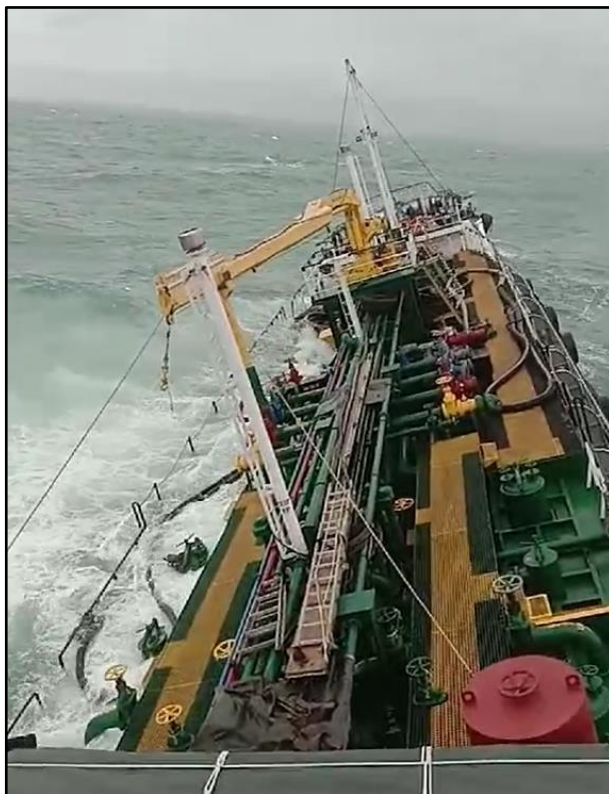
- 1.1.7 More water, as a result of sea swells, continued getting on deck when SS rolled violently due to the loss of the capability to steer. SS listed further to its port side to about 15 to 20 degrees (see **figure 3**). The vessel took in more seawater through the broken air vent at the port ballast tank and other deck openings.

Figure 3 – SS listed to port with half of the main deck immersed in water  
(Source: Video taken by the crew of SS)

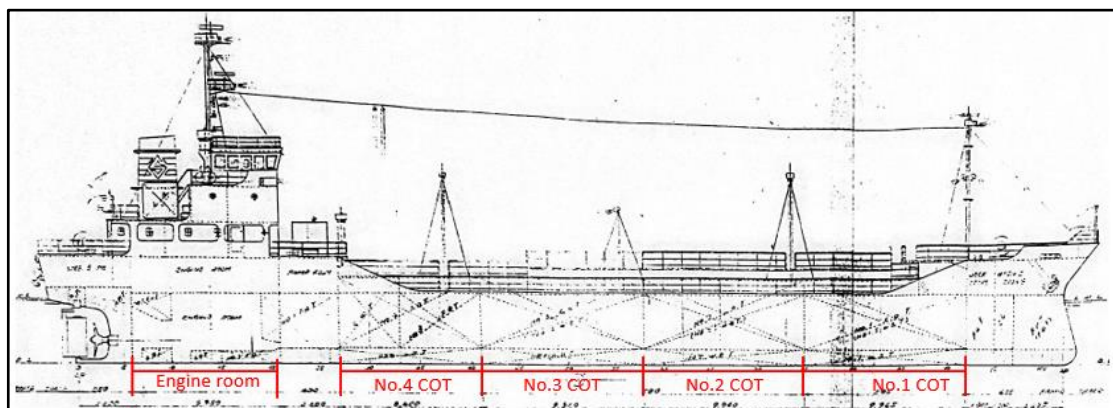
- 1.2.3 According to the Chief Officer, about 1000mt of waste oil cargo was loaded onboard SS in three phases in Port Klang since September 2023, and the last phase of loading was completed in January 2025. The waste oil cargo was distributed to all four cargo oil tanks (COTs, see **figure 4**) and two slop tanks. Eight ballast tanks, one on each side of the COT, served as double hull<sup>10</sup>.

Figure 4 – location of COTs and engine room on General Arrangement plan  
(Source: the Company, annotated in red by TSIB)

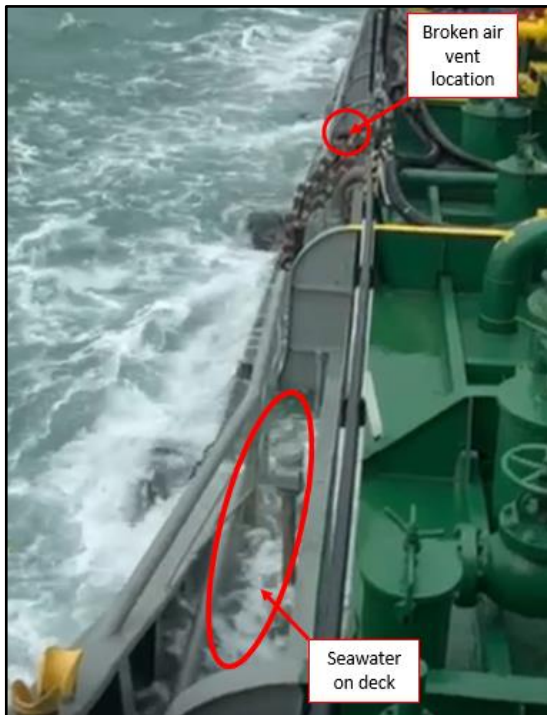
- 1.1.4 At about 1300H, the Master went on deck for an inspection and discovered a broken air vent<sup>6</sup> at a port side ballast tank. According to the Master, this broken air vent had caused seawater to enter the ballast tank and develop further list as SS continued to experience head seas. The main engine of SS also experienced intermittent overspeed when the propeller was out of seawater due to sea swells.

<sup>6</sup> The head of air vent was hit by waves and broke off from its base due to poor condition. The Master could not ascertain the broken air vent was from no.3 or no.4 ballast tank at the time of inspection.

<sup>20</sup> The Master suspected seawater had entered the port no.3 or no.4 water ballast tanks through the broken vent head, or the ballasting pipes located on deck which were in poor condition. The investigation team was unable to verify this statement as SS had sunk and had not been salvaged.

Figure 5a – Seawater washed on port deck and location of the broken air vent  
(Source: the crew of SS, annotated by TSIB)

- a) Seawater getting on port side deck due to the low freeboard (less than 1m);
- b) Water ingress into the port ballast tank (no.3 or no.4) due to the broken air vent head located on the port side deck;
- c) Water ingress into engine room through the hole of the corroded drain pipe located at the port side hull near the aft part of the engine room; and
- d) Moderate sea swells (about 1.5-2.5m height) causing more seawater onto port side deck and into the port ballast tank and engine room.

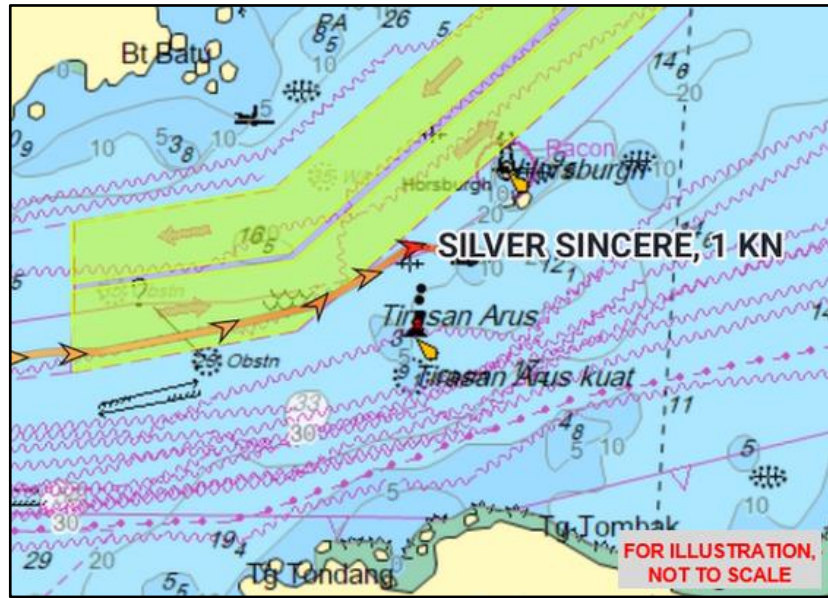
Strait. Due to the port list, the Master decided to deviate from the eastbound lane of the TSS of the Singapore Strait (see **figure 5b**) for an opportunity to drop anchor at a safe place.

Figure 5b – SS (orange arrow marks) deviated from the eastbound lane of the Singapore Strait (Source: MarineTraffic)

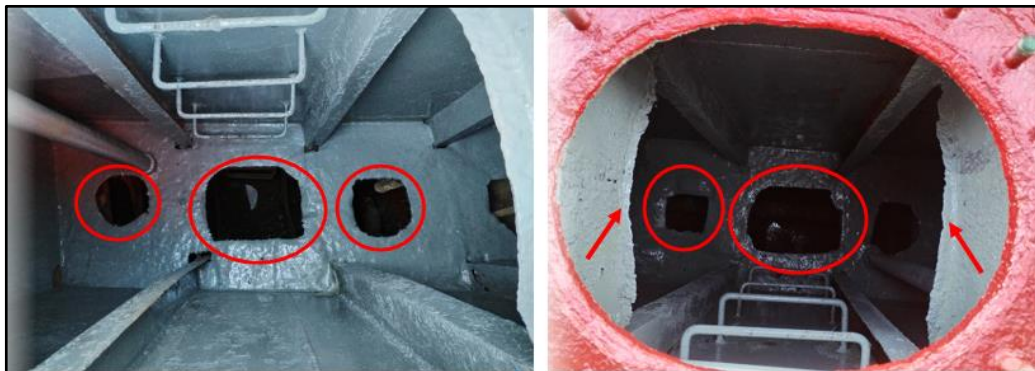
- 1.6.3 During the interview, the crew members expressed their concerns on the poor condition of SS citing heavily corroded ship structures and thinned plating observed in many areas as the vessel was more than 30 years old. The crew also mentioned that the mid floor structures of ballast tanks were corroded and de-shaped. These poor structures were not addressed adequately during the last dry-docking in February-March 2024, and there were no follow-up repairs (see **Figure 6**).

Figure 6 – View of the de-shaped and thinned tank structures in two ballast tanks painted over  
(Source: the crew of SS taken in August 2024, annotated by TSIB)

2.4.1 SS had undergone dry-docking in February-March 2024. Based on the account of the ship's crew, the condition of the mid floor structures of ballast tanks were corroded and de-shaped. Though these defects did not contribute to the sinking occurrence, they were of concerns to the adequacy of ship maintenance.

- 3.6 Based on ship's crew account, the condition of the mid floor structures of ballast tanks were corroded and de-shaped. These defects were not addressed during dry-docking, nor any follow-up repairs were carried out, suggesting a possibility of inadequacy in ship maintenance.
