FINAL REPORT

AIRBUS A330, REGISTRATION 9V-STO DIVERSION AFTER SMOKE WARNING

22 APRIL 2013

AIB/AAI/CAS.092

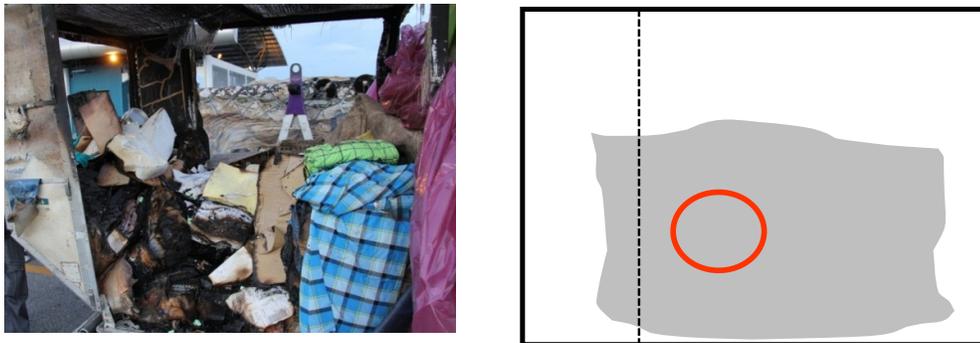
1.7.1.2 The investigators and fire experts examined the cargo containers and pallets on 24 April 2013 and identified an area in the lower middle part of container 42L which they believed was where the fire had originated (see **Figure 2**). Samples of fire debris around this area were collected by the investigators.

Figure 2: (Left) Cargo container 42L and its contents
(Right) Top view of container, red circle denotes area believed to be the fire origin

2.1.3 The area of fire origin is most likely in cargo container 42L, although it is not possible to pinpoint the exact location, given the extent of the fire damage of the contents of the container.

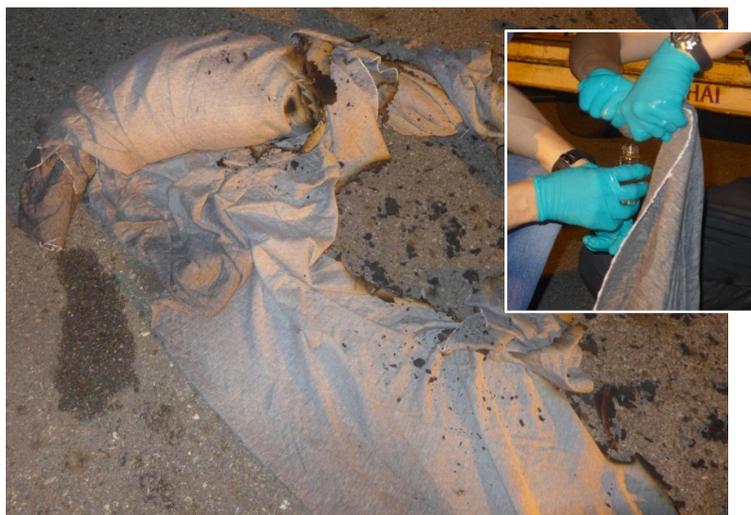
- 1.7.1.3 The investigators also found a damaged bale of fabric that was heavily soaked with an alcohol-like fluid. The investigators cut a sample from the bale and managed to collect a small quantity of the alcohol-like fluid by squeezing the sample (see **Figure 3**).

Figure 3: The bale of fabric heavily soaked in alcohol-like fluid.
(Inset: Fluid being collected by squeezing the sample of fabric)

- 1.7.1.4 The alcohol-like fluid was subsequently identified by laboratory tests⁸ to be ethanol, a flammable material. No other ignitable liquid was found.
