FINAL REPORT

RUNWAY INCURSION BY A TOW TUG IN CHANGI AIRPORT 6 AUGUST 2016

AIB/AAI/CAS.123

**Transport Safety Investigation Bureau
Ministry of Transport
Singapore**

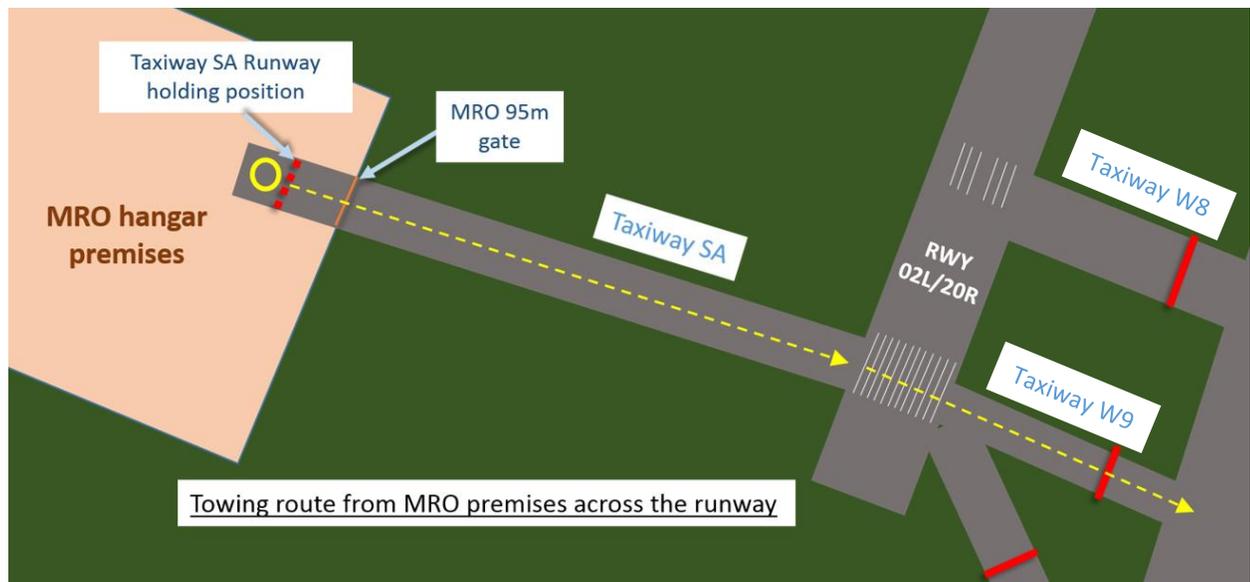
Figure 1. Planned towing route

- 1.1.1 In the early morning of 6 August 2016, a tow tug was to tow a B787 aircraft to Bay 300 in Singapore Changi Airport for the aircraft to be prepared for departure. The B787 had some maintenance work done by an aircraft maintenance, repair and overhaul organisation (MRO) located on the west side of the southern end of Runway 02L/20R. The towing would involve crossing Runway 02L/20R via Taxiway SA onto Taxiway W9 (see **Figure 1**).

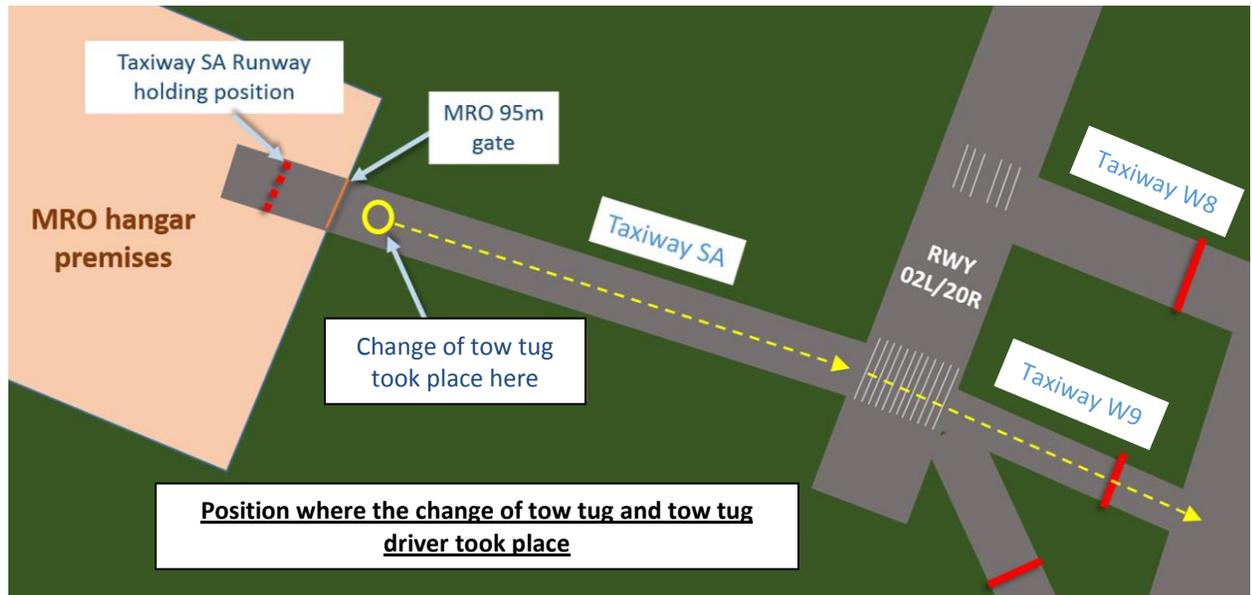
Figure 2. Change of tow tug and tow tug driver took place here

MRO's tow tug was just beyond the MRO's gate¹ to the aerodrome (the MRO called this the 95m gate because of its width) (see **Figure 2**). Here the MRO's tow tug and tow tug driver were replaced by a tow tug and tow tug driver from a ground service provider (GSP) at Changi Airport engaged by the MRO.

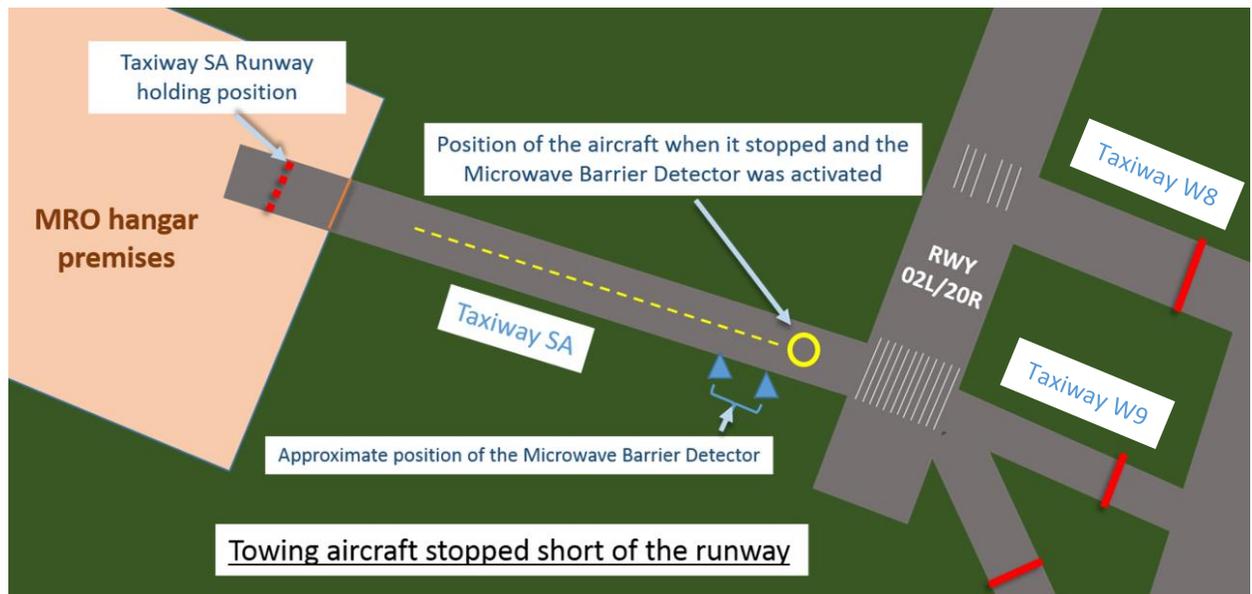
Figure 3. Approximate position of MBD

- 1.1.7 As the towing column was moving forward, the tow tug driver spotted an aircraft approaching the airport from the north. He informed the headset man who was beside him. The headset man in turn informed the EIC. The EIC and engineers at the cockpit saw the aircraft and instructed the tow tug driver to stop. The EIC reported to the runway controller that they saw an aircraft approaching Runway 02L/20R. The runway controller saw that the towing column was apparently not moving and told the EIC that he was not given clearance to cross the runway³.
- 1.1.8 In the meantime, the microwave barrier detector (MBD) of the airport's runway incursion alerting system⁴ installed at Taxiway SA (see **Figure 3**) also triggered an alarm that alerted the runway controller.

- 1.1.9 The arriving aircraft landed safely and vacated the runway at Taxiway W8 without any incident. The towing column had stopped at about 115m from the centreline of Runway 02L/20R (i.e. 85m from the edge of the runway⁵).

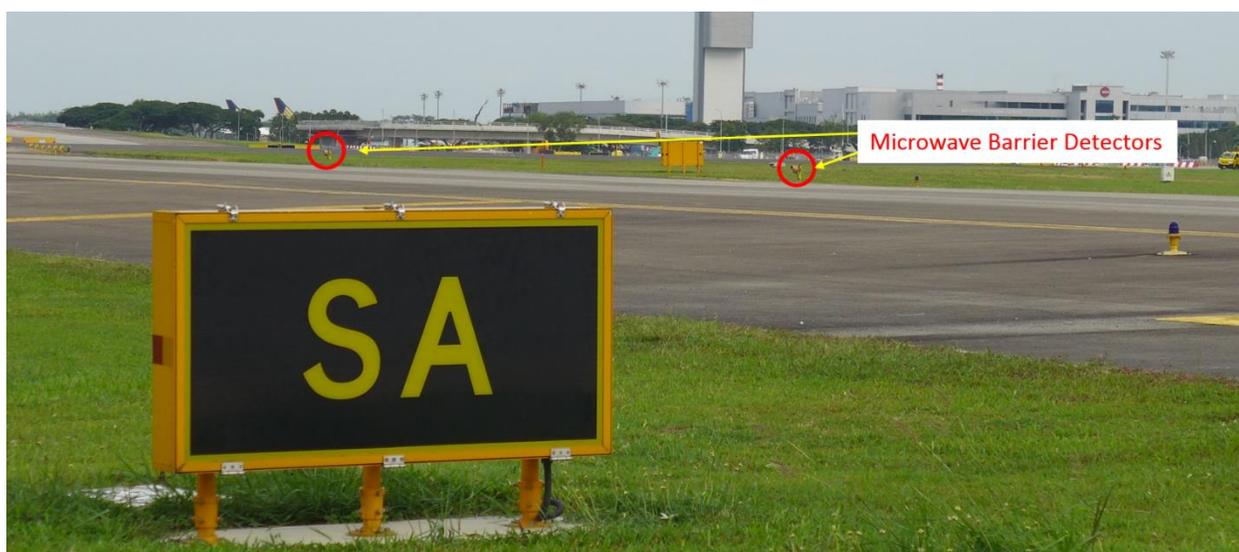
Figure 4. Microwave Barrier Detectors on Taxiway SA

1.6.1.1 The aerodrome has a runway incursion alerting system comprising a number of microwave barrier detectors (MBDs) for the detection of unauthorised entry of aircraft or vehicles into the runway. The MBDs (see **Figure 4**) are installed at all taxiways leading to a runway and are controlled by controllers at Changi Control Tower with the same switch that controls the red stop bar lights.

- 1.6.1.4 The MBD at Taxiway SA is located about 85m away from the edge of the Runway 02L/20R.
- 1.6.2 Taxiway SA
- 1.6.2.1 The MRO had a cluster of hangars on the west side of the southern end of Runway 02L/20R. Taxiway SA linked the MRO's hangar premises directly to Runway 02L/20R. Under an agreement with the then aerodrome operator⁷ in June 1993, the MRO constructed Taxiway SA (as well as the associated runway holding position, and the related markings, signage and lightings on the ground), as approved by the then aerodrome operator, when it developed its hangar facilities. The agreement also required the MRO to operate and maintain Taxiway SA.

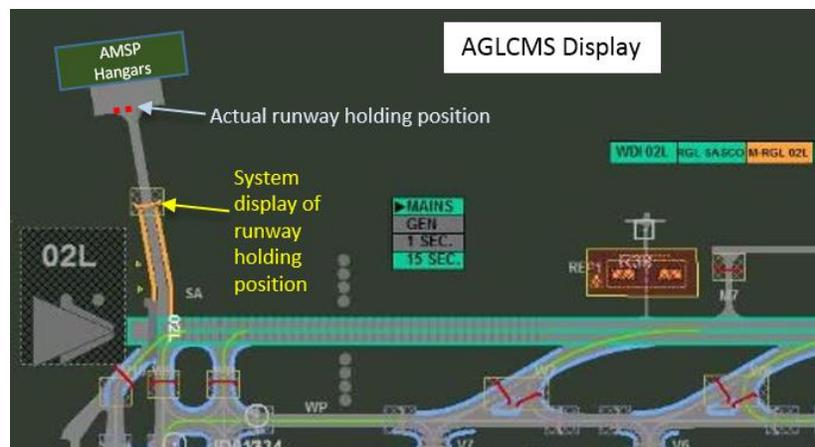
1.6.4.3 Although the runway holding position for Taxiway SA was within the MRO's premises, it was marked as being located within the aerodrome both on the AGLCMS display panel at Changi Control Tower (see **Figure 5**) and in the aerodrome chart in the Singapore Aeronautical Information Publication.

Figure 5. Incorrect display of Taxiway SA's runway holding position on the AGLCMS

- 2.3.2 Although the AGLCMS display panel at Changi Control Tower showed an incorrect location of Taxiway SA's runway holding position and red stop bar lights, the MBD detected the unauthorised entry by the towing column and set off an alarm to warn the controllers at Changi Control Tower of an impending runway incursion.

- 3.1.2 The display panel of the AGLCMS at Changi Control Tower and the aerodrome chart in the Singapore Aeronautical Information Publication were amended to reflect the correct location of the runway holding position.

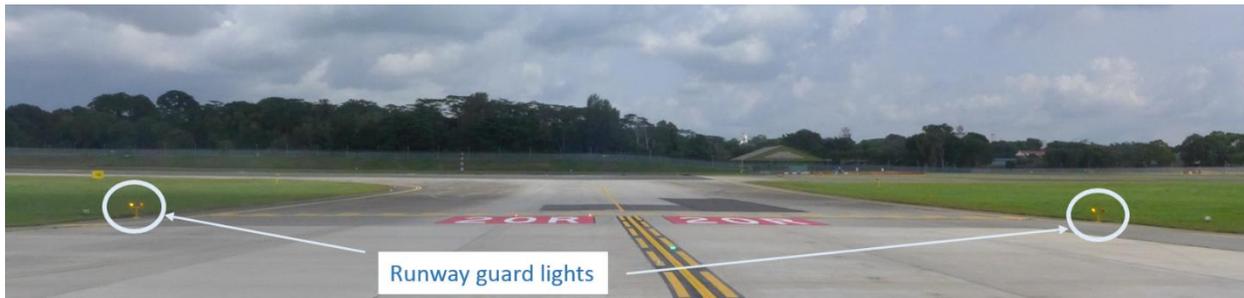
Figure 6. Runway guard lights at the side of a taxiway

1.6.5.2 Runway guard lights are for warning pilots of aircraft and drivers of vehicles when they are about to enter a runway from the taxiway. For Runway 02L/20R, the runway guard lights shall be at least 107.5m from the runway centreline¹⁵.

1.6.5.3 There were no runway guard lights at the intersection of Taxiway SA and Runway 02L/20R.

- 3.1.4 The aerodrome operator reviewed the need for runway guard lights at the intersection of Taxiway SA and Runway 02L/20R and decided to install the guard lights. The lights became operational on 14 December 2016.
