Final Report

TWO MISALIGNED TAKE-OFFS AT SELETAR AIRPORT

17 JULY and 6 OCTOBER 2024

TIB/AAI/CAS.233

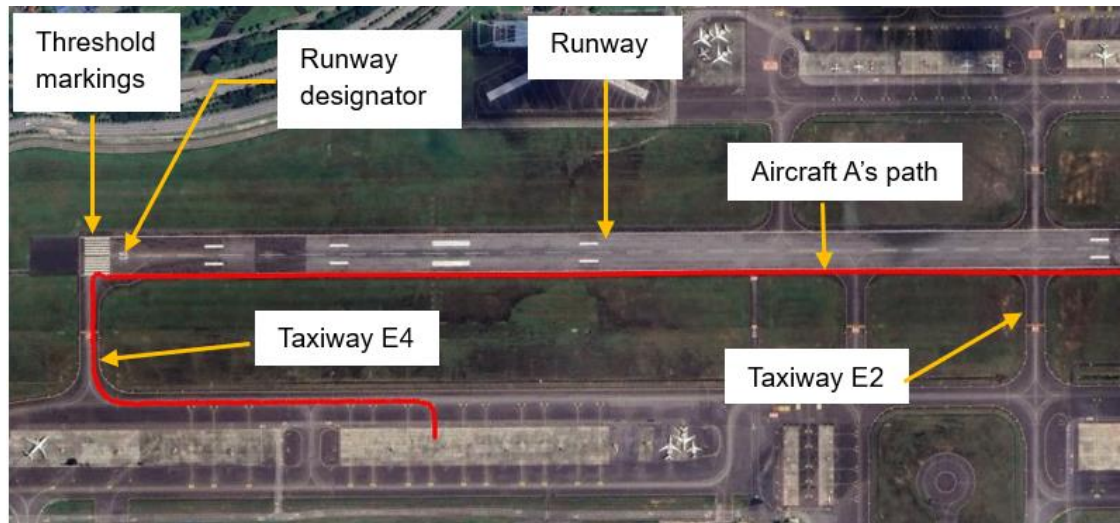
Figure 1: Aircraft A's path

and from Flightradar24² as well as the aerodrome's CCTV recordings³, showed that the aircraft started and maintained its take-off roll on the right edge of the runway. **Figure 1** shows the path of the aircraft's take-off roll. Aircraft A was the last departure that night and, as evidenced by the aerodrome CCTV, the edge light at Taxiway E2 was still lit before Aircraft A's departure (see paragraph 1.8.5.1).

- (a) Data from Aircraft A's FDR and Flightradar 24 showed that Aircraft A was on the right edge of the runway during the take-off.
- (b) Data from Aircraft A's FDR also showed that the NLG's Weight-on-Wheels (WoW) parameter changed from GND (ground) to AIR (airborne) when Aircraft A was at the location of the damaged runway edge light. The loud noise heard by the flight crew during the rotation was likely the sound generated when Aircraft A's NLG hit the runway edge light that was found damaged after the incident.
- (c) CCTV recordings from the aerodrome showed that the runway edge light went off after Aircraft A went past the location of the light.
- (d) The rectangular hole found on Aircraft A's NLG right tyre after the aircraft landed at Muscat International Airport matched the size of the runway edge light body.

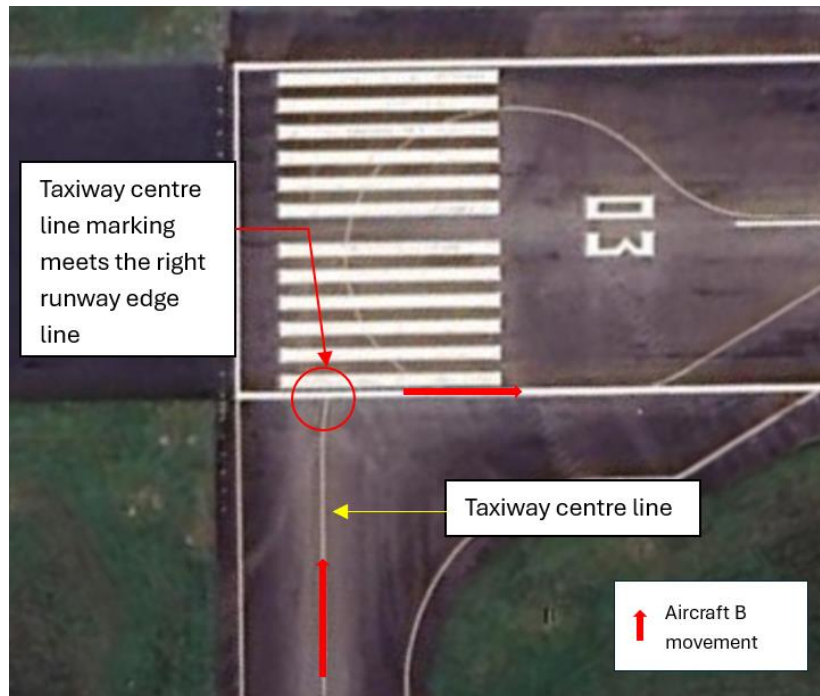
Figure 2: Aircraft B's path from Taxiway E4 to Runway 03

- 1.2.5 **Figure 2** shows the path of Aircraft B's turning from Taxiway E4 onto the runway. According to the PF, he followed the taxiway centre line marking closely when he was turning the aircraft onto the runway.

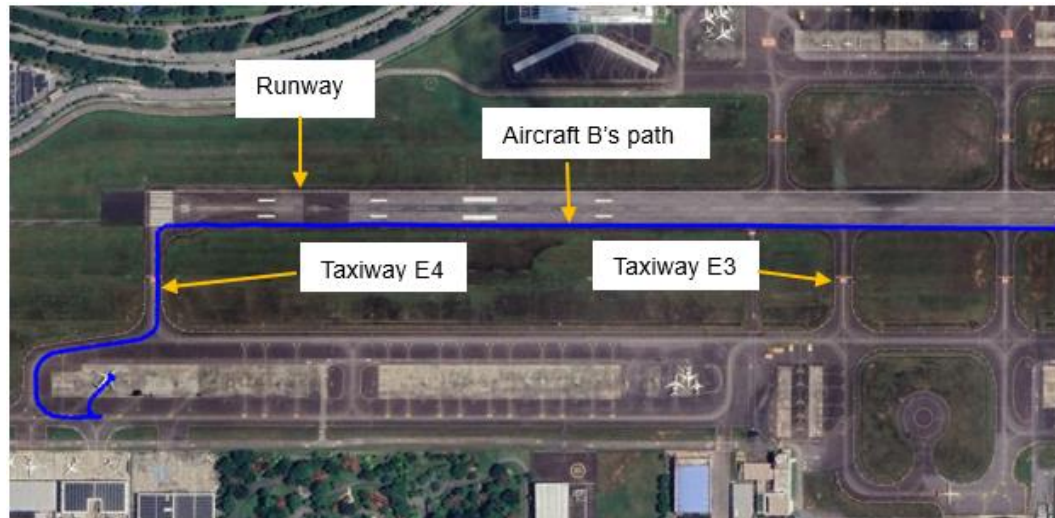
Figure 3: Aircraft B's path

- 1.2.6 According to data from Aircraft B's FDR, after turning onto the runway, the aircraft remained stationary on the runway for about 11 seconds before starting its take-off roll.
- 1.2.7 Data from the aircraft's FDR and from Flightradar24, as well as the aerodrome's CCTV recordings showed that the aircraft started and maintained its take-off roll on the right edge of the runway. **Figure 3** shows the path of Aircraft B's take-off roll. The aircraft lifted off at about 2042 hours. According to the flight crew, there were no abnormal vibrations and sounds during the take-off roll.

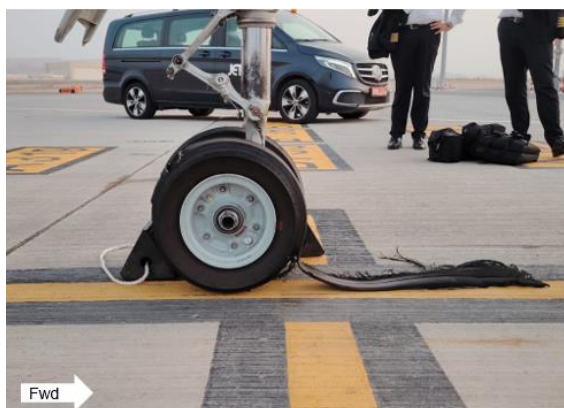
1.4.1 For Aircraft A, the NLG sustained the following damage (see **Figure 4** to **Figure 6**):

- (a) The right tyre of the NLG was found with a rectangular hole⁶. Its tyre tread was also separated from the tyre.
- (b) The auxiliary shield door was sheared off from the NLG. The main shield door of the NLG was also damaged.
- (c) An NLG electrical harness was also damaged.

Figure 4: Damaged right tyre of NLG

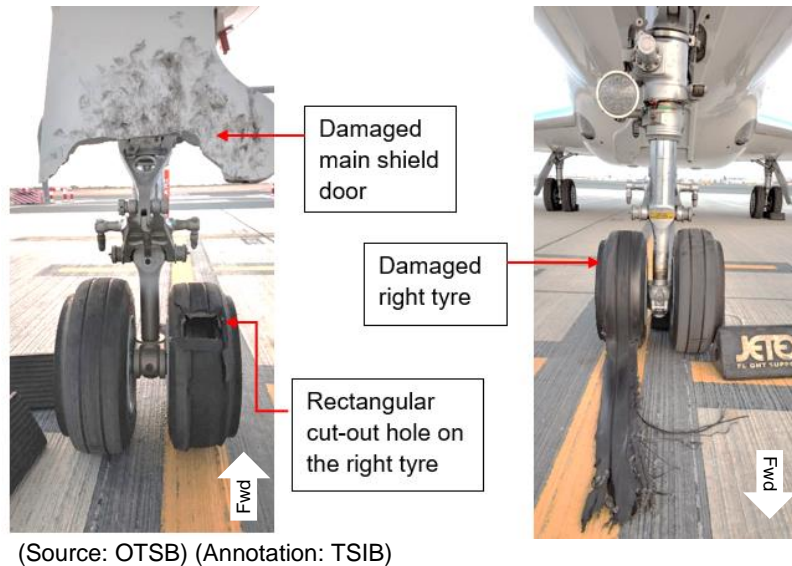
Figure 5: Damage to the right tyre and main shield door of the NLG

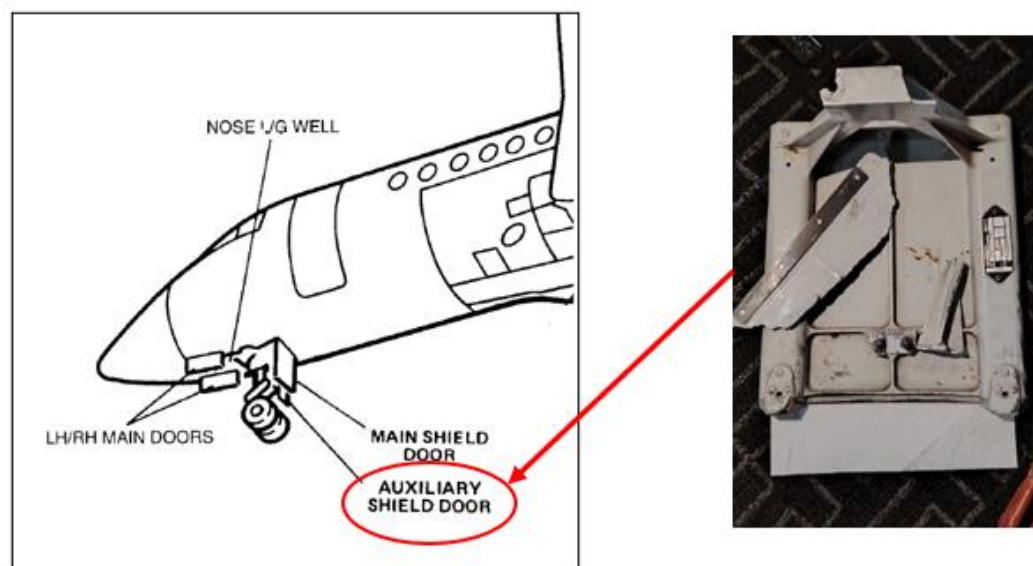
Figure 6. Damage to the sheared NLG auxiliary shield door

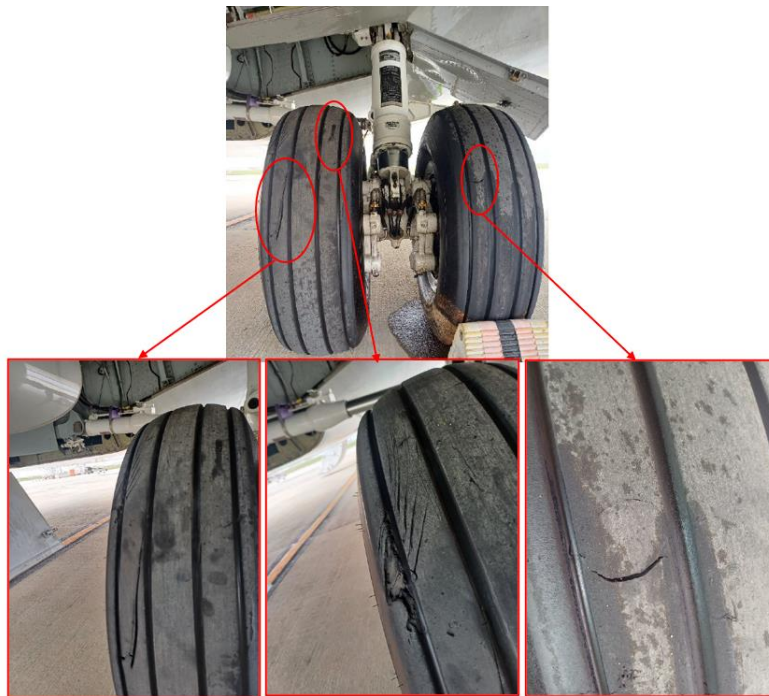
- (a) The inboard and outboard tyres had deep cuts (see **Figure 7**).
- (b) There was hydraulic fluid leaking from the sheared bleeder plugs on the outboard brake assembly (see **Figure 8**).

Figure 7: Damages to the right MLG tyres (viewed from the front)

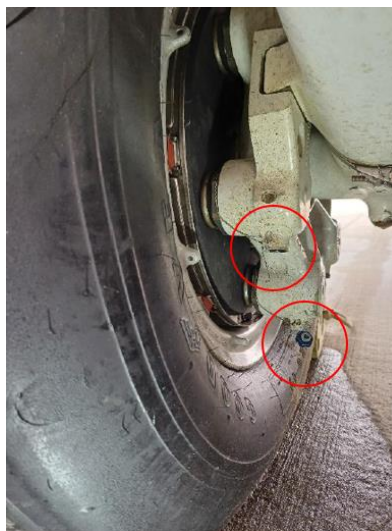
Figure 8: Sheared bleeder plugs of the right MLG outboard brake assembly

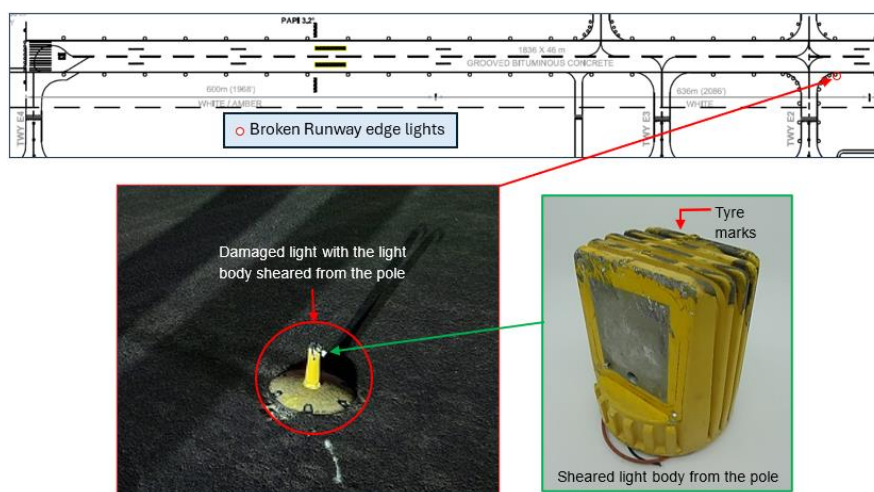
- 1.5.1 For the incident involving Aircraft A and as mentioned in paragraph 1.1.7, a runway edge light near Taxiway E2 was damaged (see **Figure 9**). The light body was sheared off from the supporting pole. There were tyre marks on the top part of the edge light body. Debris pieces of the edge light were found on the grass patch about 50m away in the direction of the departure.

Figure 9: Damaged runway edge light near Taxiway E2

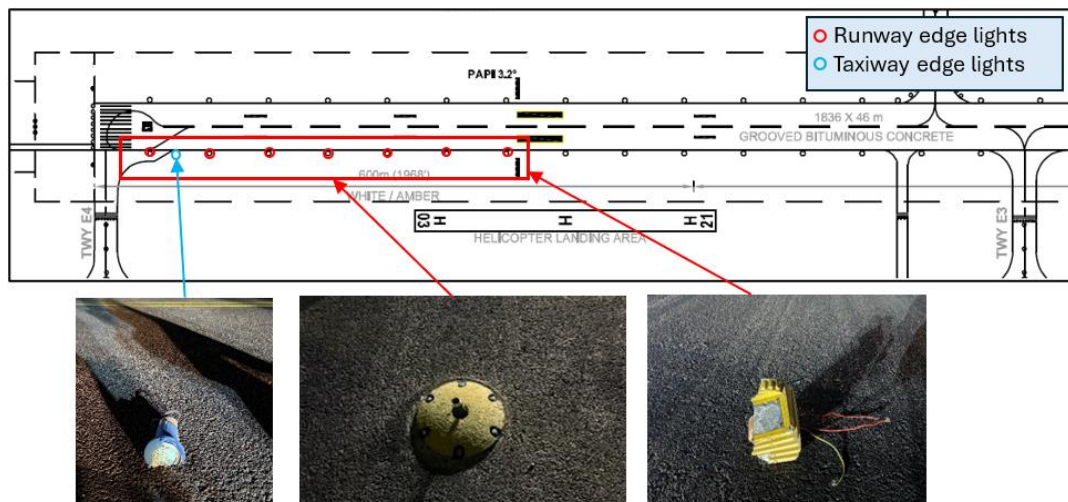
- 1.5.2 For the occurrence involving Aircraft B, seven consecutive runway edge lights on the right side of Runway 03, between Taxiways E4 and E3 and the first taxiway edge light on Taxiway E4 were damaged (see **Figure 10**).

Figure 10: Damage runway edge lights and taxiway edge light between Taxiways E4 and E3

- 5.1 It is recommended that the aerodrome operator improve the early detection of FOD on the runway by using available technologies. [TSIB Recommendation RA-2025-002]

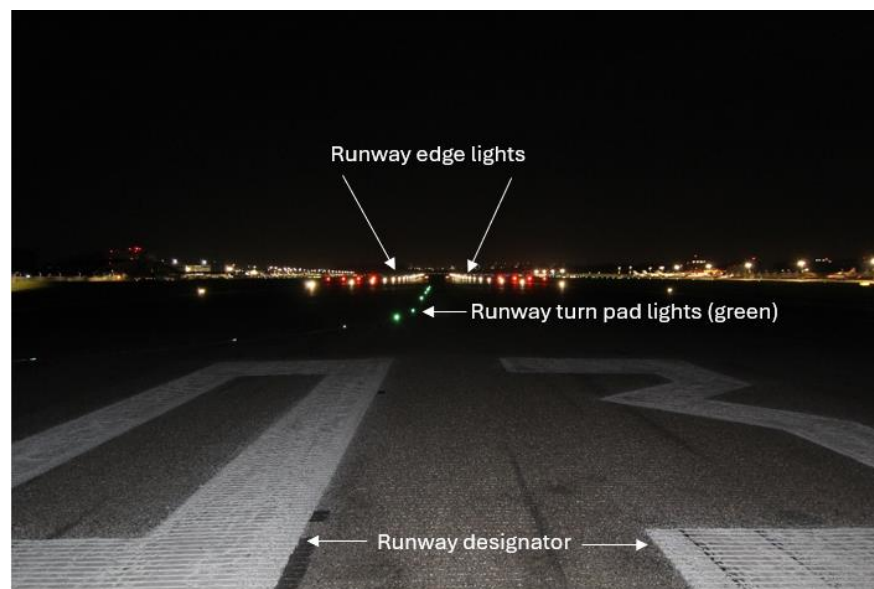
1.8.2.1 Runway 03/21 has a runway centre line marking but does not have runway centre line lights¹⁰. This is reflected in Section WSSL 2.14 of the Singapore Aeronautical Information Publication. The runway has elevated edge lights (see **Figure 11**) which are bi-directional. The runway edge lights are white, except for the last 600m on either end of the runway where the edge lights are yellow (not visible in Figure 11). The runway edge lights have five brilliancy intensities¹¹.

Figure 11: Night view of Runway 03 from the runway designator (Note: The light in the foreground was from a vehicle.)

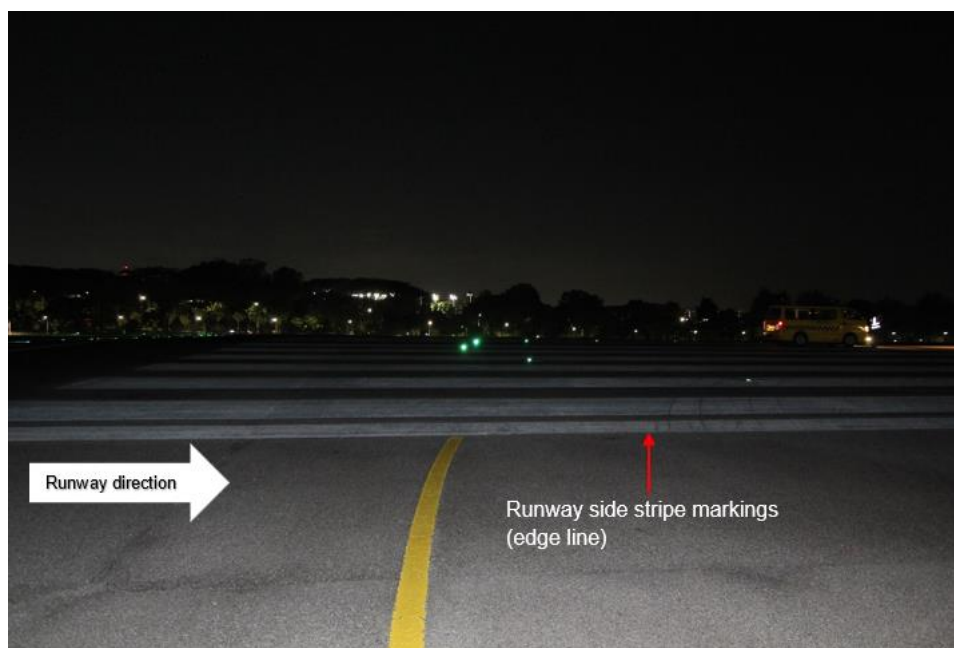
- 1.8.2.2 The runway threshold markings (see **Figure 12**) and runway designation markings¹² (see Figure 11) for Runway 03 were repainted on 16 March 2024 and 18 May 2024 respectively¹³.

Figure 12: View of runway threshold markings from Taxiway E4

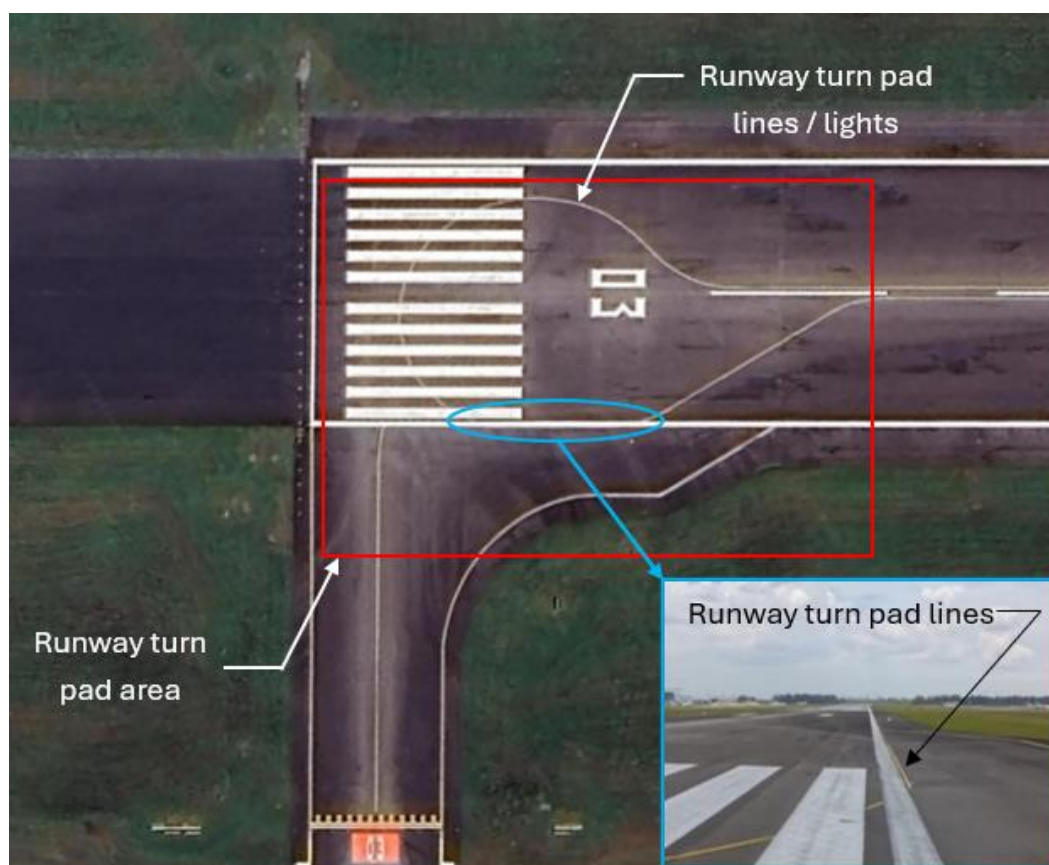
operations (see **Figure 11**). Associated with the turn pad, there is an additional paved area of about 56m by 19.50m on the right side of Runway 03 to allow for the aircraft to turn around. The extra paved area and turn pad lights are in line with ICAO's requirements.

Figure 13: Runway turn pad on Runway 03

- 2.2.3 The additional paved area to the right side of the runway edge at Runway 03 threshold may have led the flight crew to believe they were at the centre of the runway as they would have seen the taxiway edge lights demarcating the edge of the taxiway some distance away from the aircraft.

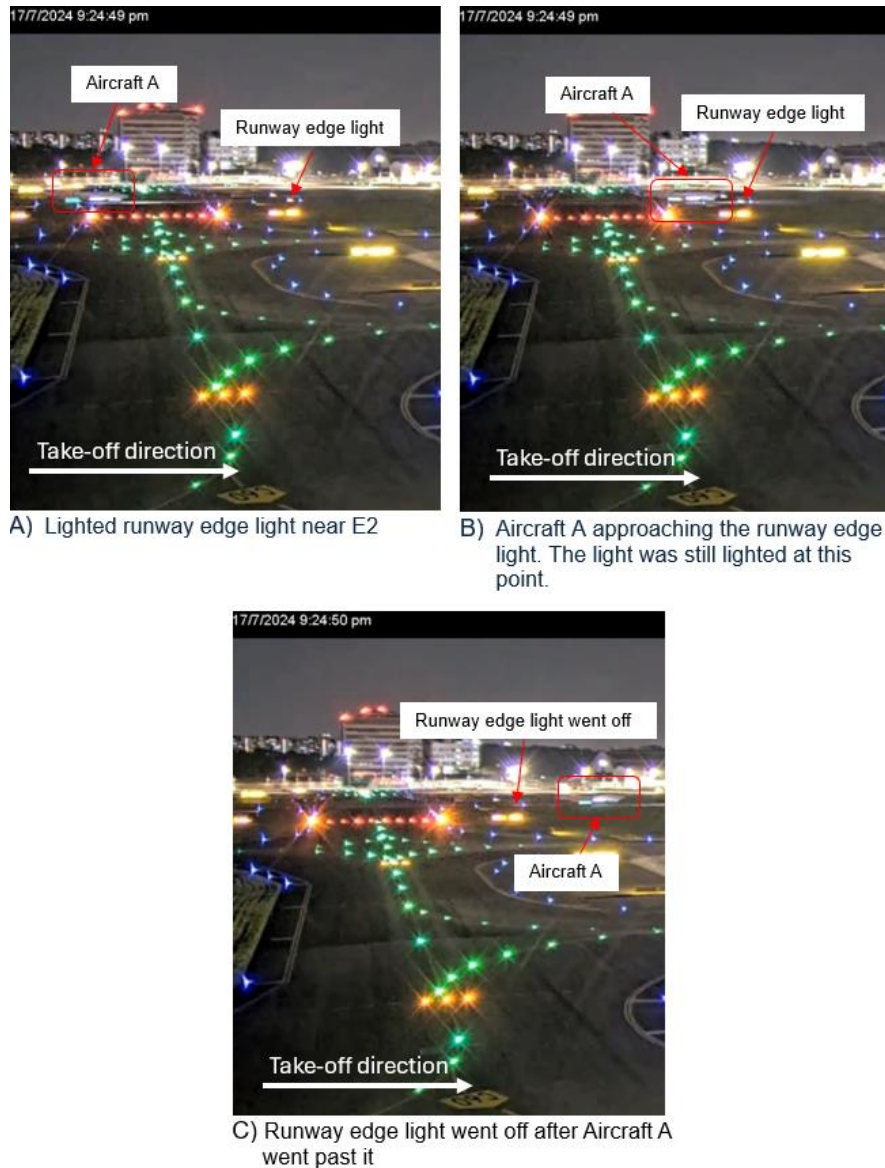
1.8.5.1 The brilliancy of the runway edge lights was set at 10% on the night of 17 July 2024. The aerodrome's CCTV recordings¹⁷ revealed that the runway edge lights on the night of 17 July 2024 were functioning properly before Aircraft A took-off. The runway edge light went off when Aircraft A passed the position of runway edge light (that was later found damaged) near Taxiway E2 (see **Figure 14**).

Figure 14: CCTV recordings¹⁸ showing the runway edge light went off after Aircraft A had passed its location

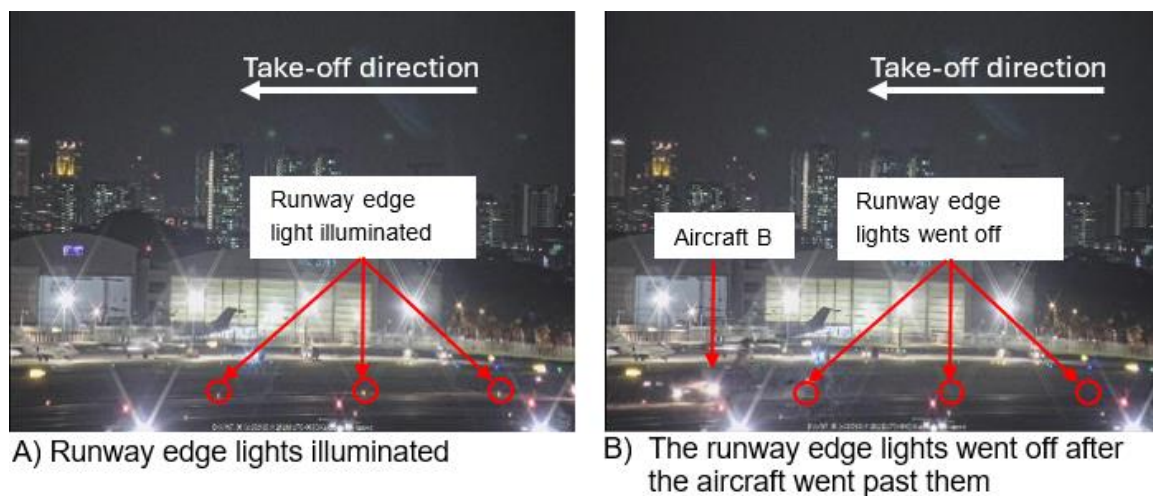
- 1.8.5.2 The brilliancy of the runway edge lights was also set at 10% on the night of 6 October 2024. CCTV recordings also revealed that the runway edge lights on the night of 6 October 2024 were functioning properly before Aircraft B took-off. When Aircraft B passed the runway edge lights' locations, the lights went off (see **Figure 15**).

Figure 15: CCTV recording showing runway edge lights went off after Aircraft B had passed their locations

- (b) CCTV recordings from the aerodrome showed that the edge lights went off after Aircraft B went past them. Data from the Aircraft B's FDR showed that at this moment the aircraft was still rolling on ground as the NLG and MLGs' WoW parameters were still at GND.
- (c) The damages sustained by the right MLG were most likely the result of it hitting the runway and taxiway edge lights.

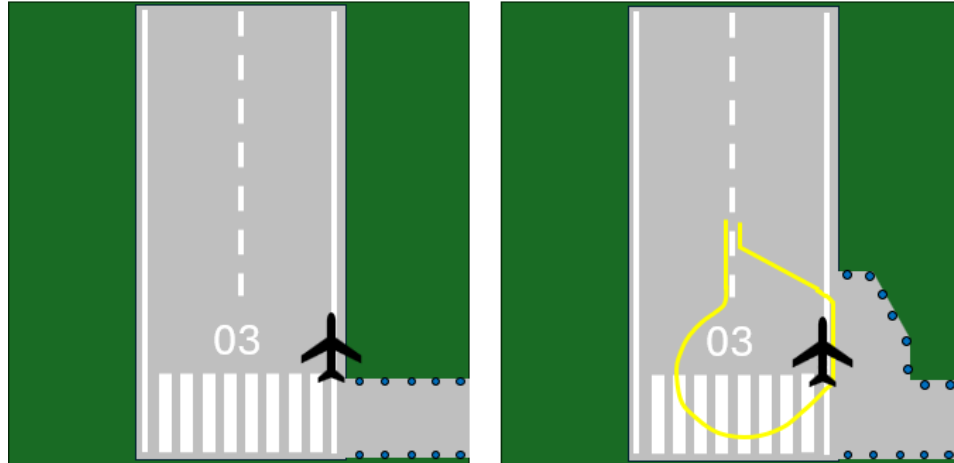
Figure 16: Lateral positioning of an aircraft
