Final Report

Missing of Fitter From SRS RTM Zheng He At Sea On 26 December 2024

TIB/MAI/CAS.187

Transport Safety Investigation Bureau
Ministry of Transport
Singapore

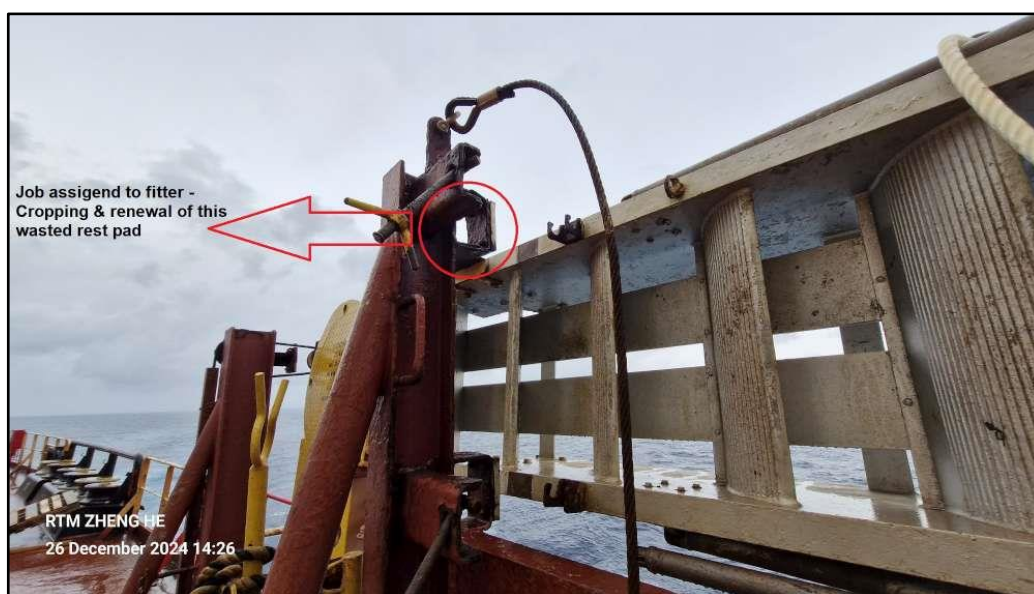
- 1.1.7 For task 5, the FTR was assigned to crop and renew the damaged rest pads used for the port side gangway (**Figure 2**) with the assistance from the Ordinary Seaman (OS) and DTSM. The OS was to help with keeping a fire watch, while the DTSM was to assist the FTR in gathering tools for the task.

Figure 2 – Location of the rest pads at the port side gangway with annotation
(Source: the Company)

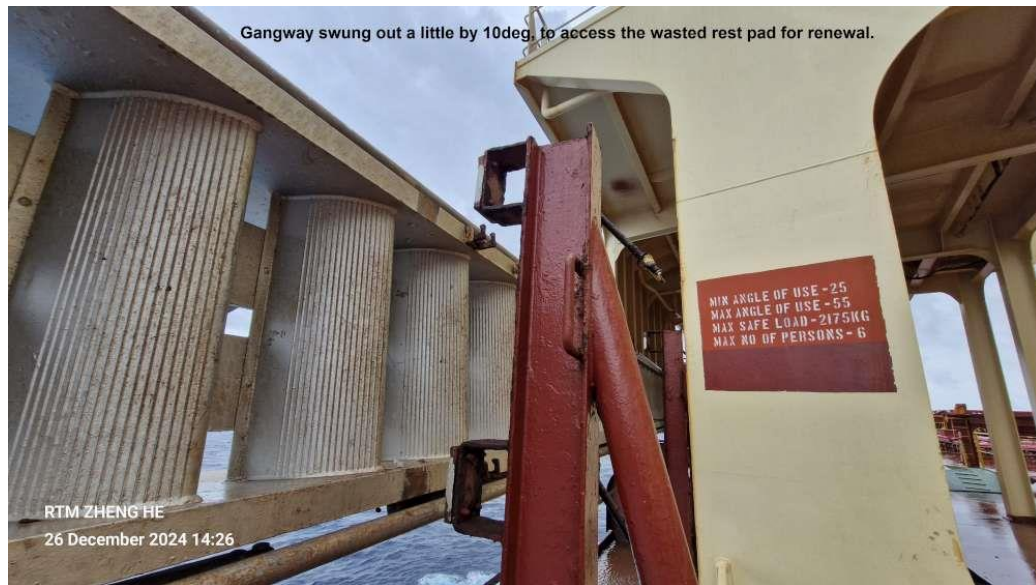
- 1.1.13 This half metre gap would provide the FTR with access to weld the new rest pad by standing on a step stool from the inboard side. The DTSM shared with the investigation team that the step stool was a two-step design, but it was not prepared and brought on-site on the morning of 26 December 2024.

- 1.1.14 According to the Company, the gangway was swung approximately 10 degrees outward from its stowed position, (**Figure 3**) against the rest pad.

Figure 3 – View of the gap after the port side gangway was swung out.
(Source: the Company)

gangway was less than 1.8m, working at the gangway, located at the shipside with a half metre gap (according to the DTSM's account), introduced a potential risk of falling overboard when working at the location, particularly when the ship was underway. Nevertheless, this incidental finding is made in the interest of enhancing safety practices and does not imply a determination of cause for this occurrence, which remains undetermined.

- 5.1 To ensure that crew don a safety harness when working near the shipside, or on tasks where there is a risk of falling overboard. **[TSIB Recommendation RM-2025-004]**
- 5.2 To ensure that all crew assigned for tasks involving enclosed space entries be clearly identified in relevant working documentation. **[TSIB Recommendation RM-2025-005]**

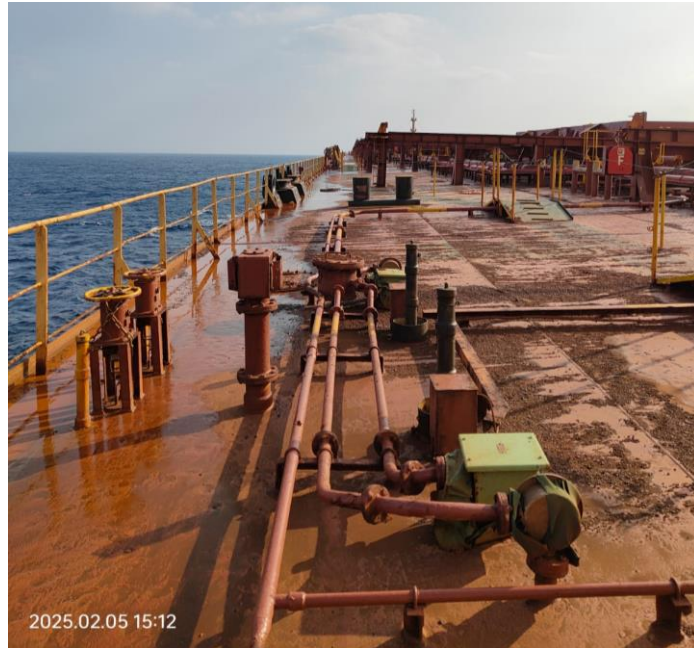
- 1.2.2 According to the Company, the distance between the CDWT(P) entrance (where the DTSM was keeping the lookout at the time), and the Bosun Store was about 250m (**Figure 4a**). The Company and the DTSM shared that the view of the Bosun Store from the CDWT(P) was blocked by deck structures.

Figure 4a – View of the Bosun Store, located at the far end of the picture, from the CDWT (P) was blocked by deck structures. (Source: the Company)

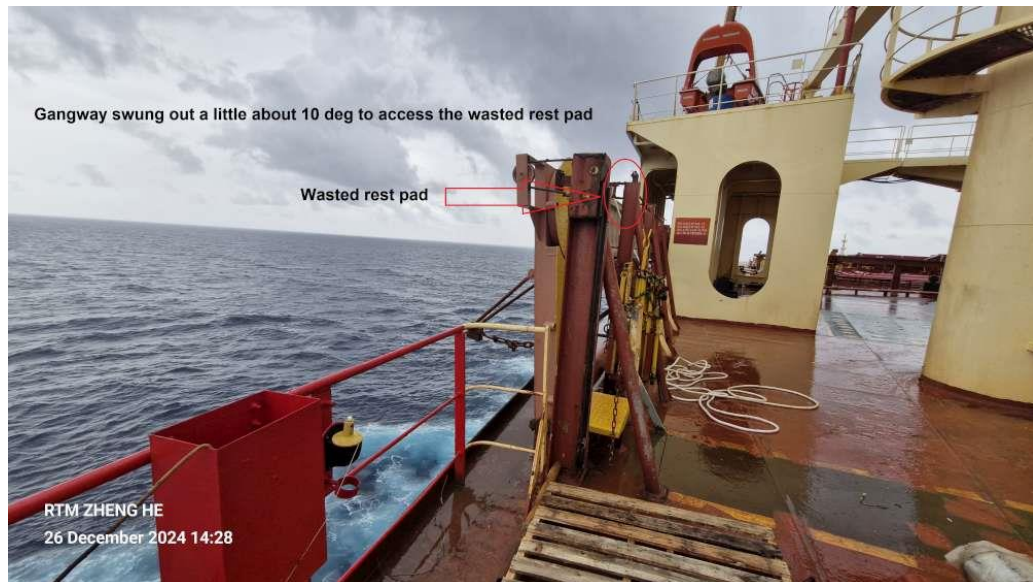
- 1.2.3 The Company also shared that the distance from the port side gangway to the CDWT(P) entrance was about 23m (**Figure 4b**) and the DTSM was likely unable to clearly see the port side gangway from his position at the CDWT(P) as his line of sight was obstructed by the accommodation structure.

Figure 4b – View from the port side gangway looking forward to the CDWT(P). (Source: the Company)
