# **Final Report**

## **RUNWAY INCURSION AT CHANGI AIRPORT**

**28 AUGUST 2024**

TIB/AAI/CAS.237

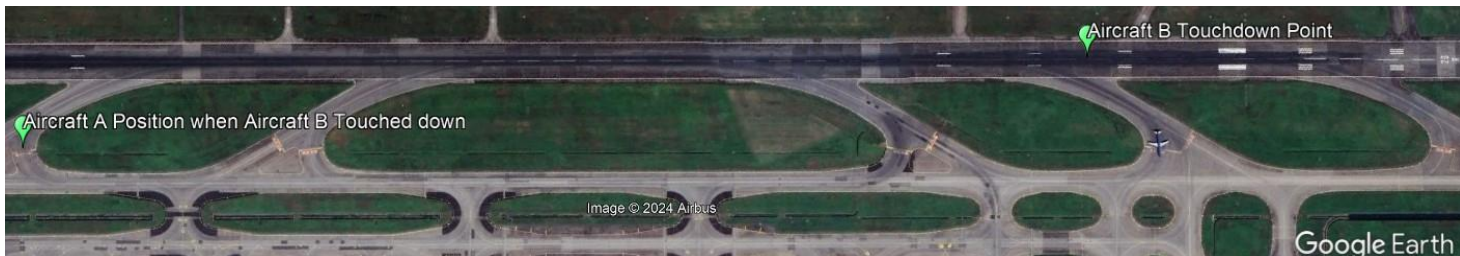
- 1.1.14 When the RWC issued the go-around instruction, Aircraft B was at 76ft AGL and about 296m before the runway threshold. Aircraft B did not acknowledge the go-around instruction. The PF of Aircraft B continued with the landing, commanding both engines to idle power at 20:13:31 hrs when the aircraft was 15ft AGL. Aircraft B touched down on Runway 20R at 20:13:38 hrs. As Aircraft B had already landed, the RWC assessed that it was no longer necessary to instruct Aircraft B to go around, taking into consideration that the tail of Aircraft A was clear of the runway edge line and there was no obstruction that would interfere with Aircraft B's landing roll. Subsequently, both Aircraft A and B taxied to their assigned parking bays uneventfully.

Figure 1: Relative positions of Aircraft A and B when Aircraft B touched down

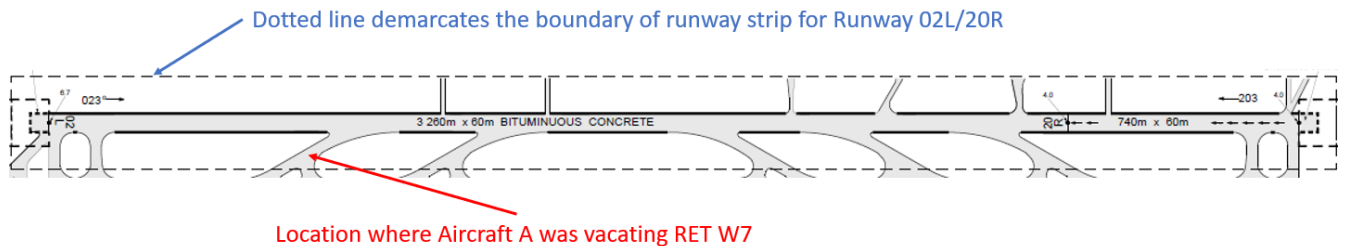
1.8.2.2 For Runway 02L/20R, the runway strip (see **Figure 2**) comprises<sup>7</sup>:

- (a) An area that extends 140m laterally from the centreline of the runway
- (b) An area that extends 60m from the ends of the two stopways

Figure 2: Runway strip area of Runway 02L/20R
