Final Report

SINKING OF TWO HARBOUR CRAFT OSHIO AND YAKUSHI MARU NO 3 RESULTING IN TWO FATALITIES ON 4 SEPTEMBER 2024

TIB/MAI/CAS.179

Transport Safety Investigation Bureau of Singapore
Ministry of Transport
Singapore

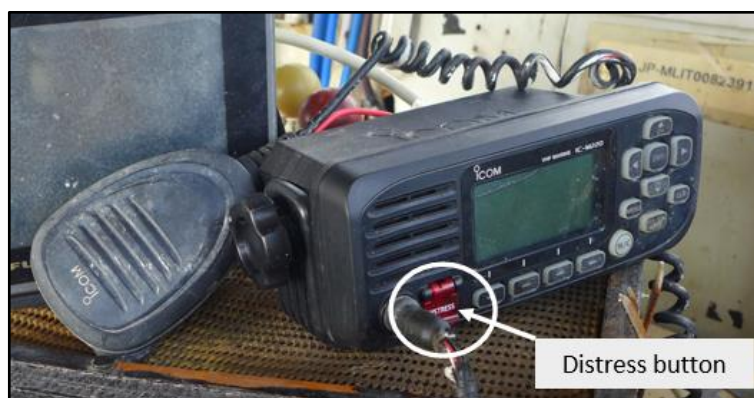
Figure 1 – One of the three VHF sets inside the wheelhouse with annotation of the distress button (*Source: the TSIB*)

2.2.2 It is unclear why the Master had called the Operator instead of activating the quick distress button on the VHF radio equipment or reporting the incident to the port authority (MPA) directly for assistance. The activation of the distress button could alert vessels in the vicinity and the port authority at the same time which would have provided faster assistance or search and rescue effort.

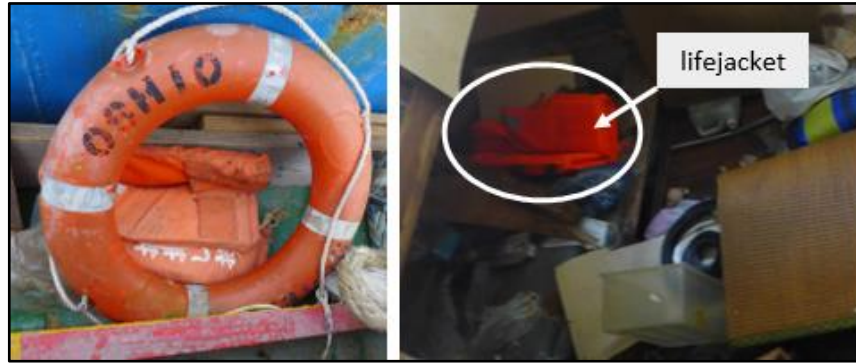
1.2.1.3 All harbour craft licenced by the MPA had to be inspected at its first registry and its subsequent annual renewal. The last inspection carried out on board Oshio was at its mooring base on 5 July 2024. Based on Oshio's inspection records, the hull condition was satisfactory, six lifejackets and four lifebuoys were placed on board as part of the life-saving appliances. All these life-saving appliances were found on board Oshio after it was salvaged (see **figure 2**).

Figure 2 - Lifejackets inside wheelhouse (left) and the resting compartment below deck (right) of Oshio (*Source: the TSIB*)

2.1.9 Both the Master and ED had lost their lives from the sinking occurrence, their bodies were discovered without wearing personal floatation device.

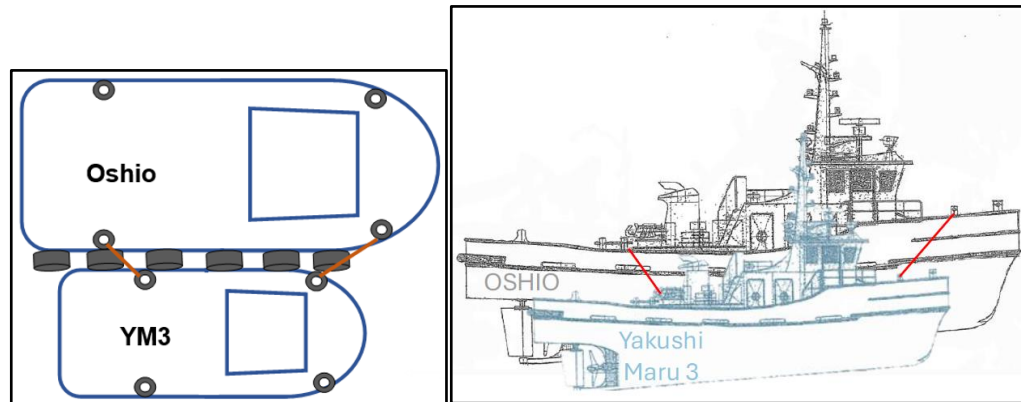
side. As per the recollection of the crane barge master, Oshio and YM3 was tied side-by-side with a single loop mooring rope through two pairs of bollards on board both Oshio and YM3 (see **figure 4**).

Figure 4 – Sketch illustration on side-tow arrangement (top and side view) (*Source: side view from the Operator*)

2.1.7 As reported by the Master, YM3 had taken in water first and followed by Oshio. The sinking YM3 could have pulled down Oshio as both harbour craft had been secured together at the forward and aft bollards. This sequence of sinking occurrence collaborated with the condition of wrecks underwater, where the stern of YM3 was found to be deeper in the seabed mud as compared to the wreck of Oshio.

- 5.1 To implement a system to ensure risk assessments are carried out by the crew members involved in a side-tow operation before commencement of the passage. **[TSIB Recommendation RM-2025-001]**
- 5.2 To review and ensure its Standard Operations Manual contains safe working practices that are relevant to its type of vessels and operations. **[TSIB Recommendation RM-2025-002]**
- 5.3 To review the procedures in its SOM to ensure that the procedures listed are relevant and implementable for its fleet of vessels. **[TSIB Recommendation RM-2025-003]**

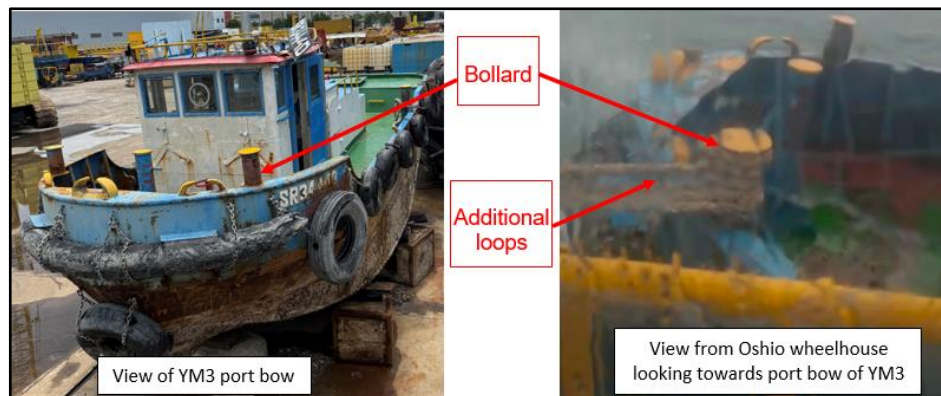
- 1.4.2 The video posted on his own WhatsApp Updates by the Master indicated additional loops of the mooring rope (see **figure 5**) had been secured onto the bollards after departing Pandan.

Figure 5 - YM3 at yard (left) and screenshot (right) of the video on the Master's WhatsApp (*Source: the TSIB*)

- 2.1.1 The two craft, Oshio and YM3, were on side-tow and experienced windy and high swell environment as shown in Master's video after departing Pandan. The two more loops of mooring rope, as observed during the underwater inspection, could have been added by the Master after experiencing the windy and high swell environment.

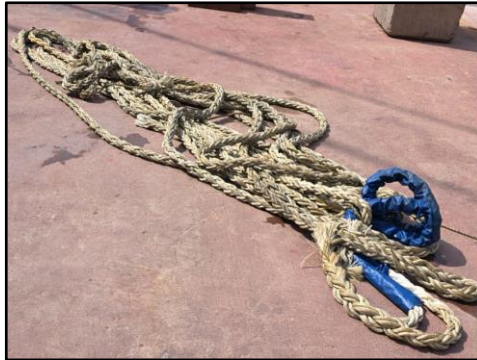
- 1.4.3 Two mooring ropes with the same specifications¹³ were used to secure the pair of bollards on board both Oshio and YM3 for the side-tow. One of the ropes (see **figure 6**) was found floating on water surface in the vicinity of the sinking site, which was identified by the Operator, to be the one securing the aft

Figure 6 - Mooring rope used for securing Oshio and YM3
(Source: the Operator)

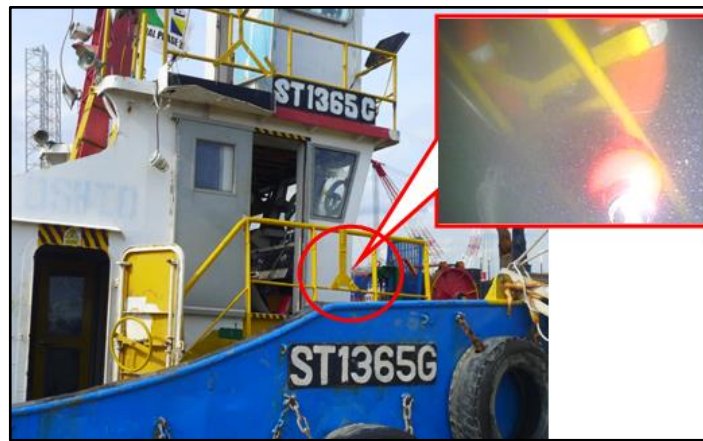
- a) The mooring rope securing both craft at the forward bollards had two more loops in addition to the single loop made at the departure of Pandan.
- b) All lifejackets and lifebuoys (an example, see **figure 8**) remained on board Oshio.

Figure 8 – Oshio starboard side forward lifebuoy with line and self-igniting light was on (*Source: the diving company*)

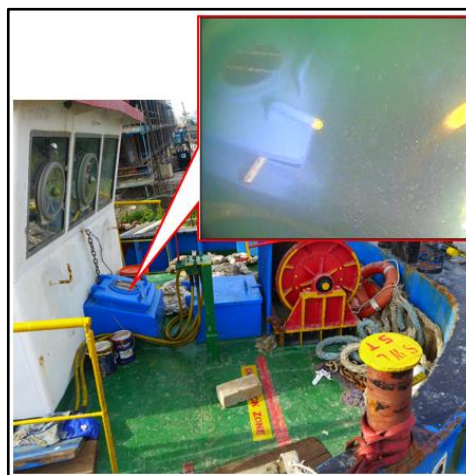
- c) The hatch of the resting compartment at forward deck was prevented from closing fully by a bar (see **figure 9**).

Figure 9 – Oshio's forward hatch was prevented from closing fully by a bar
(Source: the diving company)

- 2.3.3 For the fact that the watertight openings of YM3 and Oshio were left open, and the hole at the hull of YM3 connected to the flexible pipe linking to the bilge pump was not plugged, it also shows that the risk of taking in water was not considered for this towage operation.

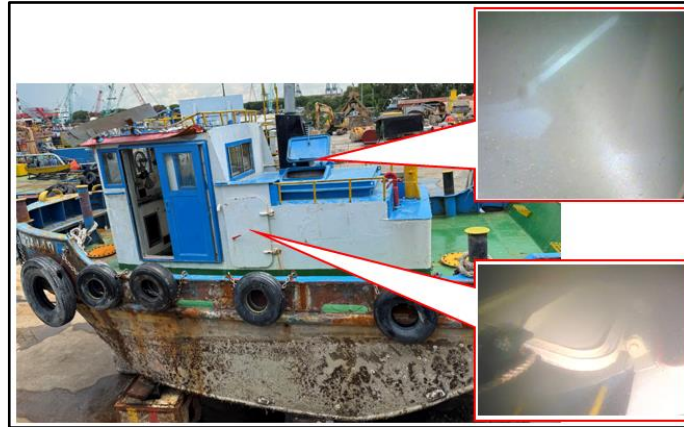
- d) On board YM3, the hatch at the midship, the entrance doors at the port and starboard sides were found open (see **figure 10**).

Figure 10 – View of hatch and entrance door
(Source: the diving company)

- b) The hatch at the midship and the entrance doors at the port and starboard sides which were found open.
- 2.1.5 The ingress of water into YM3 could have started much earlier as the weather enroute from Pandan to Tekong was windy and high swell seas but not noticed by the Master and ED as the amount of sea water taking in was gradual.

ahead during the turn. More sea water could have entered through the starboard entrance door and even the midship hatch at this time.

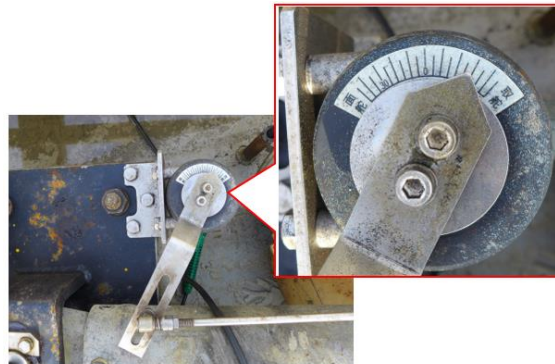
- a) Both Oshio and YM3 had no visible cracks or damage on their hulls and propeller shaft.
- b) The hydraulic steering system indicator at the aft of Oshio indicated a helm order of starboard 28° (see **figure 11**), which corresponded to a starboard alteration of course from 007° to 035° between 1348H and 1351H on the occurrence day.

Figure 11 – View of hydraulic steering system indicator (*Source: the TSIB*)

- 2.1.6 The hydraulic steering system indicator shown at starboard 28° revealed that Oshio was executing a starboard turn prior to the sinking. The starboard turn could have exacerbated YM3 taking in more water as the starboard hull of YM3 would be relatively lower facing the rough seas and high swells as moving

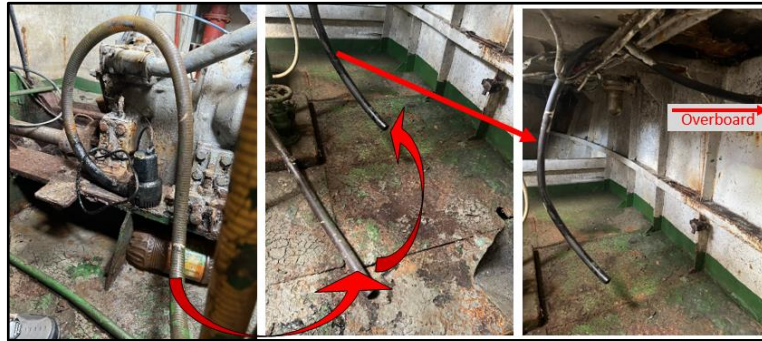
- c) A hanging flexible pipe in the machinery compartment on board YM3 linking to the bilge pump was disconnected (see **figure 12**). The pipe was used for pumping bilge water overboard.

Figure 12 - View of the disconnected bilge pipe inside engine compartment of YM3 (*Source: the TSIB*)

- 2.1.4 The following areas on board YM3, had possibly further allowed sea water to enter the compartments of YM3:
- a) The hole (overboard) at the side of YM3 was connected to a flexible pipe used for pumping bilge water out from the machinery space. However, the flexible pipe was found disconnected. As such, sea water could enter the machinery compartment through this hole, though the hole was small; and
