Final Report

TRAIN DEPARTED A STATION WITH AN OPEN-DOOR INCIDENT 17 DECEMBER 2024

TIB/RAI/CAS.015

Transport Safety Investigation Bureau
Ministry of Transport
Singapore

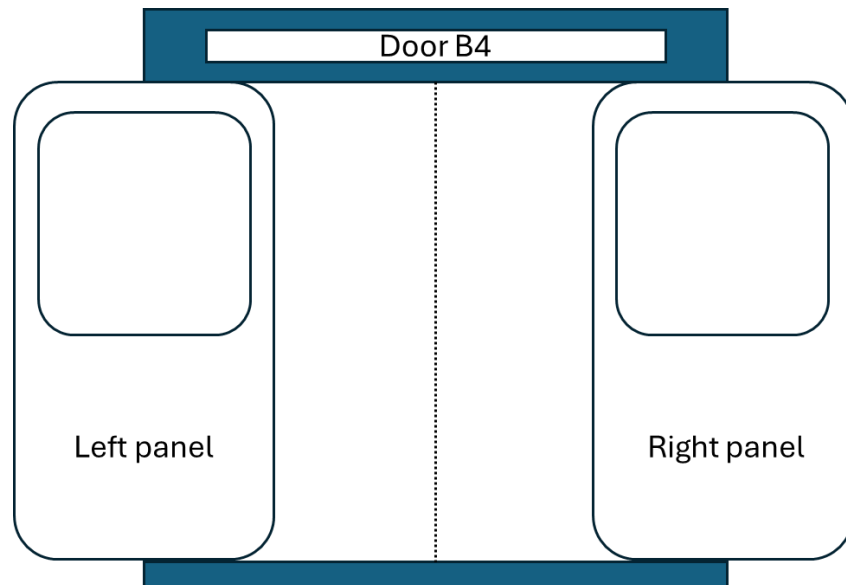
- 1.1.1 At 18:30 hours on 17 December 2024, Passenger Vehicle 02 (PV02), travelling in Automatic Mode (AM) on the Thomson-East Coast Line (TEL), arrived at the Woodlands Bound (WB) platform of Gardens by the Bay Station (GRB). As the train doors opened for passengers to alight and board, Door B4 of car 4 (hereinafter “Door B4 of car 4” will be simply referred to as “Door B4”) opened only halfway (see **Figure 1**).

Figure 1: Door B4 opened only halfway

- 1.1.2 When the dwell time was up for the train to depart GRB at 18:31 hours, the platform screen doors (PSDs) and PV02 train doors were commanded to close. However, Door B4 did not close and was stuck in the half-opened position. PV02 could not depart from GRB. The signalling system applied a train hold to PV02, which commanded all the train doors and PSDs to open, but Door B4 remained stuck in the half-opened position. At the same time, the Train Service Controller (TSC) at the Operations Control Centre (OCC) received an alarm from PV02 indicating that there was a train door fault at Door B4. He verified the situation through the station's CCTV.

2.1.1 After PV02 had arrived at GRB, nothing was found by the ASM that could have prevented the Door B4 from opening fully. The rail operator's inspection of Door B4 at depot after the train was withdrawn from service also did not find any abnormality. The Door B4 was able to open and close normally during the inspection.

2.1.2 The investigation team is unable to determine the cause of Door B4's inability to open fully at GRB platform. The investigation team has noted a postulation by the rail operator that there could have been a hidden foreign object along the doorway which prevented Door B4 from opening or closing and that this foreign object somehow dropped off from the doorway during PV02's movement from GRB to MRB.

- 3.1 The cause as to why Door B4 was stuck could not be determined, although there was a possibility of a hidden foreign object along the doorway which prevented Door B4 from opening or closing and that this foreign object had dropped off from the doorway during the train's movement from GRB to MRB.

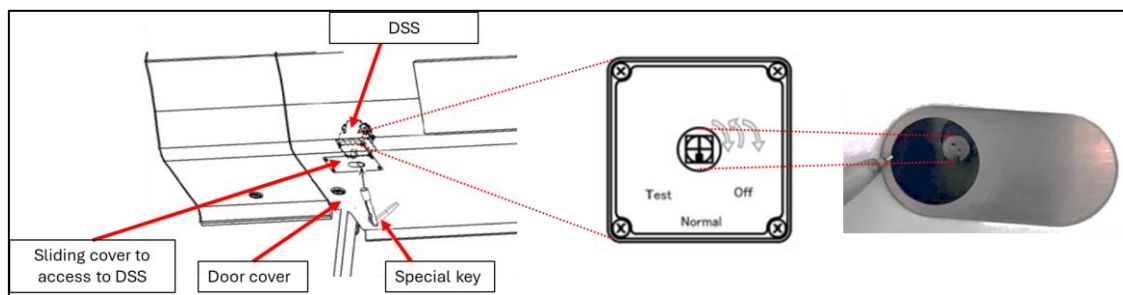
- 1.6.1 A train DSS comes in the form of a keyhole and is located at each train door behind the door cover (see **Figure 2**). The DSS keyhole has three positions: "Off", "Normal" and "Test" and is accessible through a hole on the door cover. The hole is covered by a sliding cover and is visible when the sliding cover is slid open. The wording for the DSS positions ("Normal", "Test" and "Off") is not visible.

Figure 2: DSS and its positions

2.4.1 The DSS is located behind the door cover above a door frame. It is possible to insert a switch key into the DSS through a small sliding cover to turn the DSS, without opening the door cover. This was what the ASM did. However, without opening the door cover, one will not be able to see the wording for the DSS positions ("Normal", "Test" and "Off"). Thus, the ASM relied on his memory as to the direction for turning to the "Test" position but he remembered wrongly the direction and ended up turning the DSS to the "Off" position.

- 2.4.2 Without opening the door cover to view the wording for the DSS positions, there is a risk, as shown in this incident, that operational staff could recall wrongly the direction in which they should turn the DSS. If there were markers or wording on the door cover to indicate the “Test”, “Normal” and “Off” positions, operational staff would not have to rely on memory when deciding on the turn direction and this train-departure-with-door-open incident would not have occurred.
- 2.4.3 It would be desirable for the rail operator to mark the DSS positions on the door cover, so that operational staff do not have to rely on memory to determine the correct turn direction when the door cover is not opened.

- 3.4 Without opening a door cover, one will not be able to see the wording for the DSS positions (“Normal”, “Test” and “Off”). There is a risk of operational staff turning the DSS to the wrong position if they rely on their memory when deciding on the turn direction.

- 4.1 The rail operator has issued a reminder to its operational staff on the importance of adhering to the SOP for handling a train door fault.
- 4.2 The rail operator has designed a sticker to be affixed to the door cover to guide operational staff on the correct way to turn the DSS. Installation of the stickers is now in progress and is targeted to be completed by end July 2025.
