Final Report

AIRBUS A320, REGISTRATION 4R-ABN DAMAGE TO RUNWAY EDGE LIGHTS ON LANDING

AIB/AAI/CAS.178

Transport Safety Investigation Bureau
Ministry of Transport
Singapore

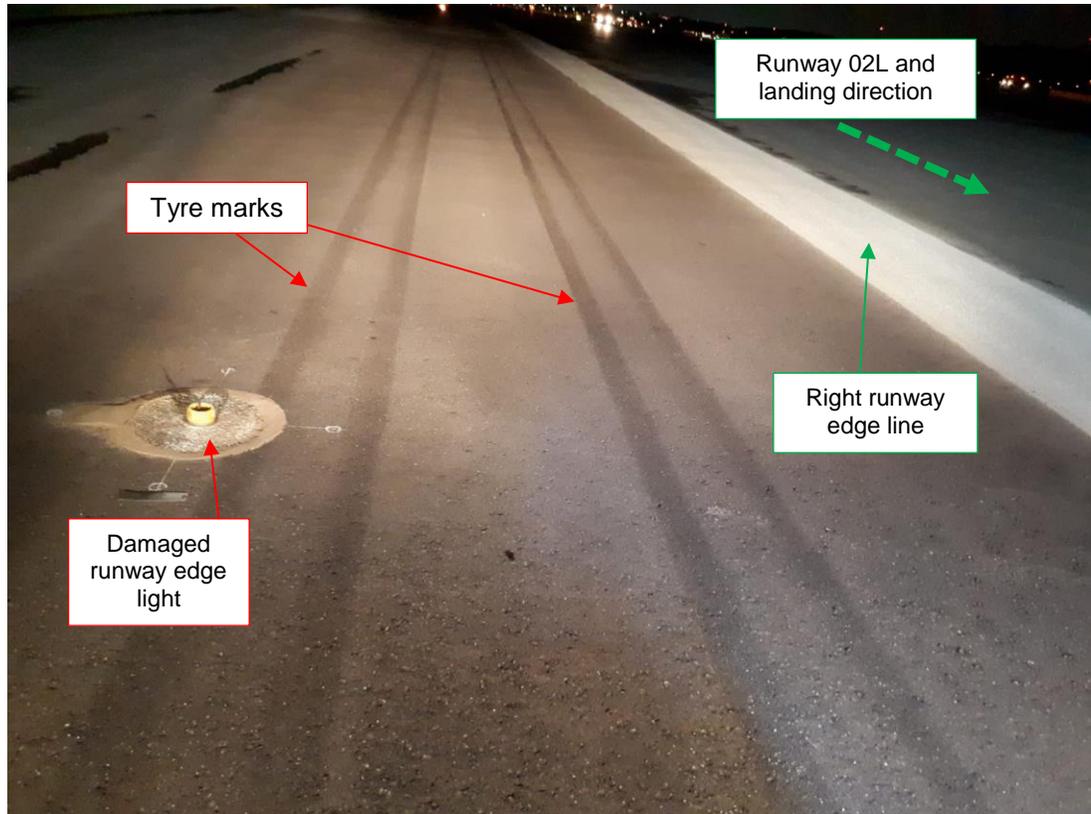
- 1.1.13 Six hours later, at 0058LT in the early morning of 22 March 2019³, an aerodrome runway inspection team discovered a damaged runway edge light near rapid exit taxiway (RET) W7 during a routine inspection. The recording of the aerodrome's runway surveillance camera showed that the aircraft had contacted and broken the runway edge light.

Figure 2. Damaged runway edge light and tyre marks

1.8.1 The recording of the aerodrome's runway surveillance camera showed that the aircraft had contacted the runway edge light causing the light to be broken and flung into the air.

- 3.2 The aircraft touched down to the right of the runway centreline and veered past the right runway side stripe marking, damaging a runway edge light in the process.
