Final Report

CESSNA 172, REGISTRATION 9V-BOQ RUNWAY EXCURSION AT SELETAR AIRPORT

27 September 2019

AIB/AAI/CAS.184

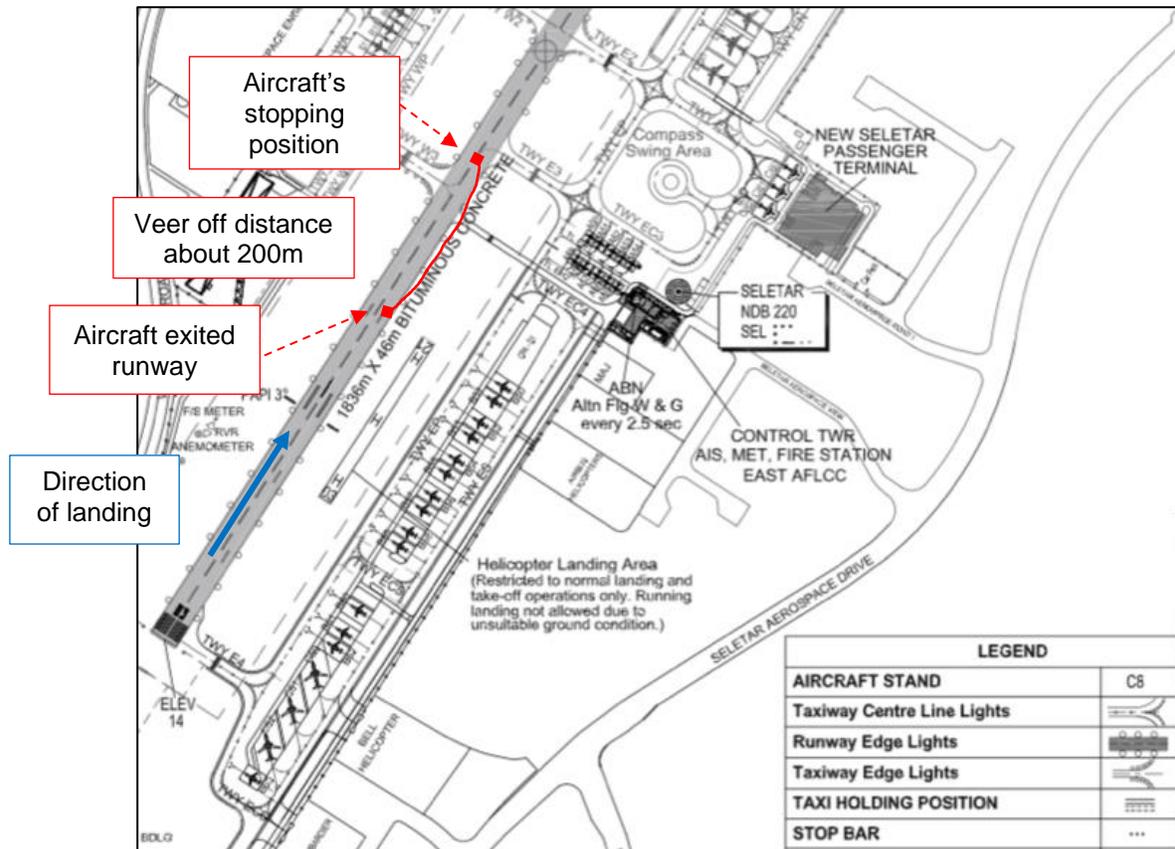
Figure 1: Aircraft ground path and stopping position

1.1.6 As the aircraft was approaching the runway edge, the pilot felt that he was not able to fully control the aircraft and was fearful that his control inputs to try to keep the aircraft on the runway could be too excessive, which could result in the aircraft's right wingtip contacting the ground. The aircraft eventually veered off the runway onto the grass area. When the aircraft had slowed down sufficiently, the pilot regained control of the aircraft and steered the aircraft back onto the runway.

1.1.7 The aircraft came to a stop on the runway and the Airport Rescue Fire Fighting Service (ARFF) was activated by the ATC. The pilot shut down the engine and exited the aircraft before the ARFF arrived (see **Figure 1**).
