Final Report

B737-800, 9V-MGL

Tail Strike Event

TIB/AAI/CAS.205

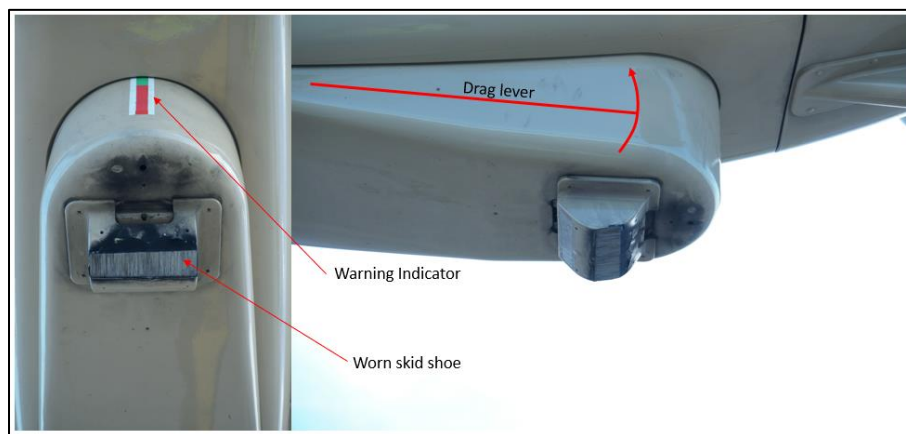
Figure 1: Tail Skid Assembly

1.3.1 There were signs of abrasion on the skid shoe of the aircraft's tailskid assembly (see **Figure 1**), indicating that there had been a tail strike in KTM. However, the drag lever had not been compressed¹⁷, indicating that there was no damage to the aft fuselage structure.

1.3.2 The contacting of the skid shoe with the runway means that the pitch angle of

¹⁷ The green band of the warning indicator was still visible, as can be seen in Figure 1.

the aircraft exceeded the pitch angle limit of 11° for the aircraft.

2.1.1 During rotation of an aircraft at take-off, a high pitch rate will increase the likelihood of a tail strike. According to the aircraft manufacturer's FCTM, when the proper rotation technique is followed, the resultant rotation rate will be between 2° and 3° per second. In this incident, the pitch rate was, at times, greater than 5° per second. As mentioned in paragraph 1.6.1 there was likely a tailwind with a component of about 10 knots along the runway during the aircraft take-off roll up to rotation. The high pitch rate together with the tailwind component during rotation probably eroded the tail-to-ground clearance margin and resulted in the tailskid contacting the runway.
