# **Final Report**

## **BOEING B777-200, REGISTRATION 9V-SQL TURBULENCE ENCOUNTER**

**18 JANUARY 2019**

AIB/AAI/CAS.175

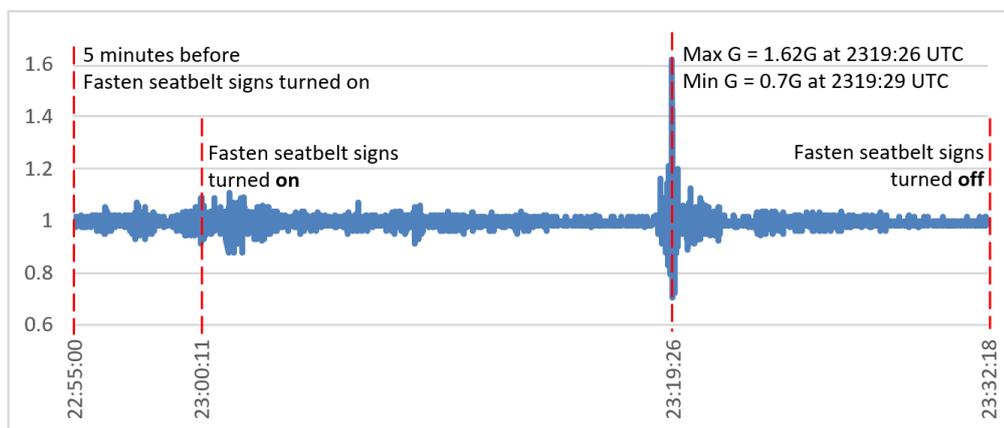
Figure 1: Variation of vertical acceleration recorded during cruise

1.7.3 **Figure 1** below illustrates the vertical acceleration recorded by the QAR from five minutes before the fasten seatbelt signs were turned on during the cruise phase until the time the signs were turned off. The largest variation of vertical acceleration recorded was between 1.62G and 0.7G within three seconds at 2319 UTC.

2.1.2 As illustrated in **Figure 1**, there were no other notably high vertical acceleration recorded during cruise when the fasten seatbelt signs were turned on other than the one recorded at 2319 UTC. Thus, the investigation team correlated the turbulence at this instance (i.e. 2319 UTC) to the time when the passenger was injured.
