FINAL REPORT

AIRBUS A330-300, REGISTRATION 9V-SSE

ENGINE FAILURE DURING CLIMB

AIB/AAI/CAS.157

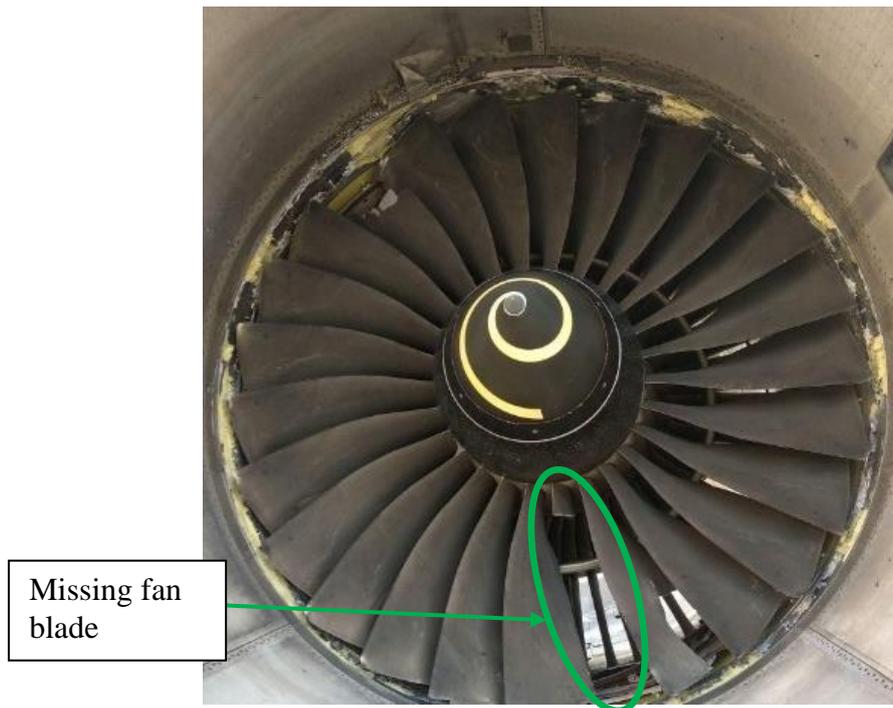
1.3.2 One fan blade was found broken across the width of the blade, with more than 75% of blade material missing (see **Figure 2**). Two other fan blades were found with impact damage and some blade material missing. The released section of the fan blade (i.e. the one with 75% missing blade material) had penetrated the fan case and was retained within the Kevlar layers⁴.

Figure 2: The missing fan blade (circled in green) with more than 75% missing material

- 3.1 The failure of the fan blade with more than 75% missing material originated from a fatigue crack that initiated at the acute corner of the inner convex surface bond.

- 5.1 The engine manufacturer address potential contributing factors associated with the design of the fan blade that could lead to the failure of the fan blade. [TSIB Recommendation RA-2019-003]

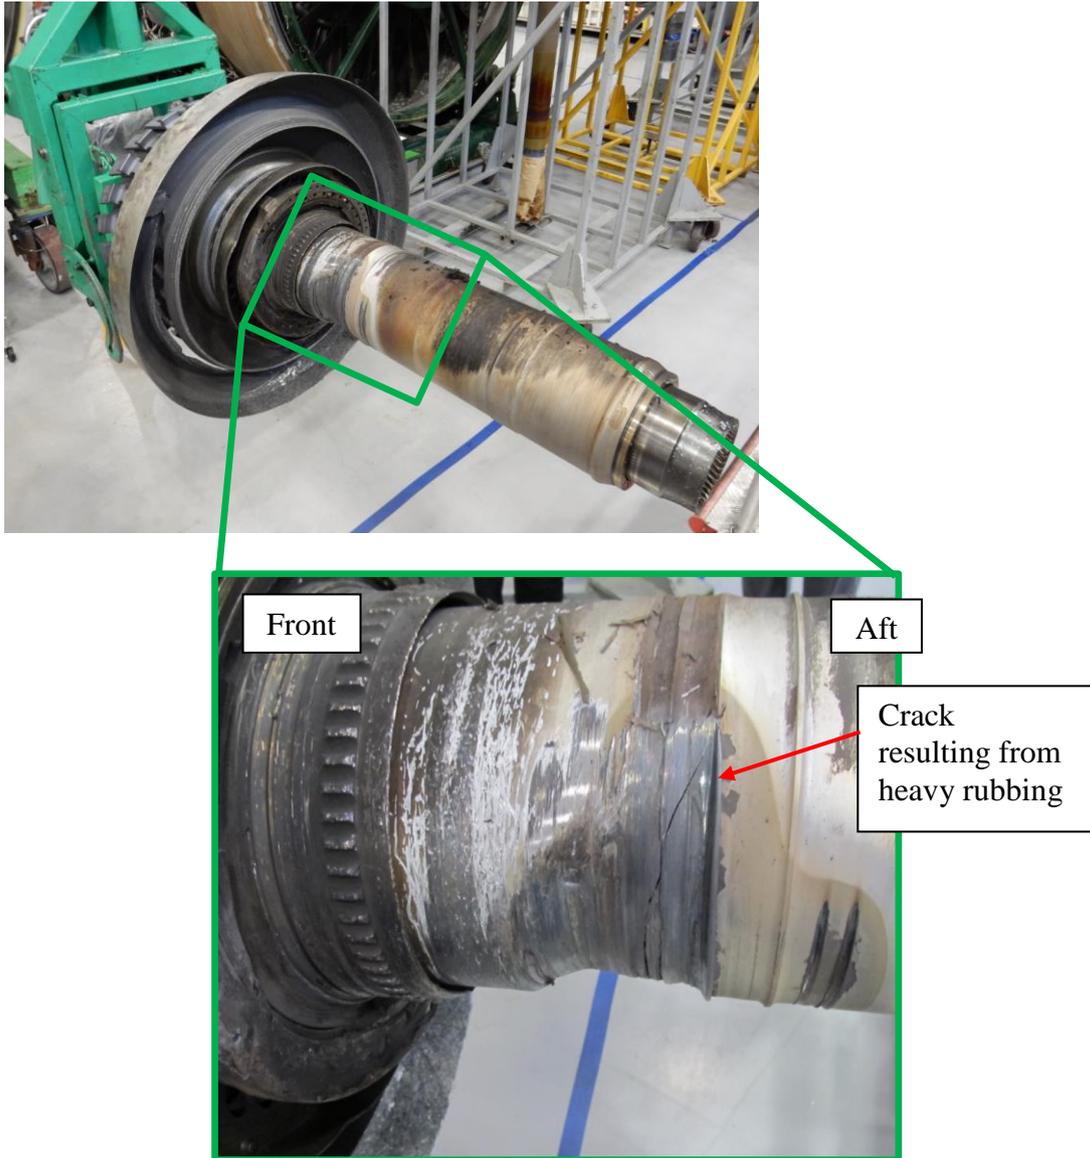
- 1.3.5 The LP shaft showed evidence of heavy rubbing with the IP shaft which resulted in deformation and bending of the LP shaft, with cracking extending approximately half the circumference of the shaft (see **Figure 3**)⁵.

Figure 3: Crack seen on heavily rubbed LP shaft

2.3.1 As mentioned in paragraph 1.3.5, the LP shaft showed evidence of heavy rubbing with the IP shaft which resulted in deformation and bending of the LP shaft, with cracking extending approximately half the circumference of the shaft. The rubbing was a result of the second fuse in the engine front bearing housing having operated slower than intended.

2.3.3 With a delay in the second fuse's operation, there would be a period of time, albeit a very short one, during which the LP shaft and IP shaft could be in contact, the result of which would be damages to the LP shaft and IP shaft.

- 4.4 The engine manufacturer has reviewed the existing fuse system and developed a new program logic which can shut the engine down quickly when an FBO event occurs. This will reduce damage to the LP shaft. This program logic modification has been introduced to the fleet.

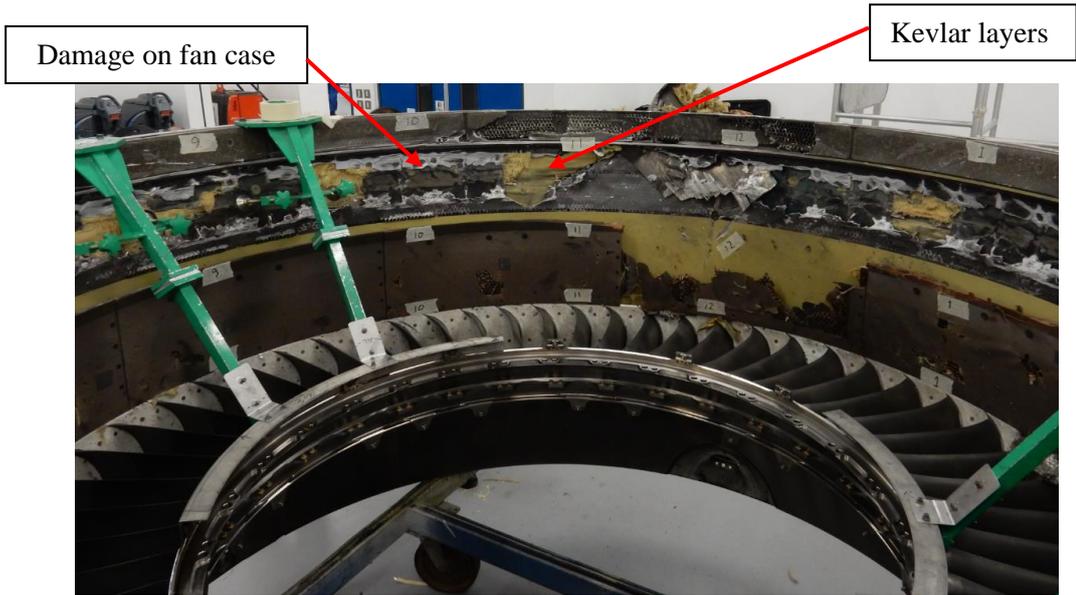
- 1.3.6 There was significant damage to the interior of the fan case (see **Figures 4, 5 and 6**).

Figure 4: Damage on the fan case (viewed from interior)

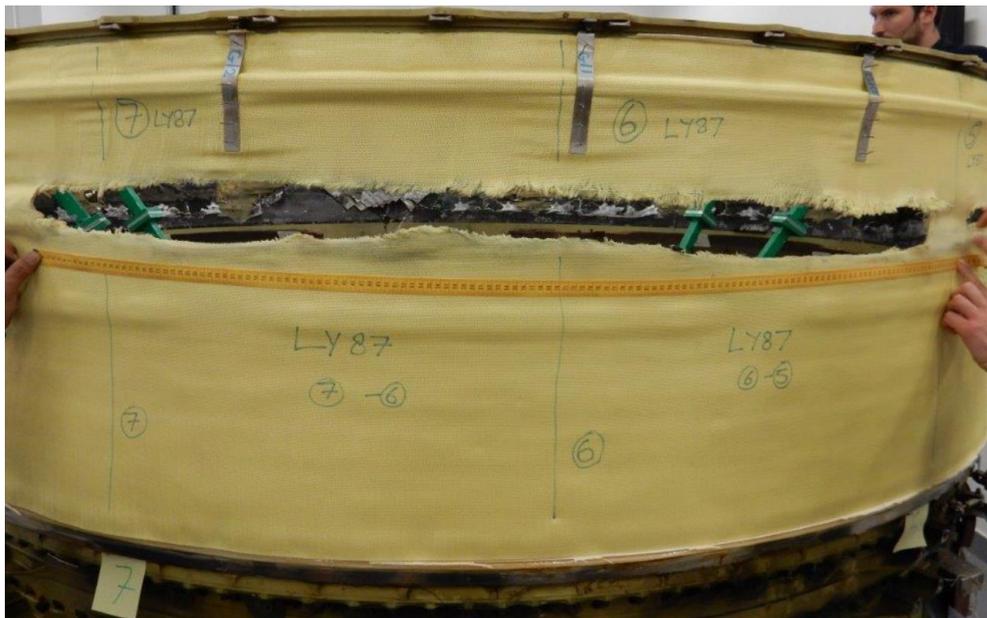
Figure 5: Damaged Kevlar layers (viewed from exterior)

Fan blade debris protruding out of fan case and retained by the Kevlar layers

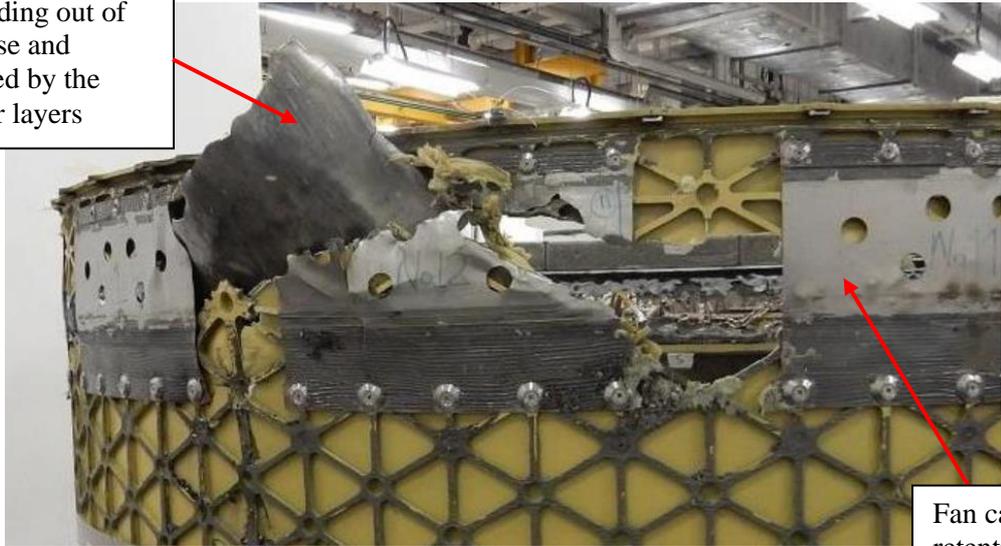
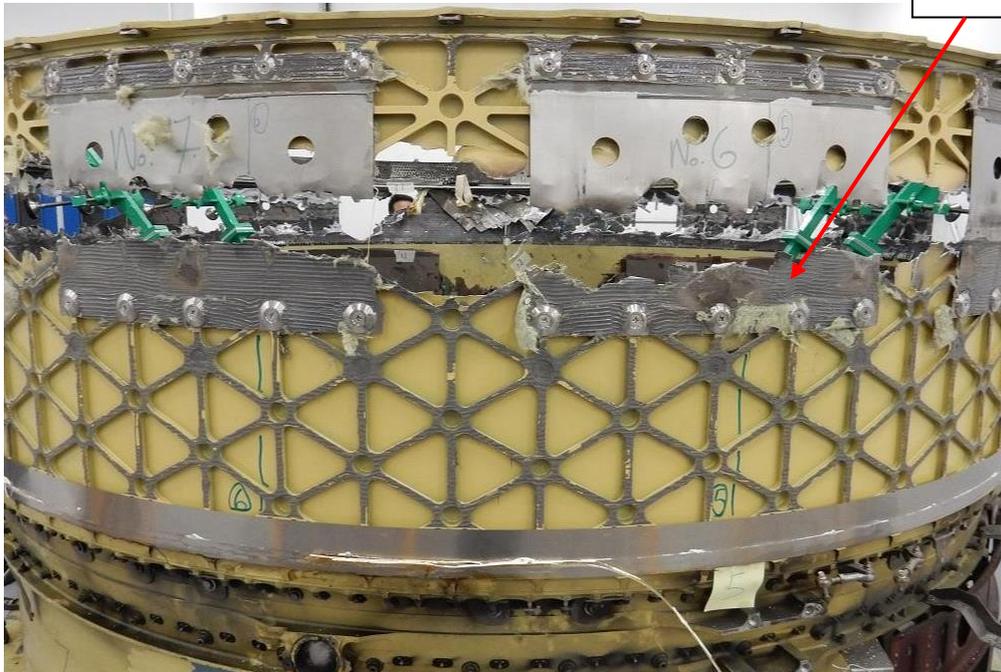
Fan case retention panels

Figure 6: Exterior view of damaged fan case (with Kevlar layers removed)

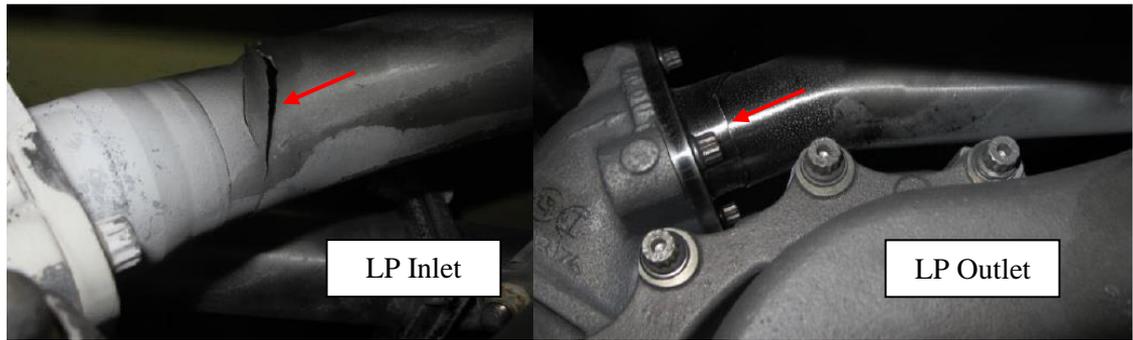
- 1.3.7 The fuel pipes at the inlet and outlet of the LP fuel pump were fractured. However, there were no signs of fire (see **Figure 7**).

Figure 7: Fractured LP fuel pump inlet and outlet pipes (indicated by red arrows)

2.5.1 As a result of the fan blade failure, both the inlet and outlet fuel pipes of the engine LP fuel pump were cracked. The cracking of the fuel pipes was due to the vibration that followed the fan blade release.

2.5.2 The investigation team was informed by the engine manufacturer that the inlet and outlet LP fuel pump pipes in the incident engine had been previously redesigned in response to one previous Trent 700 FBO event¹¹ that led to cracking of the LP fuel pump pipe. The presence of fuel released from the cracked inlet and outlet fuel pipes of the LP fuel pump could be a safety hazard.

- 3.5 Though the inlet and outlet LP fuel pump pipes had been redesigned, cracking in those pipes still occurred. The presence of fuel released from the cracked inlet and outlet fuel pipes of the LP fuel pump could be a safety hazard.

- 4.6 The engine manufacturer has initiated further design studies of the LP fuel pump inlet and outlet fuel pipes with a view to ensuring that they remain safe following a fan blade failure event and that they do not pose a safety risk.

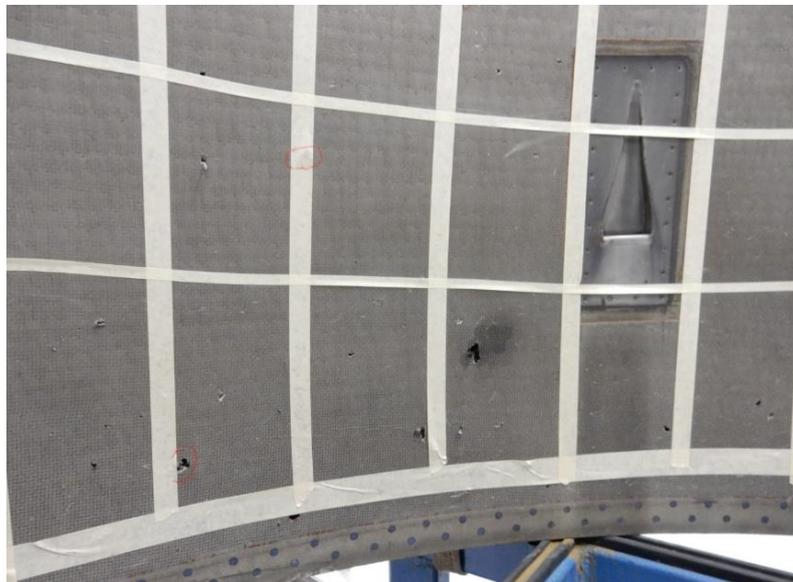
- 1.3.8 The engine inlet cowl suffered damage due to fan blade debris impacting the inner barrel.

Figure 8: Impact damages on the inner barrel of inlet cowl

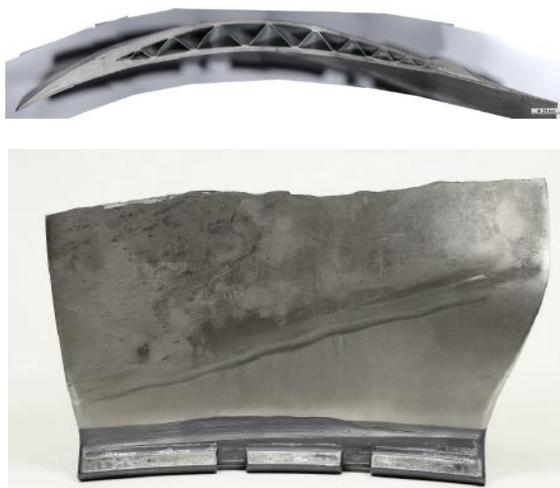
- 1.6.1 The remnant portion of the broken fan blade with more than 75% material missing (as mentioned in paragraph 1.3.2) was removed from the No.1 engine (see **Figure 9**) and sent back to the engine manufacturer for examination.

Figure 9: Fan blade segment recovered (side and top view)

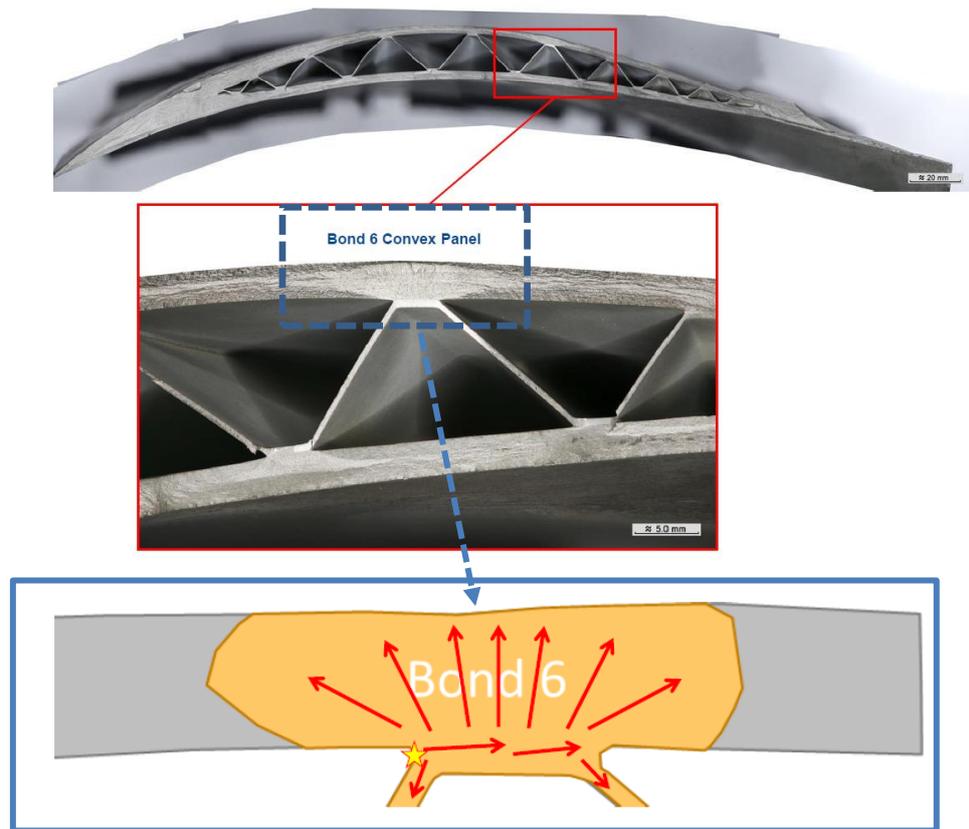
- 1.6.2 Detailed examination by the engine manufacturer revealed the following:
- (a) The fracture surfaces were inspected under a scanning electron microscope (SEM). The inspection revealed signs of fatigue failure at the acute corner of the inner convex surface bond (known as Bond 6) (see **Figure 10**).
 - (b) Examination of the acute corner of Bond 6 at higher magnification in the SEM revealed a crack initiation site believed to be in the membrane material adjacent to the diffusion bond (see **Figure 11**).

Figure 10: Fatigue failure location (Bond 6) and failure mechanism

2.2.1 The failure of the fan blade could be attributed to a fatigue crack which compromised the strength of the fan blade. This crack originated from an initiation site at the acute corner of the inner convex surface bond.

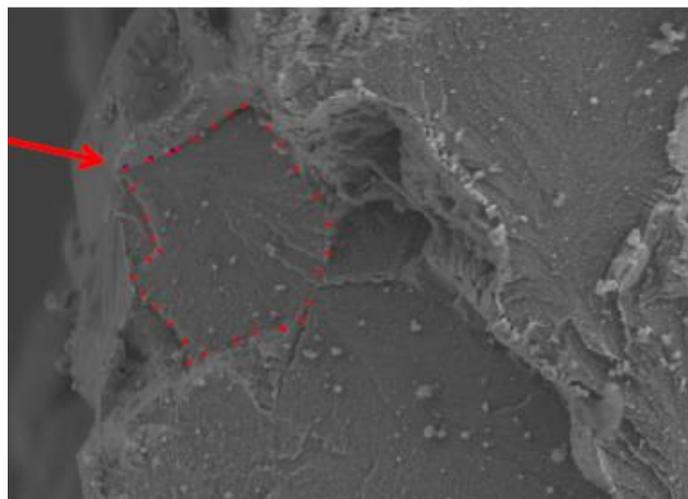
Figure 11: Fatigue failure initiation site in the membrane material adjacent to the diffusion bond (region indicated in red).
