Final Report

A330-300, REGISTRATION 9V-SSF DUAL ENGINE SURGE

23 MAY 2015

AIB/AAI/CAS.112

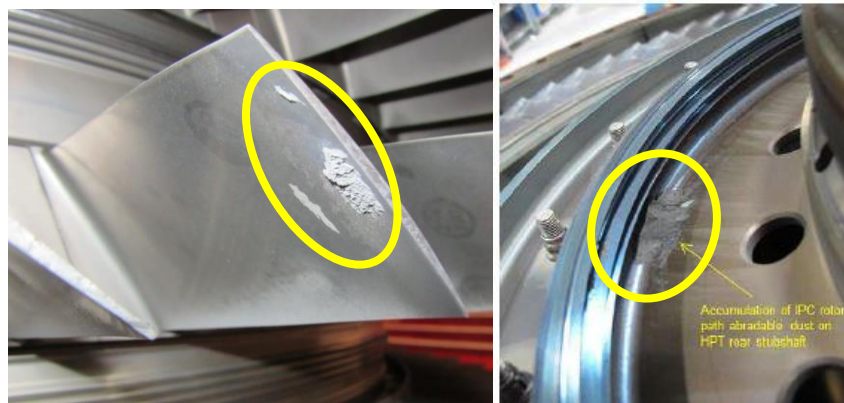
1.2.6 There was a significant amount of grey coloured dust deposit found on the aerofoil surfaces of some Intermediate Pressure Compressor (IPC) rotor blades and stator vanes, on the Intermediate Pressure Turbine (IPT) nozzle guide vanes and on the High Pressure Turbine (HPT) stubshaft (see **Figure 1**). The dust was identified to be composed mainly of aluminium and silicon, which were the main constituents of the IPC rotor path abrasible material.

Figure 1. Grey coloured dust deposit found on a Stage 3 IPC rotor blade (left) and the HPT stubshaft (right)

- a. The tips of Stage 3 and 6 IPC blades contacted and rubbed the abrasion material.
- b. The rubbing caused the abrasion material to be eroded into small particles which were carried downstream in the airflow.
- c. These abrasion material particles entered the combustion section and ignited, causing a temporary disruption of airflow through the engine.

2.1.3 The release of rotor path abrasion material has been known to cause engine surges. If the aluminium and silicon-based rotor path abrasion material is rubbed heavily, the eroded small particles are carried downstream into the core airflow. When the abrasion material and air mixture exceeds a certain threshold, the mixture can spontaneously ignite downstream in the hotter stages of the HPC or in the combustor, resulting in an engine surge.

- 4.3 The engine manufacturer has increased the rotor tip clearances, between the engine casing and IPC blades, for Stages 3 and 6 IPC which exhibited evidence of heavy tip rubs.

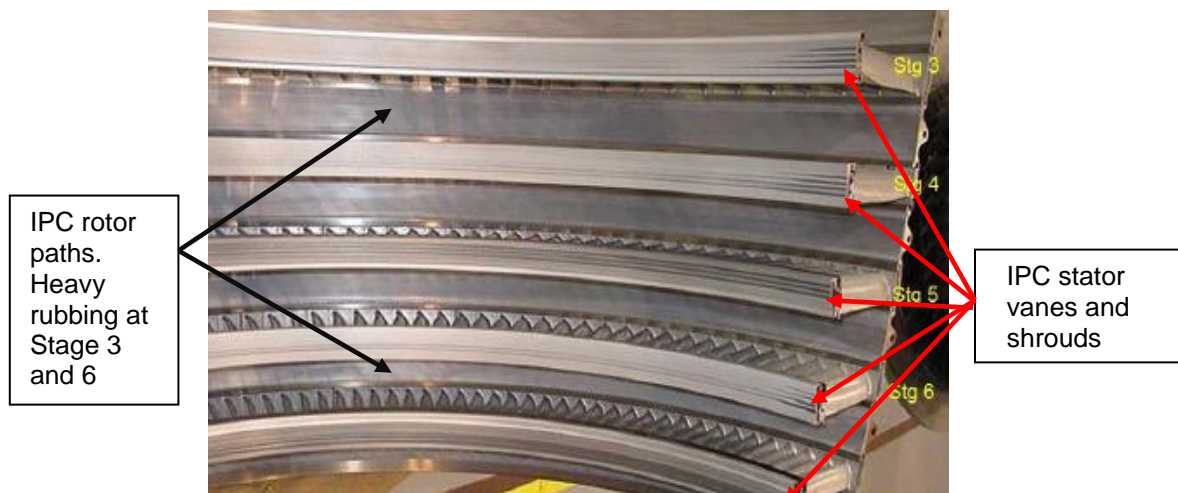
1.2.7 There were signs of heavy rubbing of the rotor path abrasible lining at Stages 3 and 6 of IPC. Light rubbing in the rotor paths were seen at Stages 4, 5, 7 and 8, and these rubs were considered typical of operational wear.

1.2.8 There was heavy rubbing at Stages 3, 4, 5, 6 and 7 stator vane shrouds. The rubbing could be attributed to contacts with the air seals of the IPC rotor drum (see Figure 2).

Figure 2. Engine casing showing alternating rotor path channels and stator vanes/shrouds

Stage 3 and 6 IPC stages showed more evidence of rubbing as compared to the other stages. A rearward shift of the IP rotor, would produce a rotor blade to rotor path closure leading to the rubs observed on the axial width of rubs in the IPC shroud abradable lining with the air seals of the IPC drum.
