FINAL REPORT

**AIRBUS A350-900, REGISTRATION 9V-SMS
DOOR DAMAGE BY CATERING TRUCK**

28 JANUARY 2019

AIB/AI/CAS.176

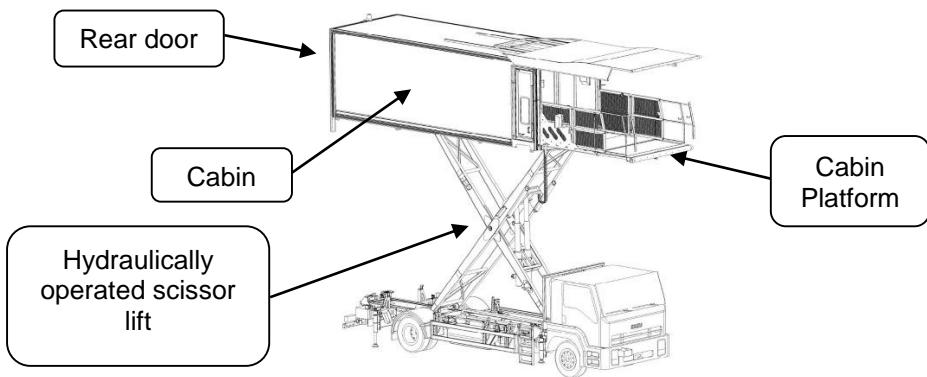
Figure 1: Schematic of the catering truck

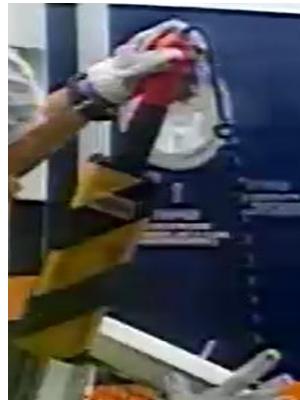
- 1.1.4 As part of the loading operation, a safety shoe (see **Figure 2**) was placed on the platform underneath the aircraft door (see **Figure 3**). This safety shoe system prevents damage to the aircraft door by adjusting the height of the catering truck platform downwards if the aircraft door lowers towards the

Figure 2: Safety shoe

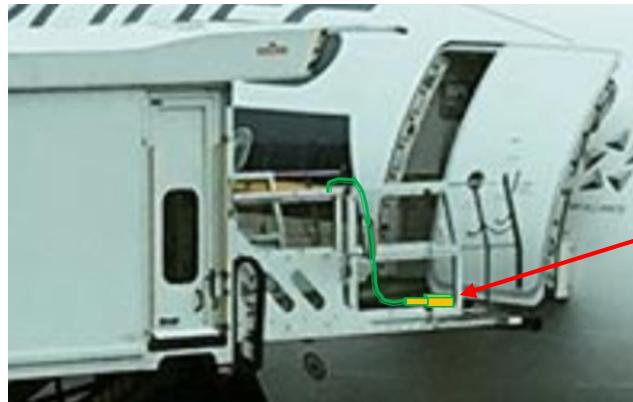
Figure 3: Illustration of the positioning of safety shoe (highlighted in yellow)

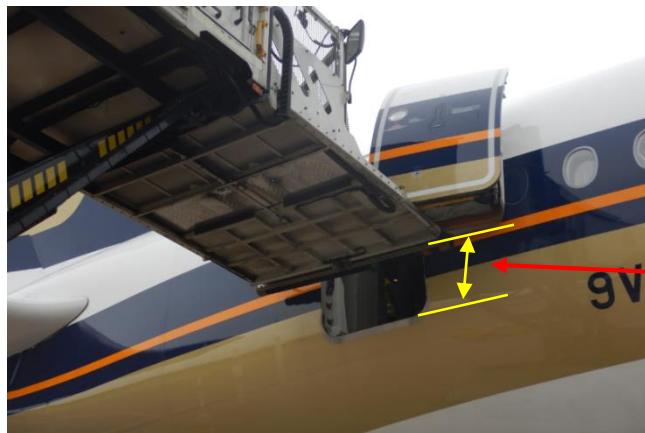
- 1.1.5 According to the truck driver, when his colleague in front signalled to him to stop raising the platform because of an impending door contact with the safety shoe, he released the toggle switch to stop the platform from rising. However, the platform continued to rise. He then activated the emergency stop switch and the platform stopped rising. By then the platform had already made contact with Door 4R and lifted it upwards (see **Figure 4**).

Figure 4: Vertical displacement of Door 4R

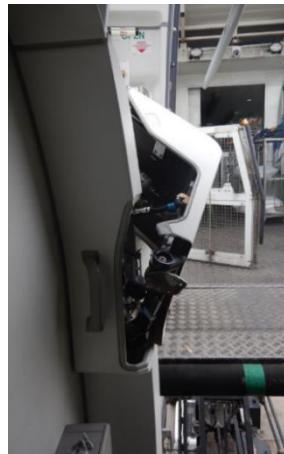
- 1.3.1 The truck cabin platform lifted Door 4R upwards causing the door hinge to twist (see **Figure 5**). The adjoining door frame was also damaged.

Figure 5: Damage to the door hinge

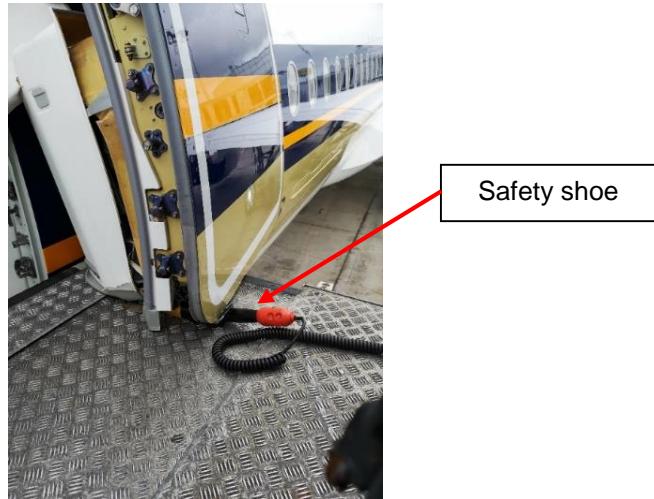
- 1.3.2 The safety shoe was found sandwiched between Door 4R and the platform (see **Figure 6**).

Figure 6: Sandwiched safety shoe

- 1.4.3.2 In this occurrence, the safety shoe was found sandwiched between Door 4R and the platform. The safety shoe had been compressed during the platform height adjustment by the truck operator, yet this apparently did not result in the triggering of the safety feature of automatic lowering of the cabin platform.

- 2.3.1 The safety shoe was supposed to be a feature that would prevent damage to the aircraft door. When compressed, it was supposed to trigger a command to the hydraulic pump of the truck cabin scissor lift to lower the cabin platform until the safety shoe was no longer compressed. In this occurrence, the safety shoe did not trigger any platform-lowering command when compressed.

- 2.3.2 According to the truck manufacturer, the design of the safety shoe system was such that any command from the cabin control panels (front or rear) would override the safety shoe's safety mechanism of automatically generating a platform lowering command. Apparently this was not made known to the truck operators who might have been falsely believing that the safety shoe's safety mechanism would equally work when the safety shoe was compressed by a rising cabin platform instead of by a lowering aircraft door.

- (a) Requiring a weekly check to verify that the engine idle speed is 900RPM.
- (b) Requiring catering companies using its trucks to modify the safety shoe such that the activation of the safety shoe's safety mechanism will cut off the main engine and stop all functions, except the safety shoe mechanism of automatically generating a platform lowering command via the hydraulic pump.
- (c) Requiring that the rear cabin control panel can only be used to raise the cabin up to a height of 1.8m and that only the front cabin control panel can be used to raise the cabin to above 1.8m (the typical height of a loading bay).
- (d) Setting an acceptable level of cabin lowering (the limit was set at 1cm of lowering over 45 minutes).

- (a) Modification of all its catering trucks such that the rear cabin control panel can only be used to raise the cabin up to a height of 1.8m and that only the front cabin control panel can be used to raise the cabin to above 1.8m.
- (b) Modification of the safety shoe designed as required by the truck manufacturer.
- (c) Updating of its cabin services procedure manual to require truck operators to verify, before each truck usage, that the engine idle speed is 900RPM usage. This is more than the weekly check required by the truck manufacturer.

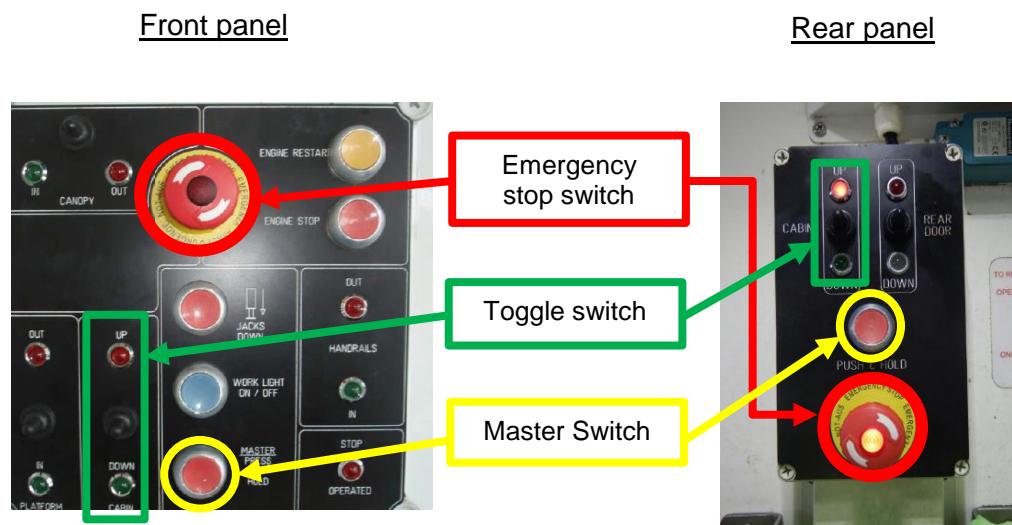
Figure 7: Front and rear cabin control panels

- 1.5.1.1 After the occurrence, the catering company (i.e. the employer of the truck operator) engaged an independent vehicle surveyor to examine the incident truck. The front and rear cabin control panels were found to be working⁴ and there were no other abnormalities with these panels. The abnormalities as reported by the truck operator could not be replicated.
- 1.5.1.2 Separately, the investigation team also examined the front and rear cabin control panels of the incident truck and found no abnormalities with their operations.
