# **Final Report**

## **AIRBUS A350-900, REGISTRATION 9V-SMU TAKE-OFF WITHOUT CLEARANCE, BARCELONA AIRPORT**

**24 OCTOBER 2020**

TIB/AAI/CAS.193

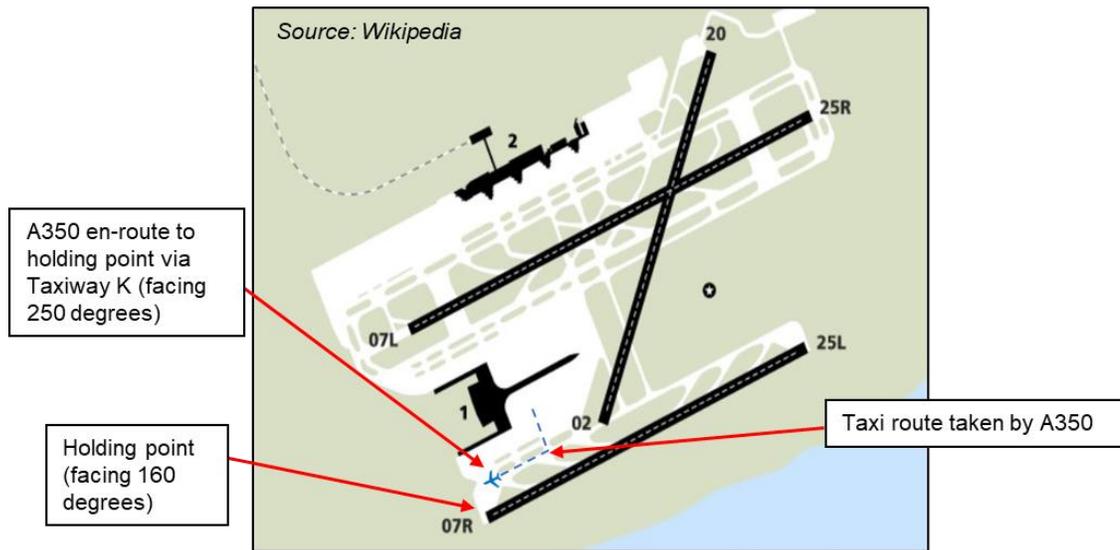
Figure 1: Runway map of Barcelona Airport and the A350's taxi route

1.1.2      The Air Traffic Control (ATC) was using Runway 07R as the departure runway and Runway 02 (a runway with an approach path that crosses over Runway 07R) as the arrival runway (see **Figure 1**). The A350 was assigned Runway 07R for departure. At about 1044hrs, the A350 was pushed back from its parking stand. It then taxied to the holding point<sup>1</sup> of Runway 07R via Taxiway K, a taxiway which is parallel to Runway 07R.
