Final Report

BOEING B737-400, REGISTRATION HS-KMC TYRES BLOWOUT DURING TAKE-OFF, CHANGI AIRPORT

28 SEPTEMBER 2021

TIB/AAI/CAS.200

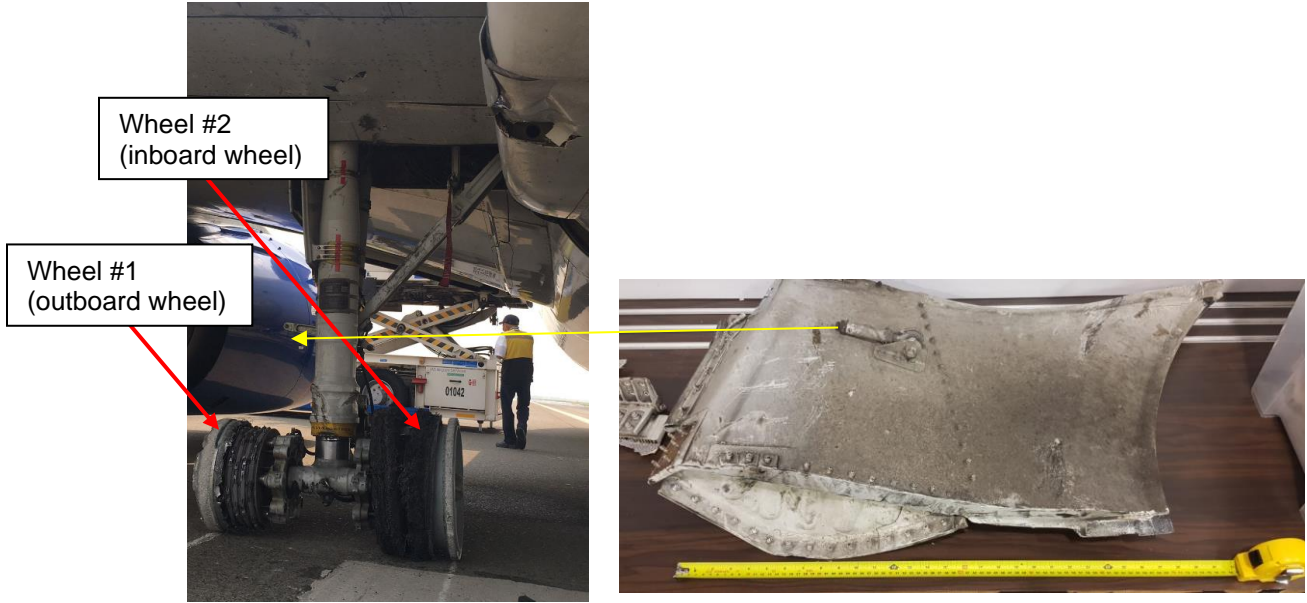
- (a) The two tyres on the left landing gear had suffered a blowout and a panel on the left landing gear was missing (see **Figure 1**). Tyre debris and the panel were recovered at Changi Airport (see paragraph 1.3.2).

Figure 1: Damage to the left landing gear (left photo, view from the rear of aircraft) and the left landing gear panel retrieved from Changi Airport (right photo)

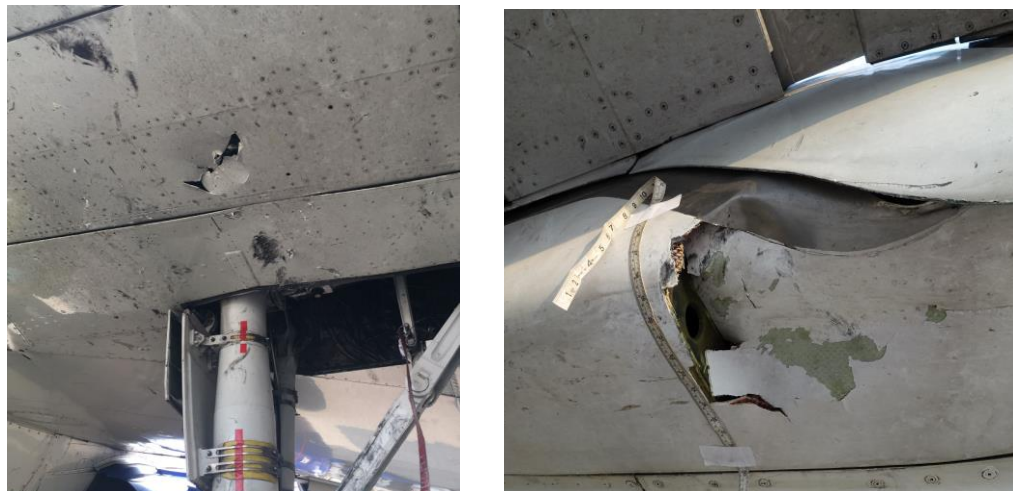
- (b) There was impact damage to the skin of the underside of the left wing in several areas near the left landing gear and the mid and outer flaps (see **Figure 2**).

Figure 2: Damage to the underside of the left wing

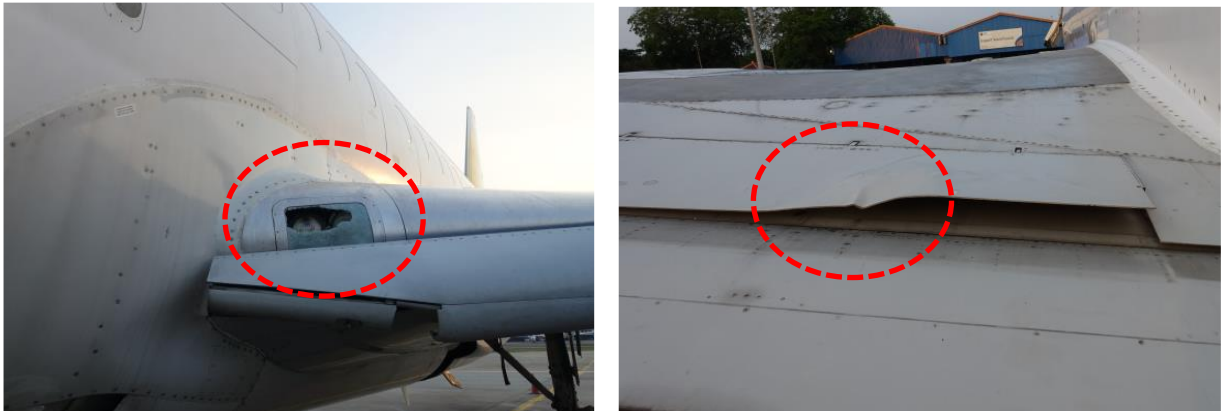
(c) The landing light at the root of the left wing was damaged and the left wing trailing edge above the flap was deformed (see **Figure 3**).

Figure 3: The left landing light was damaged (left photo) and trailing edge of left wing was deformed (right photo)

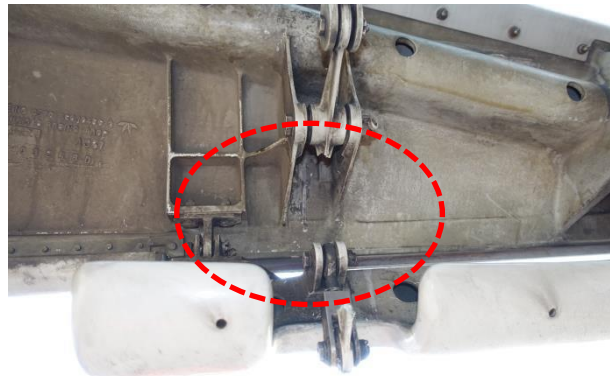
(d) The link of the left wing inboard leading edge flap was broken (see **Figure 4**).

Figure 4: Link of left wing inboard leading edge flap broken

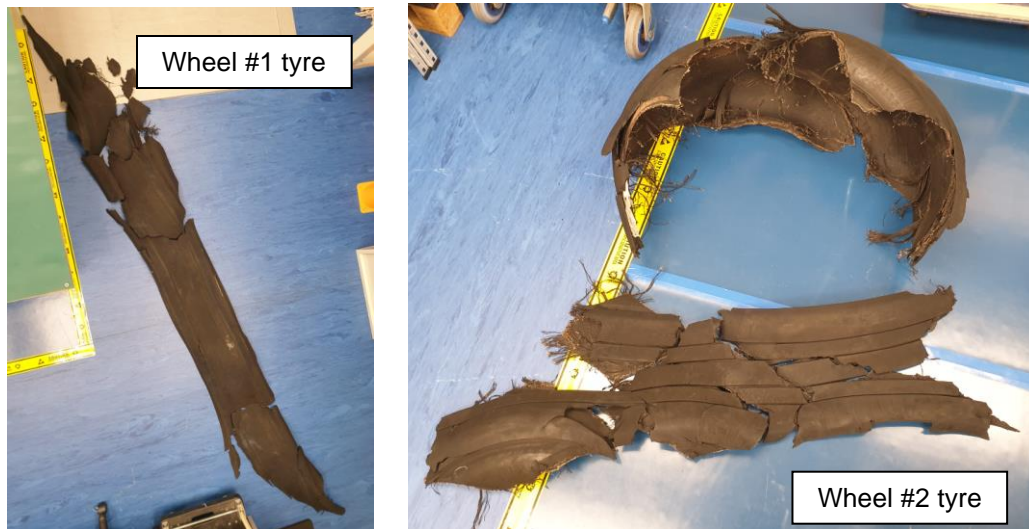
1.3.2 **Figure 5** shows the tyre debris pieces recovered from Runway 02R of Changi Airport. The debris pieces were identified to their respective wheels by means of the serial number and/or retreading² status that was marked on the side of the tyres.

Figure 5: Debris of Wheel #1 and #2 tyres

1.6.3.3 The Wheel #1 tyre manufacturer indicated that both tyres had experienced casing rupture and tread separation and that the likely cause for this failure was

over-deflection resulting from an under-inflation and/or overloading of one of or both the tyres.

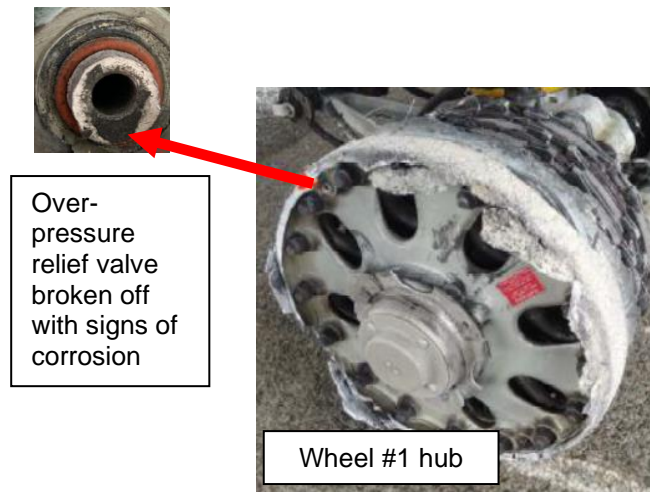
1.3.3 **Figure 6** shows the over-pressure relief valve of Wheel #1 hub which was found to be broken off and showing signs of corrosion.

Figure 6: Corrosion found on the over-pressure relief valve of Wheel #1 hub

The corrosion found on the over-pressure relief valve of Wheel #1 hub could have caused the wheel to lose pressure progressively over time and the tyre to operate in an under-inflated condition, thus stressing the Wheel #2 tyre. If Wheel #1 tyre had indeed been operating under-inflated over some time, then Wheel #2 tyre should have incurred some damage. However, this was not the case as no damage was found on the previously replaced Wheel #2 tyre.
