# **FINAL REPORT**

## **BOEING 737-400, REGISTRATION HS-KMC MAIN LANDING GEAR TORSION LINK DAMAGE DURING LANDING**

**5 June 2019**

AIB/AAI/CAS.180

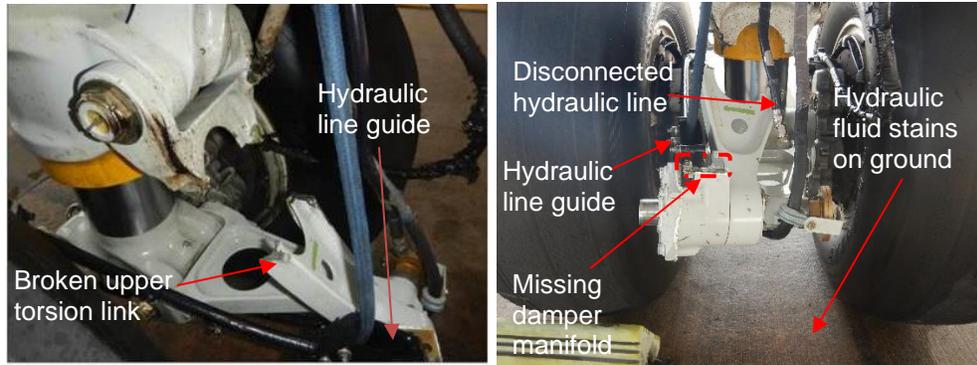
After arrival at the parking bay, the right main landing gear upper torsion link was found broken. The main landing gear damper manifold and the hydraulic line guide were recovered from the taxiway along the taxi route to the parking bay. No one was injured in the occurrence.

Figure 2: Damaged RH MLG torsion link assembly

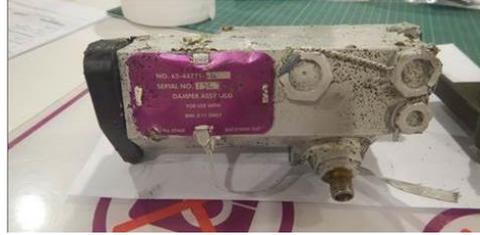
<sup>6</sup> The MRO-S Duty Engineer assessed that the missing damper manifold would pose a danger to other aircraft if it had dropped on the runway or taxiway.

Figure 3: Damper manifold

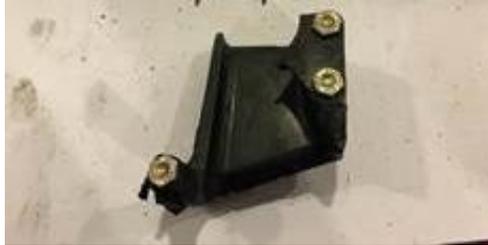
Figure 4: Hydraulic line guide

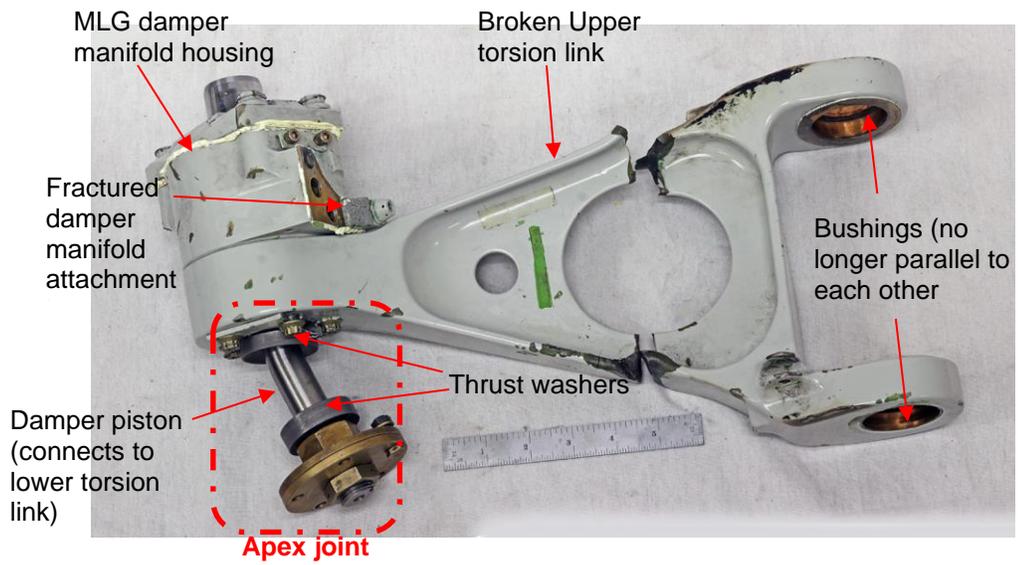
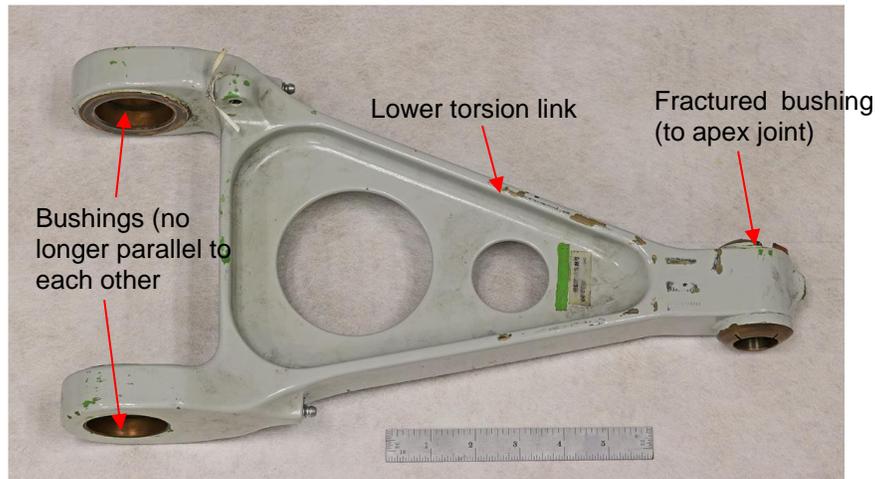
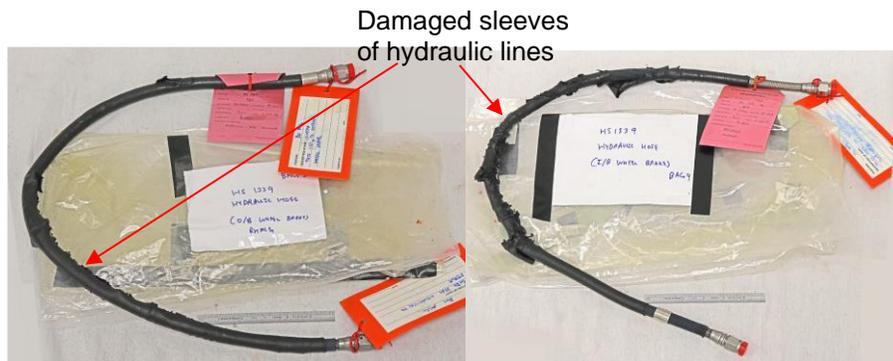
- 1.3 Damage to aircraft
- 1.3.1 The damage to the RH MLG included the following (see **Figures 5 and 6**):
- (a) The upper torsion link<sup>7</sup> of the RH MLG was broken and its bushings were out of position and no longer parallel to each other.

- (b) The lower torsion link was distorted and one of its bushings at the end of the link, which connected to the apex joint<sup>8</sup>, was fractured.

- (c) The damper manifold was detached from its mount.
  - (d) The outer sleeves of the hydraulic return line (connecting the hydraulic system and damper) and other hydraulic lines of RH MLG were torn resulting in a hydraulic fluid leak.

- (e) The damper piston was bent.
  - (f) Scuffs and score marks were found on the two tyres of the RH MLG.

Figure 5: Damaged components of RH MLG torsion link assembly

- 4.1 After the occurrence, the incident aircraft's RH MLG was repaired and both of its dampers were bled at MRO-S. The aircraft operator then checked for proper bleeding of the MLGs dampers on all the remaining B737 Classic aircraft in its fleet.
- 4.2 The aerodrome operator has disseminated two Airside Safety Notices to all members of its airport community that operate in the aerodrome arising from this occurrence:
  - (a) Airside Safety Notice No. 13/2020 as a safety reminder to highlight on the importance of prompt reporting on all safety issues related to aircraft operations and the avenues to report such safety issues.
  - (b) Airside Safety Notice No. 14/2020 on communications measures between the aerodrome operator and aircraft operators/ground handling agents.

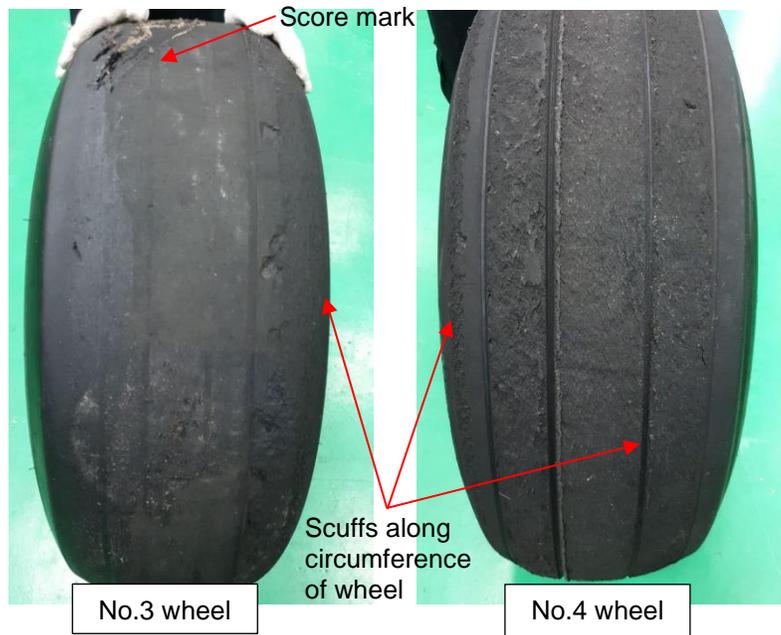
Figure 6: Damage on tyres of RH MLG

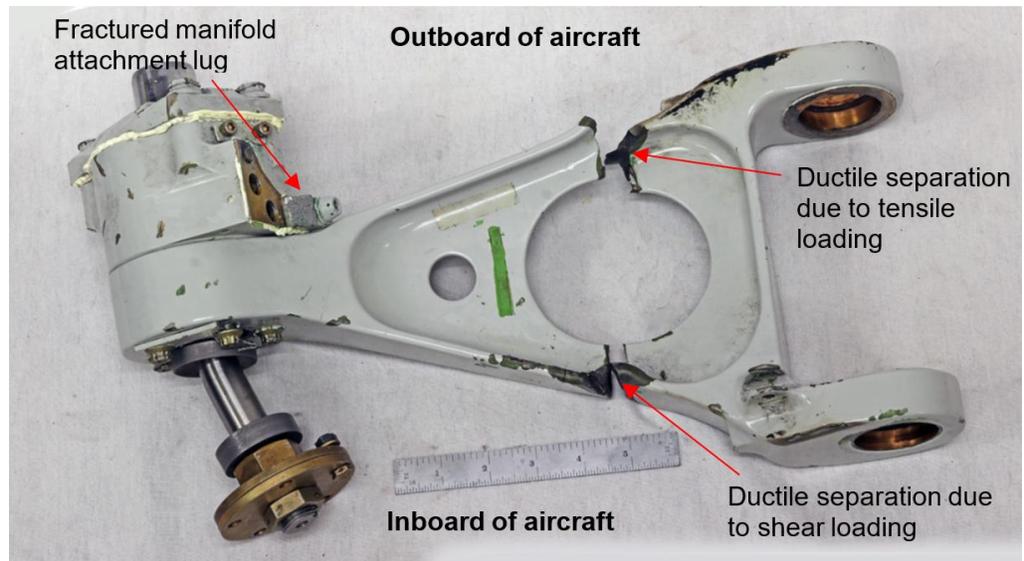
- 1.9.3 The conclusions of the aircraft manufacturer's failure analysis were as follows:
- The parts were genuine parts from the aircraft manufacturer.
  - The upper torsion link broke into two segments mid span. The outboard fracture surface was consistent with ductile separation due to tensile loading. The inboard fracture surface was consistent with ductile separation due to shear loading (see **Figure 11**). There was no evidence of corrosion or fatigue.

Figure 7: Damages on the upper torsion link
