Final Report

Boeing 737-8 (MAX), Registration 9V-MBF Tyre Damage on Landing, Singapore Changi Airport

3 December 2021

TIB/AAI/CAS.202

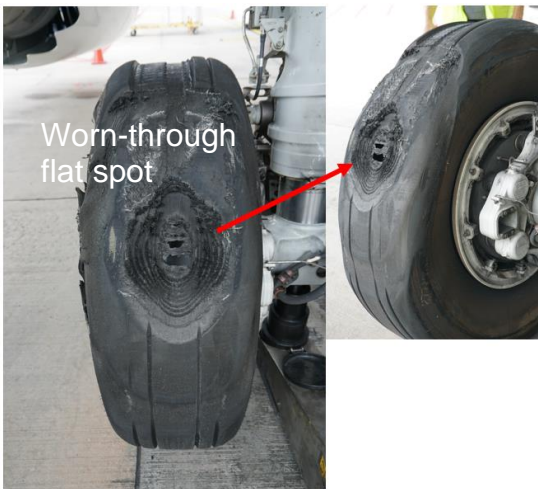
- (a) The outboard tyre of the left MLG had burst. It had a worn-through flat spot (**Figure 1**).
- (b) The inboard tyre of the left MLG had a flat spot (**Figure 2**).
- (c) The frame of the fixed door of the left MLG was damaged (**Figure 3**).

Figure 1 - Outboard tyre on left MLG (viewed from aft of aircraft)

- (a) The cause of the flat spots on both tyres was aircraft skidding.
 - (b) The outboard MLG tyre had burst as a result of the flat spot grinding through the tyre material.

2.1.1 The damage to the left MLG's tyres were caused by skidding. The wheels skidded because the left MLG wheels were locked (i.e. not spinning) during the landing (see Paragraph 1.7.3), given that the Antiskid system was inoperative. The brake pressure (of 1500 psi) applied to the left MLG wheels by the SFO, before the speedbrakes were manually deployed to ensure the aircraft weight was on the MLGs²¹, was sufficient to result in the locked-wheel situation.

- 5.1 The aircraft operator emphasise to all its pilots the importance of following the operational requirements of the Minimum Equipment List. [TSIB Recommendation RA-2022-006]

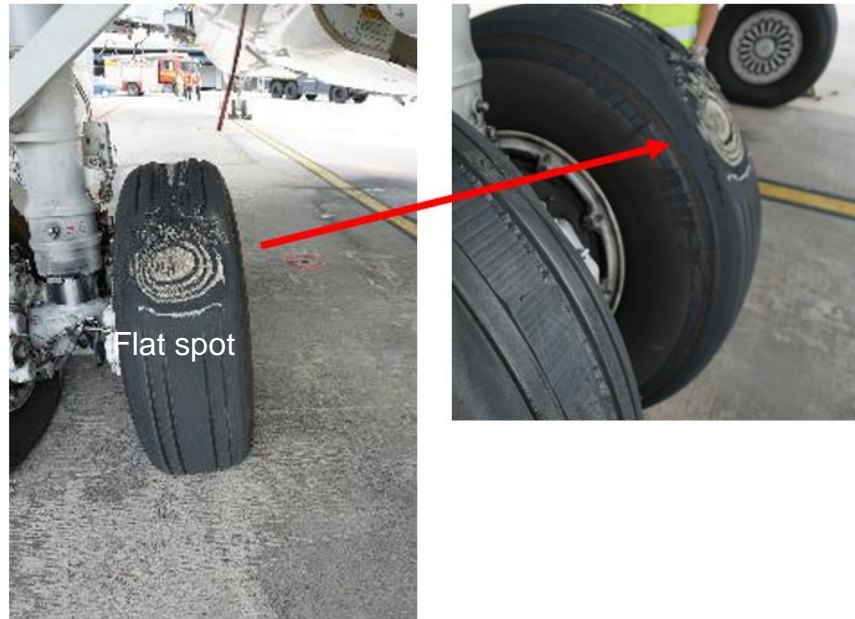
Figure 2 – Inboard tyre on left MLG (viewed from aft of aircraft)

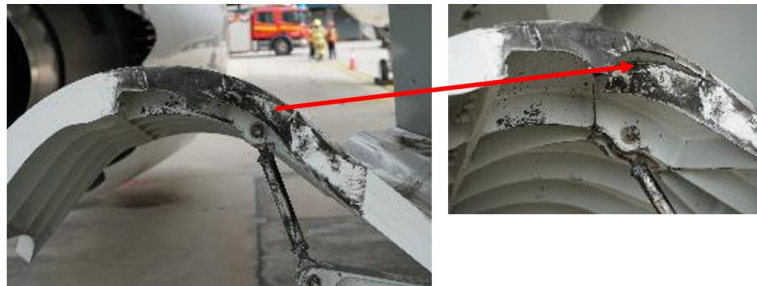
Figure 3 – Damaged frame on fixed door of left MLG
