Final Report

Boeing B747-400F, REGISTRATION 9V-SFO ENGINE GROUND STRIKE AT AUCKLAND AIRPORT, NEW ZEALAND

AIB/AAI/CAS.189

Transport Safety Investigation Bureau
Ministry of Transport
Singapore

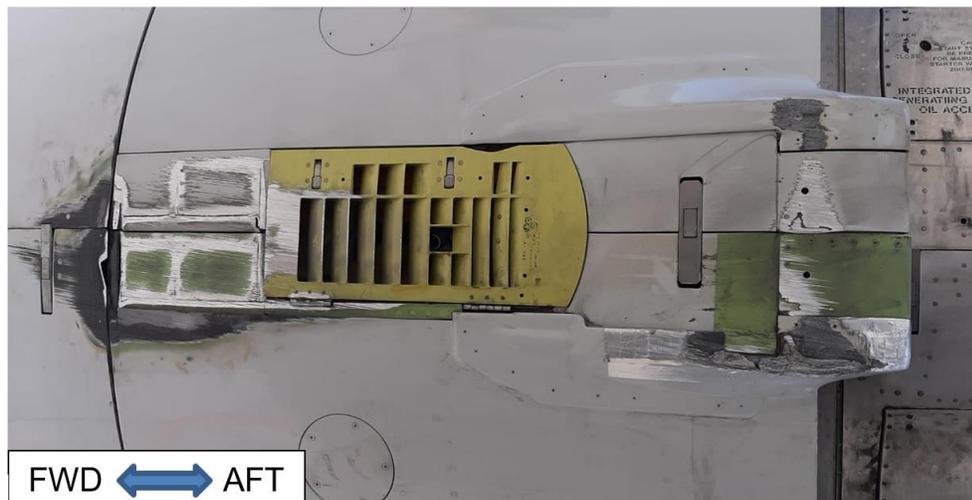
1.3.1 The fan cowl panel, thrust reverser panel, thrust reverser lower track fairing and louvered exhaust door assembly at the underside of the No. 1⁵ engine sustained gouge and tear damage (see **Figure 1**).

Figure 1: Damage to underside of No. 1 engine

- 2.1.4 The investigation team believed that it was at this moment that the No. 1 engine struck the runway because of the aircraft's bank angle (which the FDR data showed to be about 7°), resulting in what appeared to ATC to be sparks coming from the left wing of the aircraft.

- 3.5 As the aircraft tracked towards the right after touchdown and believing that the aircraft was airborne, the PIC applied left aileron to align the aircraft with the runway centreline. This caused the left wing to bank to the left and the No. 1 engine to scrape the runway.

- 4.1 From 6 May 2020, the operator reduced the roll angle threshold to capture abnormal roll during landing in the Flight Data Analysis Programme from 9° to 7° when the aircraft was below 10ft, regardless of whether this occurs within 10sec from touchdown or not.
- 4.2 The operator will implement a requirement in December 2020 whereby pilots will be asked to demonstrate during simulator checks that they are able to apply all the three crosswind landing techniques recommended in the aircraft manufacturer's Flight Crew Training Manual.

- (a) the pitch attitude of the aircraft will increase slightly during landing;
- (b) the speedbrakes would induce further pitching up of the aircraft if they are deployed upon landing while the aircraft was pitching up; and
- (c) any excessive aileron input when the aircraft is close to the runway may result in a roll exceedance and engine contacting the runway.

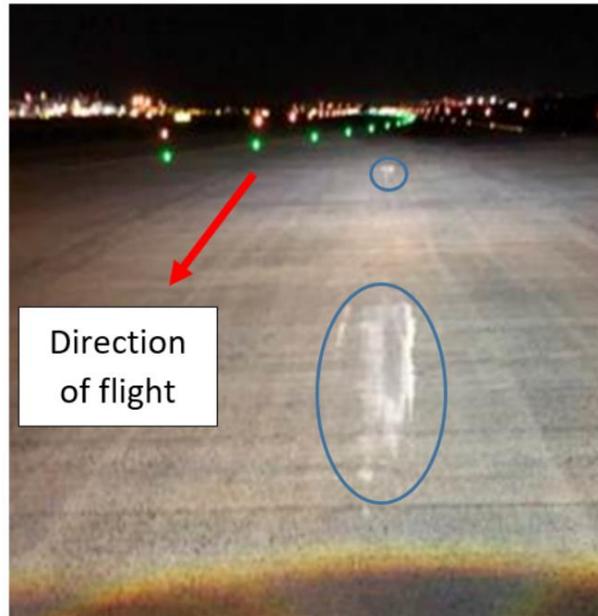
1.4.1 Two scrape marks were observed on the runway about 1,040m from the Runway 05R threshold (see **Figure 2**), each measuring about 1m by 0.3m.

Figure 2: Scrape marks (circled in blue) on runway
