FINAL REPORT

**BOEING B777-200ER, REGISTRATION 9V-SVC
AIR TURNBACK DUE TO FUEL DISCREPANCY**

16 APRIL 2014

AIB/AAI/CAS.103

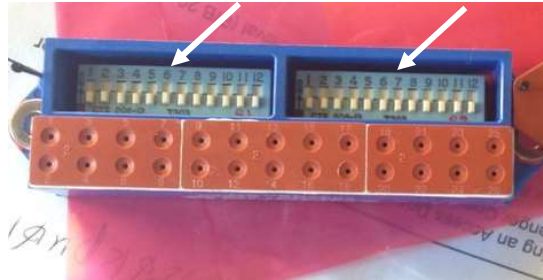
- 1.4.3 The aircraft was installed with a program switch module (PSM) (see **Figure 2**) consisting of pin switches that could be preset¹². The PSM pin switch pattern for the Boeing 777-200ER was different from that for the Boeing 777-200 and allowed the FQPU to accept the inputs from the eight additional sensors on the Boeing 777-200ER centre fuel tank. In other words, the PSM made the FQPU “know” which aircraft model it was dealing with so that the FQPU would get inputs from the correct sensors and compute the fuel quantity accordingly.

Figure 2: Program switch module with two sections of pin switches (white arrows)

- 1.4.5 However, when the PSM was inspected after the incident, it was found that the PSM had the correct pin switch pattern for a Boeing B777-200ER. The FQIS had also been operating normally prior to this incident flight and there was no recent maintenance work done to the FQIS or PSM.

- 1.4.6 The aircraft manufacturer carried out a detailed inspection of the PSM. Its key findings were as follows:
- (a) The seals of the connection wire grommets were distorted with damage. The aircraft manufacturer suspected the damage had arisen from the PSM not having been seated squarely in its receptacle during installation but was unable to comment on how the damage could have occurred.

- (b) Some of the PSM’s soldering junctions had incomplete solder fillings and did not conform to the aircraft manufacturer’s standards.

- (c) The switches showed signs of wear from multiple movement, including some witness marks of physical contact on the switch housing and possible ink marks on two of the switches which the aircraft manufacturer believed to be consistent with the use of a pen to move the switches.
- (d) The PSM showed much more wear than other modules returned from service.

- 2.1.1 The fuel discrepancy was a result of the under-reading of the total fuel quantity by the FQIS. The under-reading was due to the centre tank's eight fuel tank sensors not being taken into account in FQPU's computation despite the correct setting of the PSM. The under-reading resulted in the overfuel of 41 tonnes of fuel. The aircraft manufacturer explained that the reason the eight centre fuel tank sensors were not taken into account by the FQPU was a fault in the PSM. While the aircraft manufacturer mentioned past reports of faults due to poor connections between FQIS components (e.g. FQPU, PSM and other wiring connections), it did not identify such problems on this incident aircraft. Neither the aircraft manufacturer nor the investigation team was able to establish the nature of the fault in the PSM.

- 2.1.2 The aircraft manufacturer had found that, while the PSM switches were correctly set for B777-200ER, they showed signs of wear from multiple movement, along with ink marks which it believed to be consistent with the use of a pen to move the switches. The degree of wear was also higher than on other PSMs that were returned to the aircraft manufacturer from service. In the opinion of the aircraft manufacturer, such wear had the potential to cause a fault in the FQPU and might cause it to default to the B777-200 mode. There had been no recent maintenance work done to the FQIS or PSM prior to the occurrence, but the investigation team understands that aircraft maintenance personnel may at times need to reset the PSM switch pattern in the course of troubleshooting the fuel quantity indication system. Such troubleshooting practice could probably explain the ink marks and wear. However, it cannot be established whether the wear had affected the FQPU and caused it to default to the B777-200 mode.

- 4.1 Immediately after the incident, the aircraft operator had replaced the incident aircraft's FQIS components (e.g. the FQPU, the fuel tank sensors, the PSM and associated components).

- 4.4 The aircraft manufacturer upgraded subsequent versions of the FQPU to be able to detect and prevent incorrect program pins configuration.
- 4.5 The aircraft manufacturer reviewed two areas of potential safety concerns pertaining to overfuelling, raised by the FQIS referencing an incorrect aircraft model, namely, runway overrun in a rejected take-off scenario and insufficient climb capability. The aircraft manufacturer determined that the aircraft would have sufficient safety margin in both scenarios and did not consider that the scenarios presented a safety hazard.

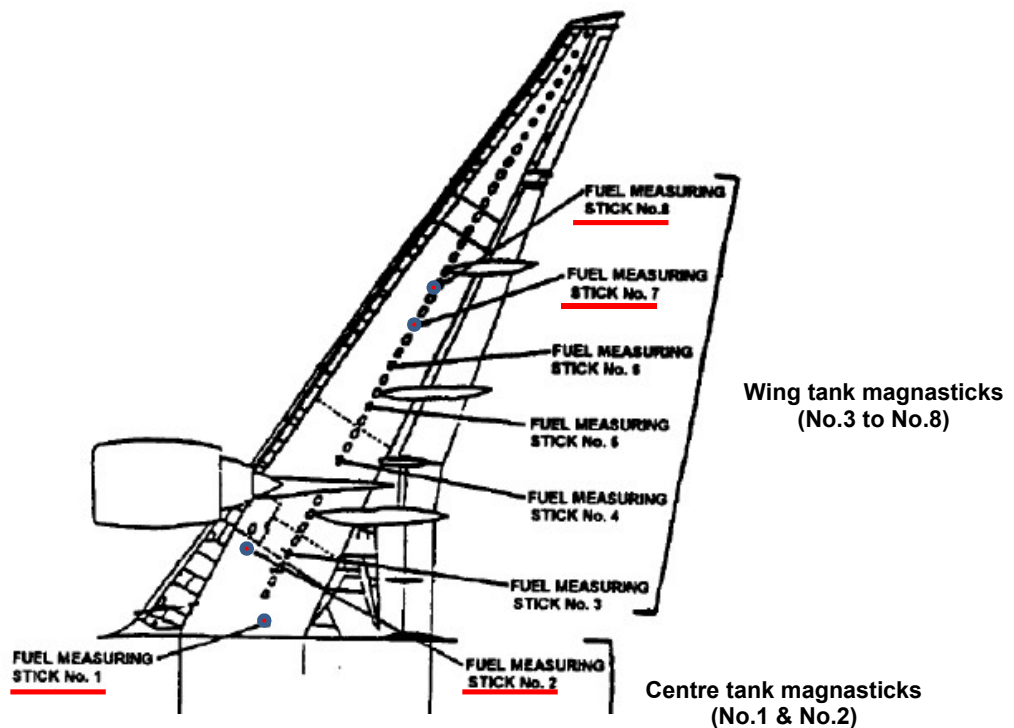
Figure 4. Magnastick locations on the B777 (magnasticks underlined in red were required to be read)

1.6.4 The magnastick check for this incident flight would require the maintenance personnel to take magnastick readings from the left and right No.1 magnasticks of the centre fuel tank (and also from the left and right No.2 magnasticks¹³ when fuel load was high¹⁴) and the No.7 and No.8 magnasticks of the left and right main wing tanks. However, the CT had assumed that the two main wing tanks were full, with 28.227 tonnes each, and directed the LT to take (without any explanation to the LT) the left and right No.1 magnastick readings from the centre tank. The CT made this assumption on the basis that the refuelling system was programmed to always fill the left and right main wing tanks full before the centre fuel tank was filled. Thus, the LT only took readings from the left and right No.1 magnasticks of the centre fuel tank. Both the left and right

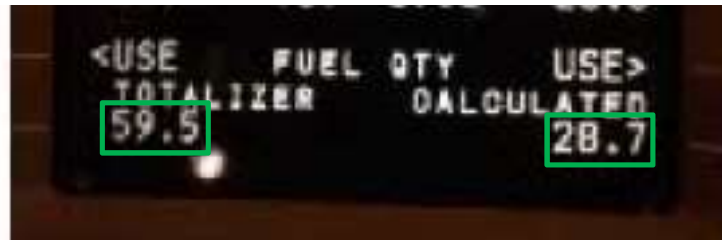
- 1.8.2 This FMC “calculated fuel” was displayed real-time to the flight crew, who could compare it with the real-time “measured fuel” displayed by the FQIS or Totalizer, both fuel figures being displayed side by side (see **Figure 5**). The FMC “calculated fuel” should match the FQIS “measured fuel”. However, in this incident flight, the flight crew was alerted by the EICAS warning of “FUEL DISAGREE”. They also noticed, on checking further, that the FMC “calculated fuel” was lower than the FQIS “measured fuel” and the difference between these two figures was increasing.

Figure 5. FMC displaying the discrepancy between “measured fuel” remaining (i.e. totalizer) and “calculated fuel” remaining (i.e. calculated)

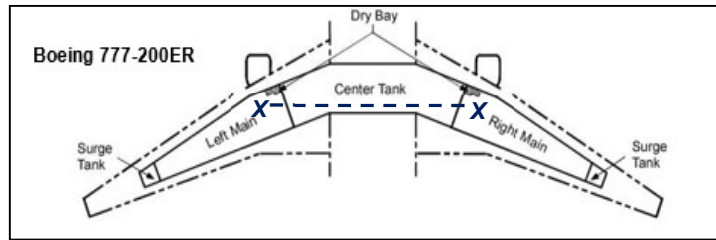
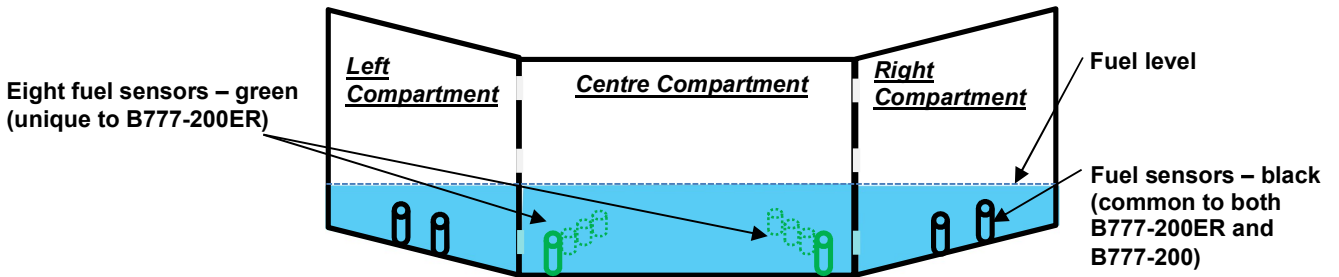
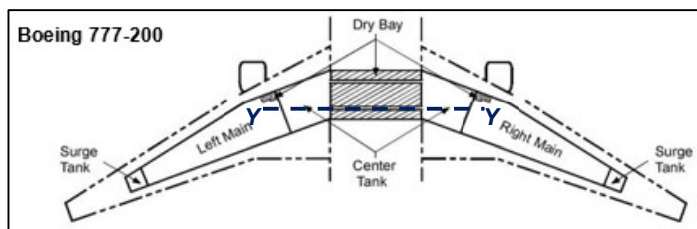
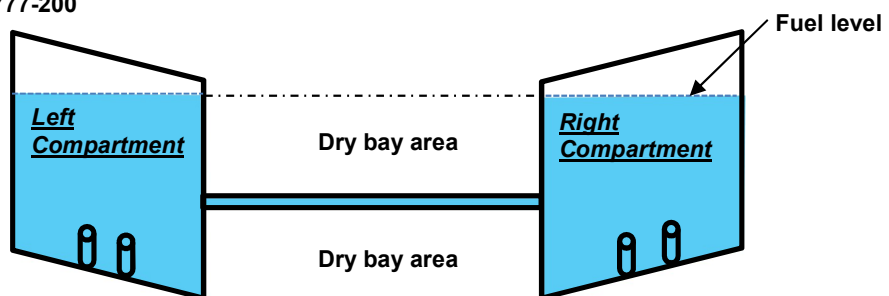
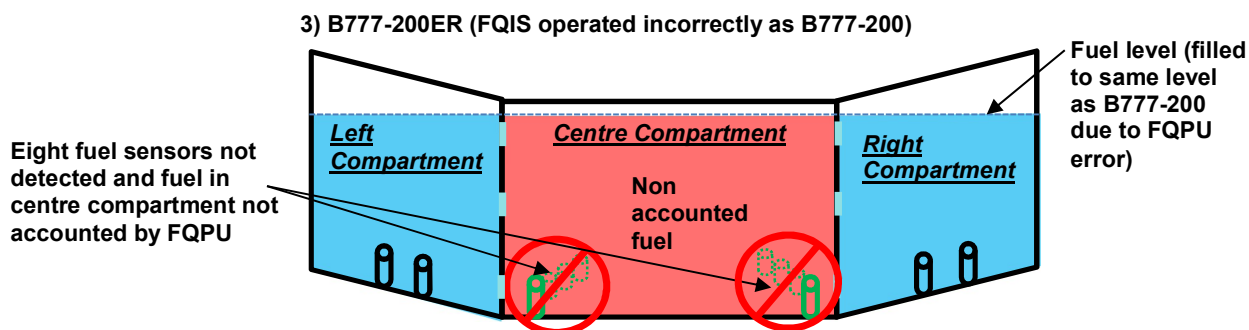
Figure 6: Explanation of FQIS under-reading

2.4.1 Due to the incorrect aircraft model referenced by the FQIS which resulted in the eight centre fuel tank sensors not being recognised by the FQPU, the FQIS was under-reading the actual overfuelled state of the centre tank. The actual fuel uplifted to the centre tank for this incident flight was about 70.546 tonnes, much more than the intended 29.547 tonnes (i.e. about 41 tonnes overfuelled). This under-reading meant that the 70.546 tonnes of actual fuel in the centre tank was represented by 29.547 tonnes on the FQIS cockpit indication (i.e. more actual fuel would have to be expended before the FQIS cockpit indication records a change). Thus, the FQIS “measured fuel” quantity appeared to be decreasing at a slower rate (see **Figure 6** for details of the under-reading).

Cross section X – X of simplified B777-200ER centre fuel tank.
 The centre fuel tank of the B777-200ER comprised three (left, centre and right) compartments. When the FQIS was operating correctly, the fuel level shown schematically above corresponded to the amount of fuel in the centre fuel tank needed for the incident flight (i.e. 29.547 tonnes). The fuel sensors detected the fuel level in the left, centre and right compartments of the centre fuel tank and sent that information to the FQPU which computed the total fuel quantity in the centre fuel tank (which displayed that figure on the IRP and cockpit indicators).

Cross section Y – Y of simplified B777-200 centre fuel tank (note the smaller fuel tank and the dry bay area in place of a centre compartment).
 In the smaller B777-200 centre fuel tank, the same 29.547 tonnes of fuel in the centre fuel tank would be stored mostly in the left and right compartments of the centre fuel tank.

Details of incident aircraft's B777-200ER centre fuel tank (which was operated as the B777-200 model).
 With the malfunctioning PSM, the FQPU "thought" it had a B777-200 fuel tank configuration and received no input from the eight fuel sensors in the centre compartment. The fuel in the left and right compartments needed to reach the same high level as shown in the earlier diagram in order for the FQPU to "believe" it had 29.547 tonnes in the centre fuel tank. However, filling up the left and right compartments also filled up the area in the centre compartment that would have been dry bay volume in a B777-200. This resulted in overfuelling of 41 tonnes of fuel (in red).
