FINAL REPORT

RUNWAY INCURSION INVOLVING B777 AND TWO DEPARTURES IN CHANGI AIRPORT 29 JUNE 2017

AIB/AAI/CAS.149

**Transport Safety Investigation Bureau
Ministry of Transport
Singapore**

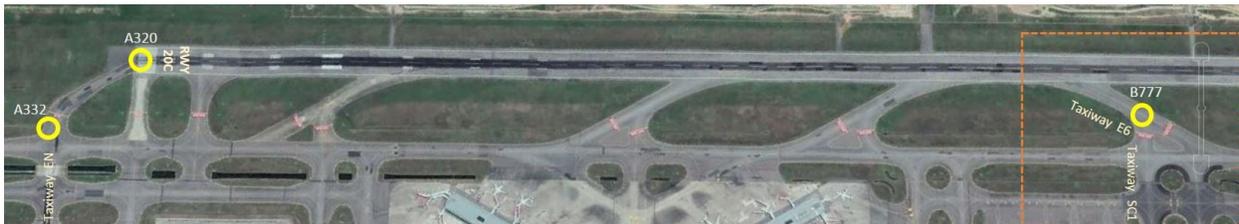
1.1.2 The RWC monitored the movement of the arriving B777. He saw that it had vacated the runway and was moving on E6. Assessing that the aircraft would soon be clear of the runway holding position marking while on E6², the RWC issued a departure clearance to the A320 that had lined up on the threshold of Runway 20C. He also cleared an A330 to line up behind the A320. **Figure 1** shows the positions of the three aircraft.

Figure 1. Positions of A320 and A330 as the B777 vacated Runway 20C

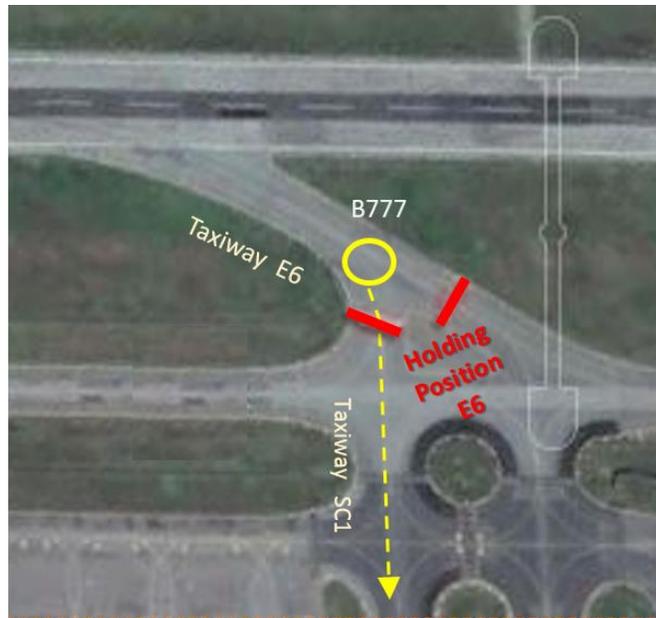
1.1.3 As the B777 was moving towards the runway holding position on E6 (see **Figure 2**), the aircraft's Pilot Monitoring (PM) called the GMC and reported, "Good afternoon, vacated runway for South Cross 1 (SC1)". Proceeding from E6 to SC1 would involve turning the aircraft about 50-60° to the right after the runway holding position on E6.

Figure 2. Holding Position at E6 and taxi route for B777

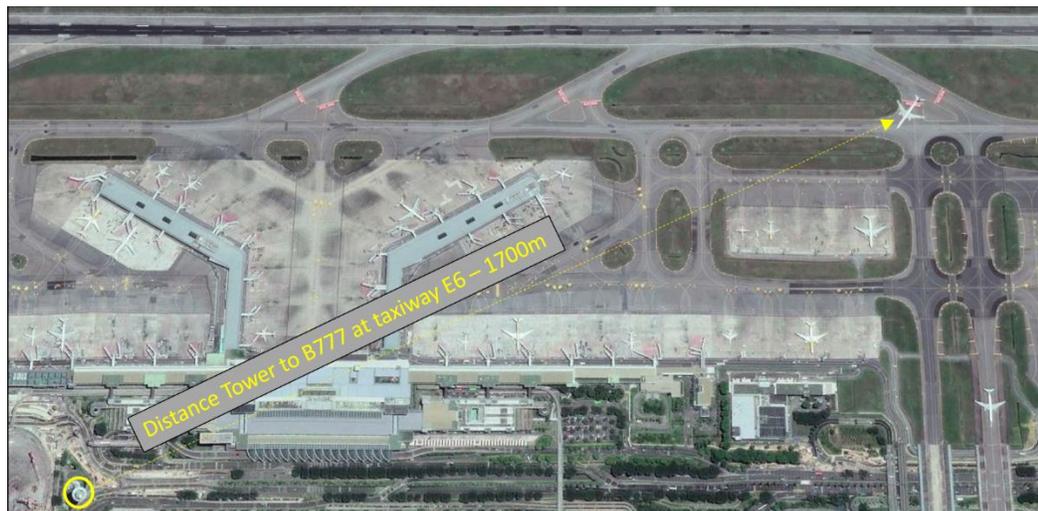
1.1.4 The Pilot Flying (PF) used the tiller to effectuate the turning. The PF felt that the aircraft was not responding to his tiller input. He applied more tiller input but this resulted in the aircraft turning more than the desired angle. Sensing that the steering control was lost, the PF stopped the aircraft on E6. The aircraft ended up with its nose pointing more or less in the direction of the Control Tower which was about 1,700m away (see **Figures 3 and 4**).

Figure 3. Nose of B777 facing the Control Tower

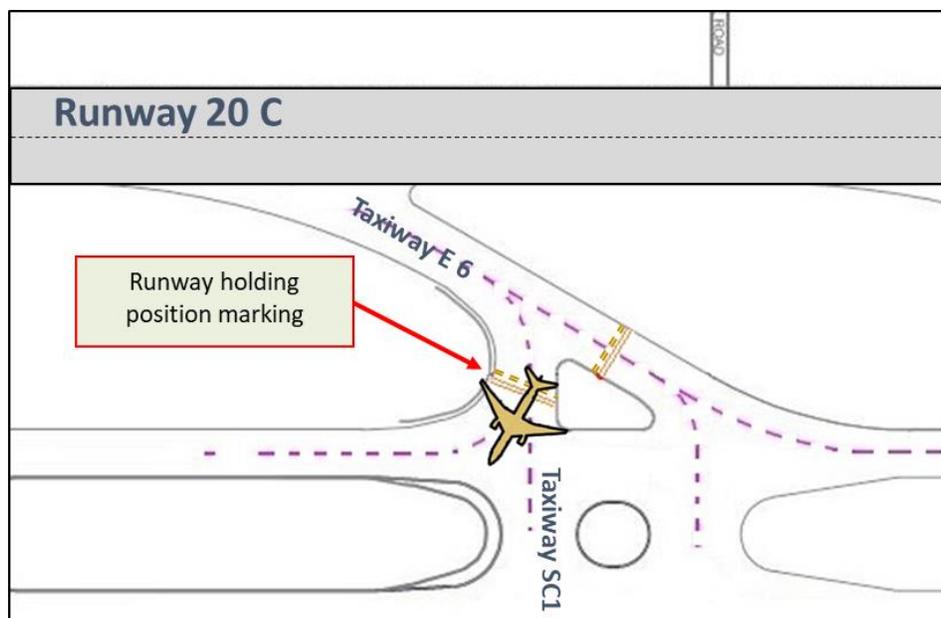
Figure 4. Orientation of B777 at E6

1.5.2 A nose landing gear system functional test was carried out on the B777. The nose gear steering metering valve was found faulty.

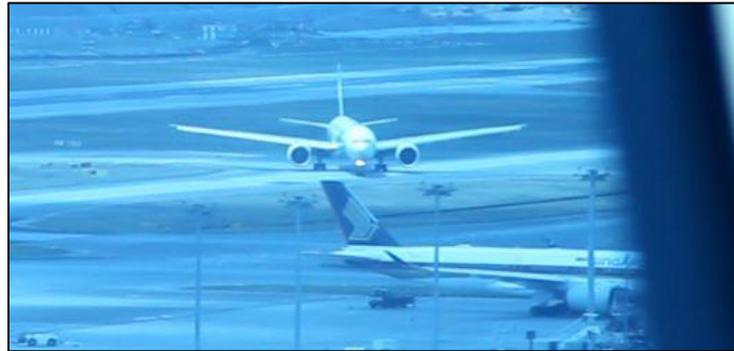
position marking and that parts of the marking were obscured by the shadow casted by the wings of the aircraft (see **Figure 5**). Nevertheless, he assessed that the B777 was clear of the A330 as the B777 appeared to him to have crossed the marking entirely. The WM indicated to the RWC that it would be all right for the A330 to take off and the RWC issued the take-off clearance for the A330. The A330 departed at about 1528LT.

Figure 5. Reconstructed picture to illustrate the view from the Control Tower of an aircraft vacating a rapid exit taxiway

- 2.4.3 Had the B777's nose been pointing in the direction of the centreline of E6, it would not have been difficult for controllers in the Control Tower to decide whether the tail end of the aircraft had crossed the runway holding position marking. However, the aircraft had developed an unexpected problem with its tiller which resulted in the aircraft stopping at the runway holding position with its nose pointing more or less in the direction of the Control Tower, and this nose orientation was such that the nose and main landing gears of the aircraft could be seen as having crossed the runway holding position marking but that parts of the marking were obscured by the shadow casted by the wings of the aircraft. The Control Tower being at a distance of about 1,700m from the aircraft, it might not always be easy to judge whether the tail end of the aircraft was ahead, over or behind the runway holding position marking. This incident suggests that it would be useful to rope in a third party to go the aircraft if there is doubt, to ascertain the position of the aircraft relative to the runway holding position marking, as was done eventually.

4.1.2 The air traffic service provider implemented, on 17 January 2018, an improvement to its Advanced-Surface Movement Guidance and Control System (ASMGCS) which consisted of adding a visual reference on the ASMGCS monitors to help air traffic controllers ascertain that there is enough separation between an aircraft departing on a runway and an arriving aircraft vacating the runway via a rapid exit taxiway.

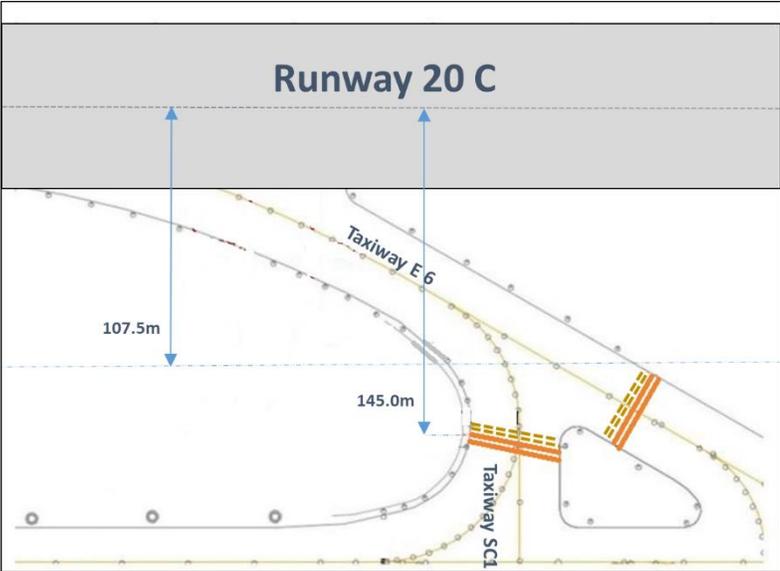
1.6.2 The distance from Runway 20C centreline to the runway holding position marking at E6 was 145m. The minimum distance⁴ for large aircraft like B777, A330 and A320 was 90m and for larger aircraft like B747 and A380 was 107.5m (see **Figure 7**).

Figure 7. Distance from Runway 20C centreline to E6 runway holding position marking

- 2.4.4 Fortuitously, there was an extra margin of safety in the distance between the runway holding position on E6 and Runway 20C. The incomplete crossing by the B777 of the runway holding position marking on E6 did not entail a risk of collision with an aircraft rolling on Runway 20C.
