Final Report

BOEING B777-300ER, REGISTRATION 9V-SWQ IN-FLIGHT ENTERTAINMENT SMOKE INCIDENT

27 MARCH 2023

TIB/AAI/CAS.221

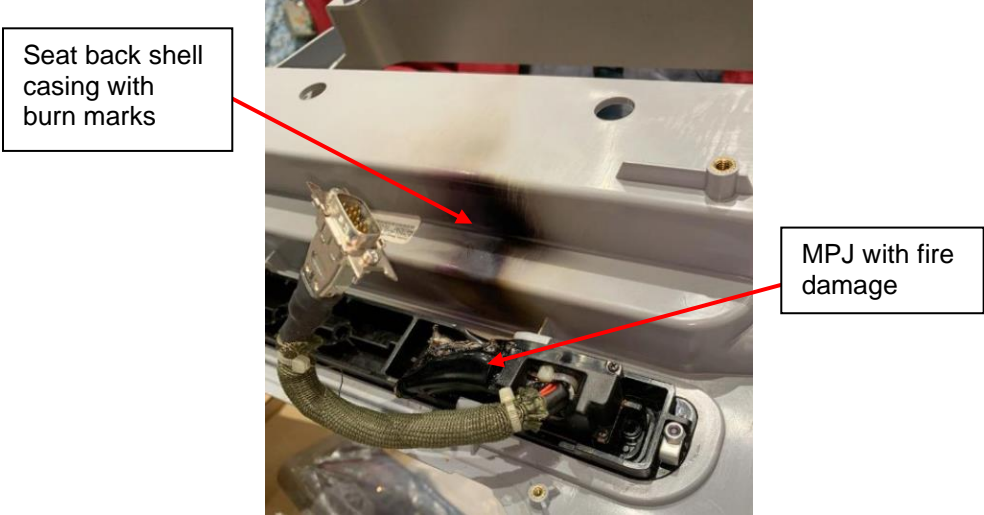
1.3.1 Seat 47K's back shell casing and the MPJ suffered heat and fire damages.

Figure 3: Heat damage to seat back shell casing and the MPJ

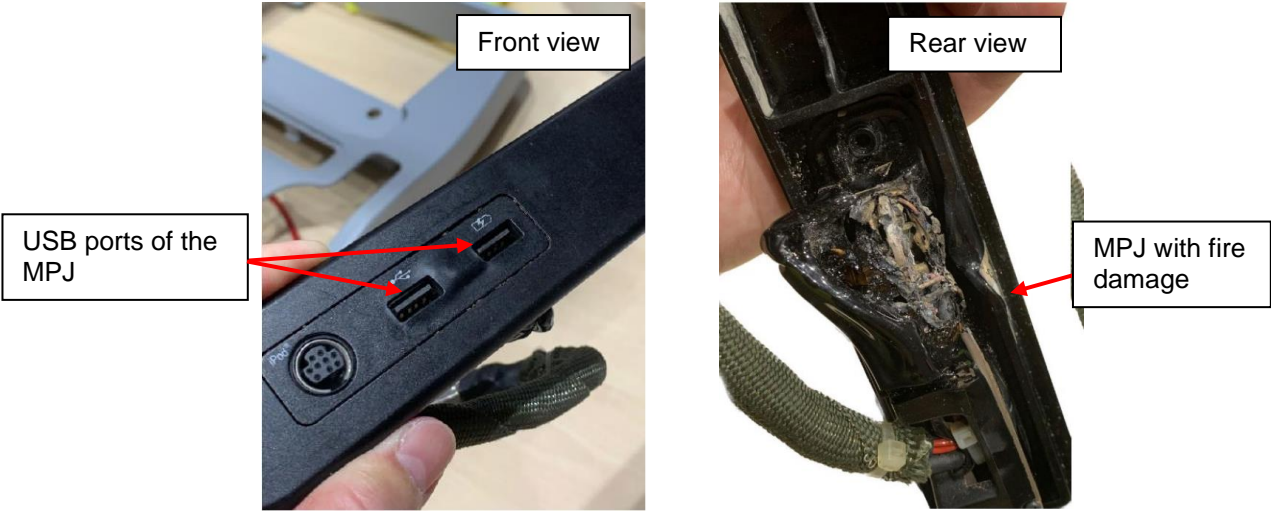
Figure 4: Heat damage to the MPJ and USB ports

- 5.1 The aircraft operator replace MPJ with those that have incorporated MOD 3 and MOD 4 on the B777 fleet. [TSIB Recommendation RA-2024-001]

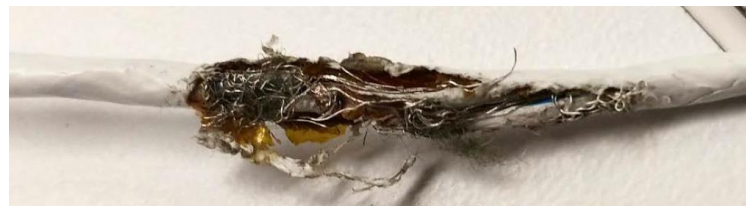
1.5.2.1 Following the incident on 27 March 2023, the aircraft operator carried out a more in-depth investigation of the IFE electrical system and found previously undetected damage to the wires and cable insulation on the folding arm-type IFE display panel at Seat 41H. The wires were found with damaged insulation and exposed bare wire. This resulted in a shorting condition where the 28V IFE power supply was unintentionally connected, via the chassis ground wiring system, to all the other IFE units within that cabin column.

Figure 5: Damaged wire and cable insulation found

- 2.1 A previously undetected wire damage on the folding arm-type IFE display panel at seat 41H resulted in a shorting condition where 28V high voltage main power was presented to all other seats' IFE units within the cabin column concerned via the chassis ground wiring system.

- 4.1 The IFE manufacturer recommends periodic checks on the cable harness in the seats' armrest mechanism every 5 to 7 years to detect any signs of incorrect or degenerated cable routing and clamping which can lead to cable damage.

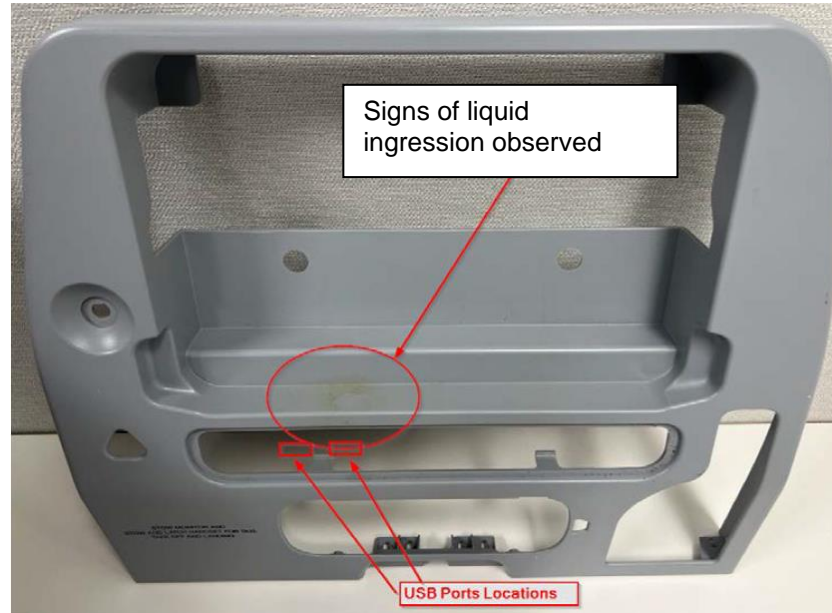
1.5.2.3 The IFE manufacturer also examined the damaged MPJ circuit of the IFE unit from the 27 March 2023 incident and found signs of liquid ingress on the IFE frame.

Figure 6: Liquid ingress found on the IFE frame by IFE manufacturer (27 March 2023 event)

- (a) As a result of damaged wires and cable insulation, the IFE panel was exposed to a high voltage (28V) via the chassis ground which was shared between seats in the same cabin column.
- (b) A shorting between this high voltage chassis ground and the digital ground on the MPJ caused by the liquid that had ingressed onto the IFE frame.
- (c) This shorting resulted in overvoltage and heat damage and thus smoke.

- 2.2 In addition to this latent exposure to the high voltage coming from the chassis ground, a secondary exposure to liquid ingress on the MPJ panel established a connection between this high voltage chassis ground and the digital ground within the MPJ panel. This resulted in an overvoltage condition and heating within the IFE unit that led to smoke and sparks forming.
