Final Report

Boeing 787-9 Registration HL-7209 Taxi Incident

24 February 2023

TIB/AAI/CAS.215

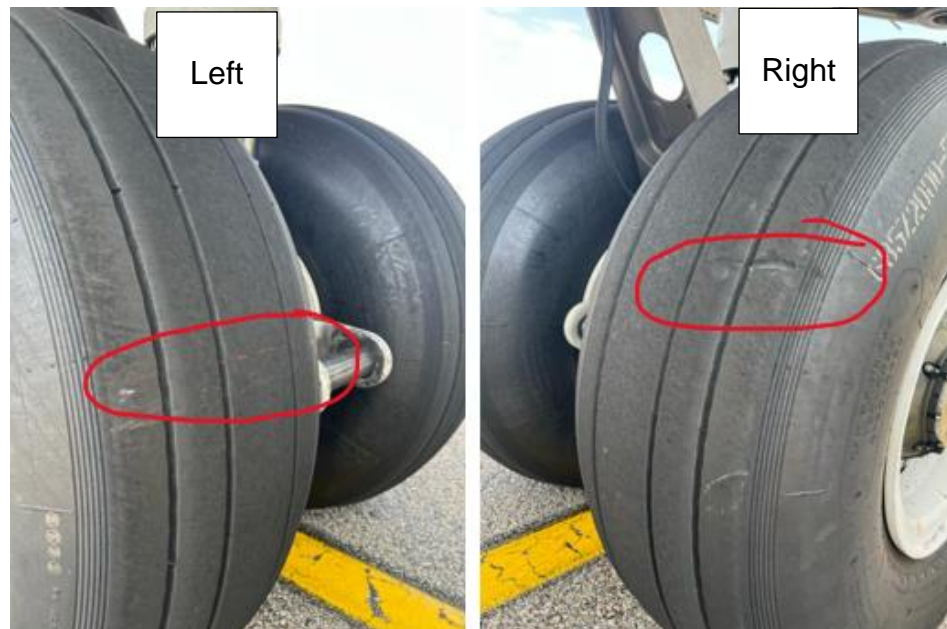
1.3.1 There were scuff marks on the nose wheels (see **Figure 4**) as well as red paint marks from the marker board placed near the junction of Taxiways T and P2.

Figure 4: Damage on each nose wheel

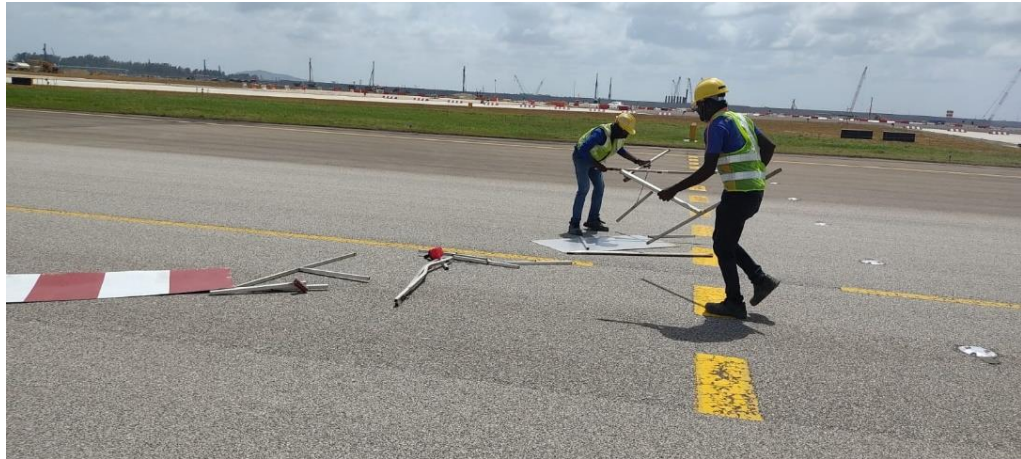
1.4.1 The marker board near the junction of Taxiways T and P2 was broken owing to the impact with the aircraft's nose wheels (see **Figure 5**).

Figure 5: The damaged marker board

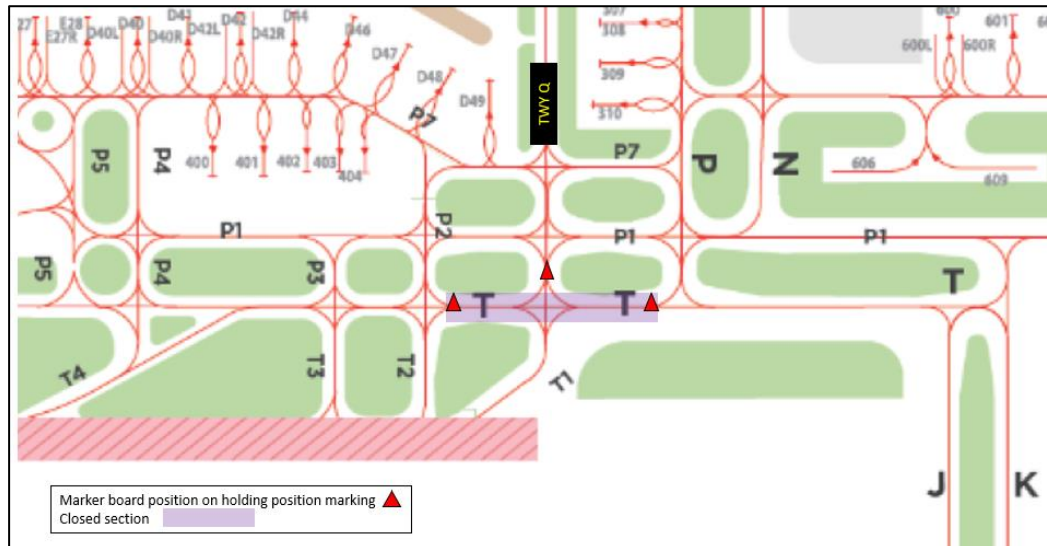
- 1.8.1.1 The section of Taxiway T between Taxiways P and P2, including the junction of Taxiways T and Q/T1¹¹ (see **Figure 6**), was temporarily closed for taxiway guidance signage work. The closed section of Taxiway T was demarcated with marker boards and obstacle lights in accordance with the aerodrome operator's standard operating procedure. One marker board was placed on the taxiway centreline at the intermediate holding

position near the junction of Taxiways T and P2 to mark one end of the closed section and another marker board was placed on the taxiway centreline at the intermediate holding position near the junction of Taxiways T and P to mark the other end. Further, one marker board was placed on the taxiway centreline at the intermediate holding position near the junction of Taxiways T and Q to denote the closed section of Taxiway T.

Figure 6: Locations of marker boards

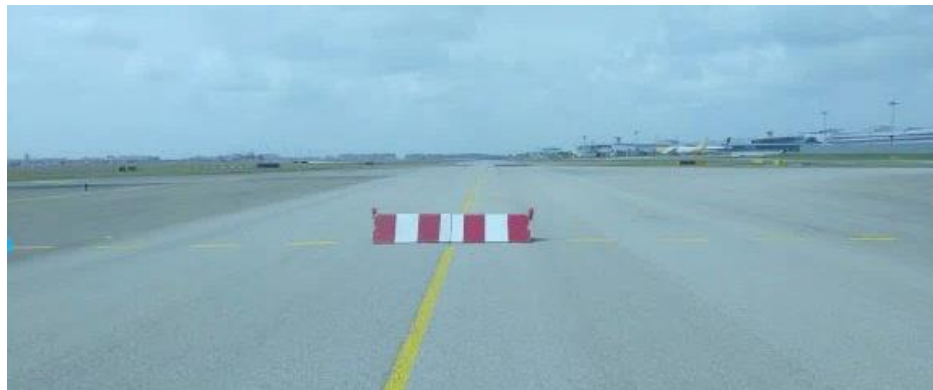
1.8.2.2 **Figure 8** is a picture provided by the aerodrome operator which shows the marker board placed near the junction of Taxiways T and P2 before the incident.

Figure 8: The marker board near the junction of Taxiways T and P2 before the incident
