# **Final Report**

## **BOEING B747- 400F, REGISTRATION B-18719 TYRE BURST DURING TRANSIT**

AIB/AAI/CAS.169

Transport Safety Investigation Bureau  
Ministry of Transport  
Singapore

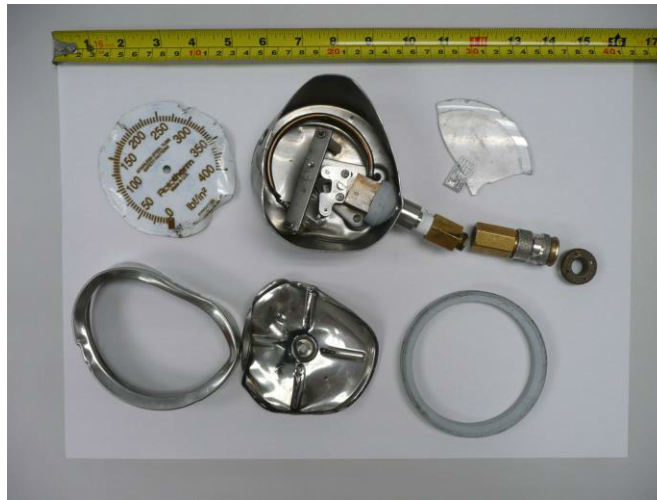
Figure 4: Shattered manual tyre pressure gauge

1.2.1 The manual tyre pressure gauge that had been left on the top of the tyre was completely shattered (see **Figure 4**).

1.2.2 The aircraft sustained the following damage, likely to be a result of debris pieces from the manual tyre pressure gauge flying and hitting the areas concerned:

(a) There were cracks on the aircraft's wing body fairing above the tyre. Behind the fairing, there were cracks on a composite box structure and on a web support structure.

(b) The clamp that was holding one of the electrical conduits that ran adjacent to the right main landing gear's rear body truck tilt linkage was badly deformed, but there was no damage to the wire within the conduit.

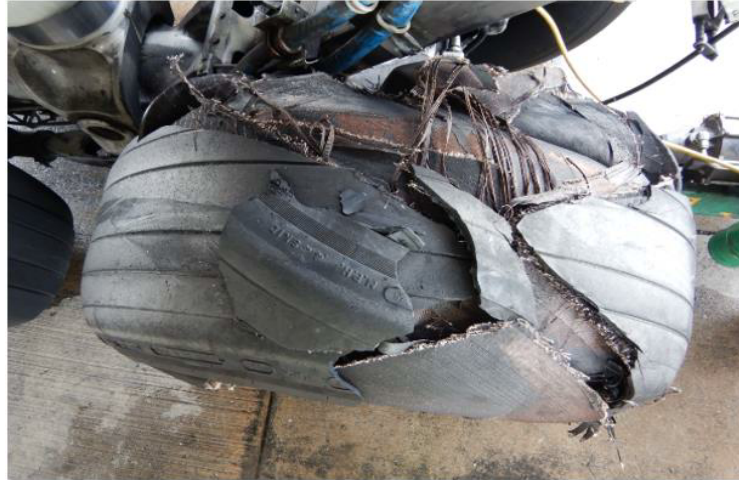
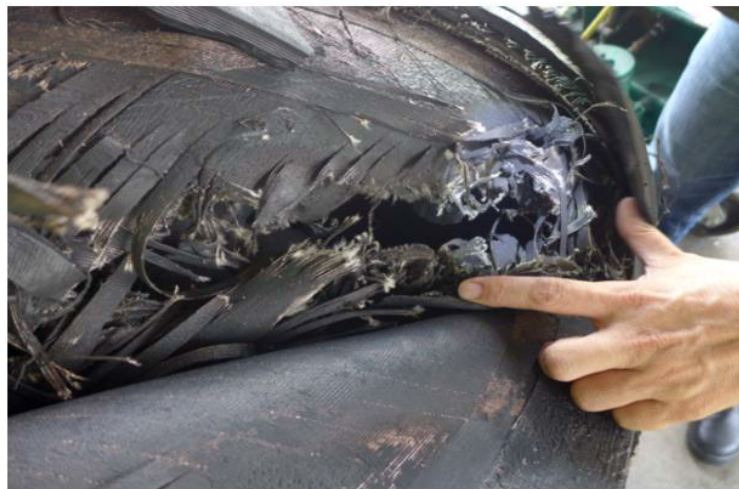
Figure 5: Burst tyre

1.2.3 The No.11 tyre had burst (see **Figure 5**). The wheel assembly of the No. 11 tyre was subsequently disassembled at a workshop and an inspection of the tyre interior revealed a continuous circumferential crack under the shoulders of the tyre (see **Figure 6**).

- 3.4 The bursting of the tyre was probably a result of the progressive weakening of the tyre wall because of a ply cord deterioration condition. The integrity of the tyre was compromised progressively and it was during this incident that the tyre wall could no longer withstand the internal inflation pressure and thus give way to a tyre burst.

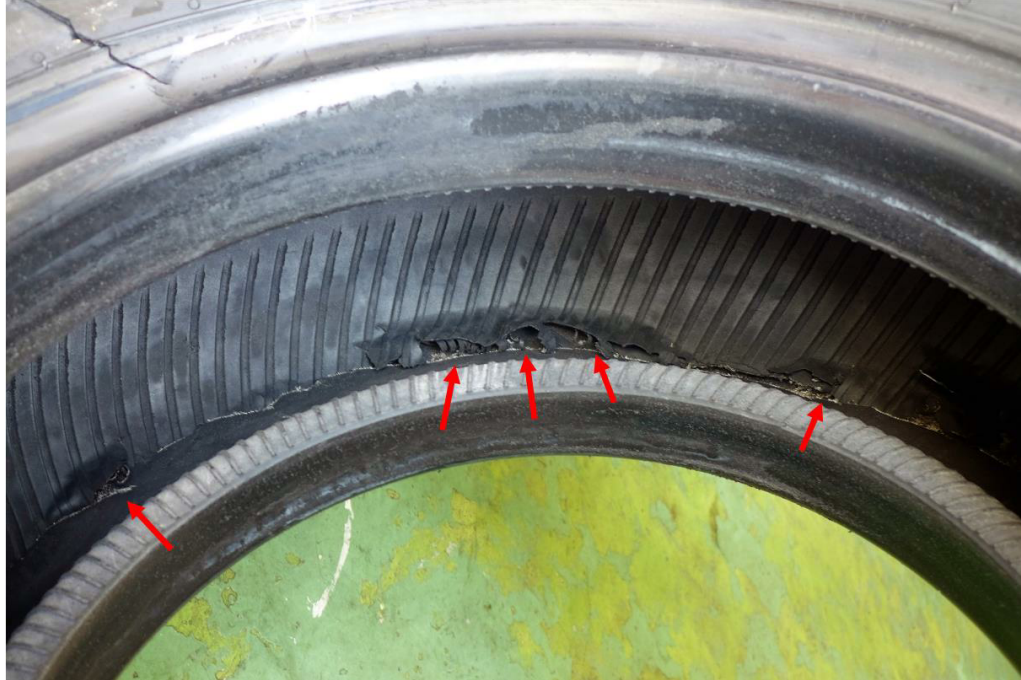
Figure 6: Continuous crack line along the interior shoulders of the tyre

1.5.2.1 The burst tyre was sent to the tyre manufacturer for examination. The examination concluded that there was a ply cord breakage on the inner surface at the shoulder of the tyre and that the ply cord breakage was consistent with the tyre having been operated under significantly low pressure.

- 2.4 Cause of tyre burst
- 2.4.1 The examination of the burst tyre by the tyre manufacturer suggested that there was a pre-existing ply cord deterioration condition on the tyre and that this condition was consistent with the tyre having been operated under significantly low pressure prior to the incident. Indeed, had the tyre been appropriately serviced, it seemed very unlikely that the tyre pressure could have dropped to 170 psi. The ply cord deterioration was likely accompanied by a slow deflation of the tyre which was somehow not noticed during daily checks of tyre pressure or transit walk-around inspections. The integrity of the tyre was compromised progressively by the ply cord deterioration and it was during this incident that the tyre wall could no longer withstand the internal inflation pressure and thus give way to a tyre burst.
