Final Report

BOEING B777-200, REGISTRATION 9V-SQK TOW TUG FIRE

29 NOVEMBER 2017

AIB/AAI/CAS.155

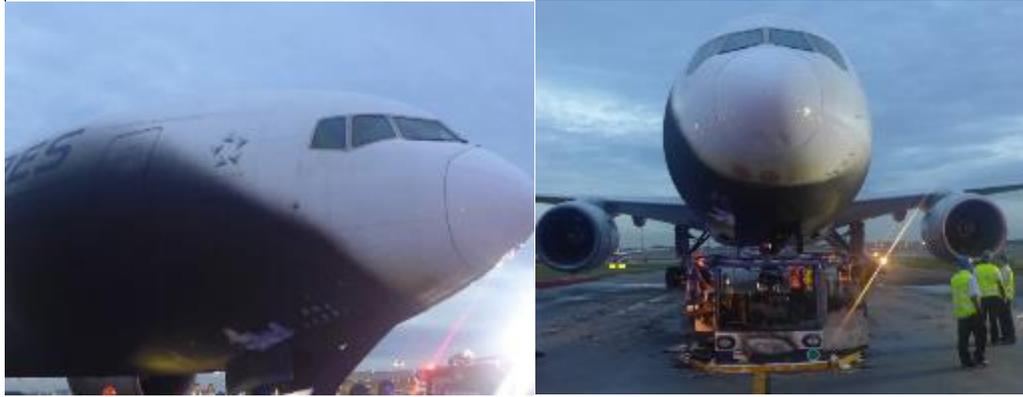
Figure 2: Damage to aircraft structure and nose landing gear

1.3.1 The following components of the aircraft sustained heat damage (see **Figure 2**):

- Radome
- Nose landing gear and tyres and nose landing gear doors
- Hydraulic and electrical components inside the nose landing gear wheel well
- Some fuselage skin panels and supporting structure between the radome bulkhead and aft edge of Door 1 and below the cockpit floorboard
- Panels and several electrical components in the Main Equipment Compartment (MEC)

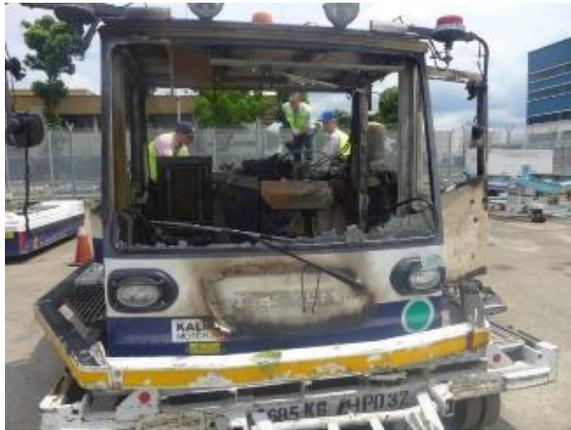
Figure 3: Damage to the driver's cabin of the tow tug

1.4.1 The tow tug was destroyed (see **Figures 3 to 5**).

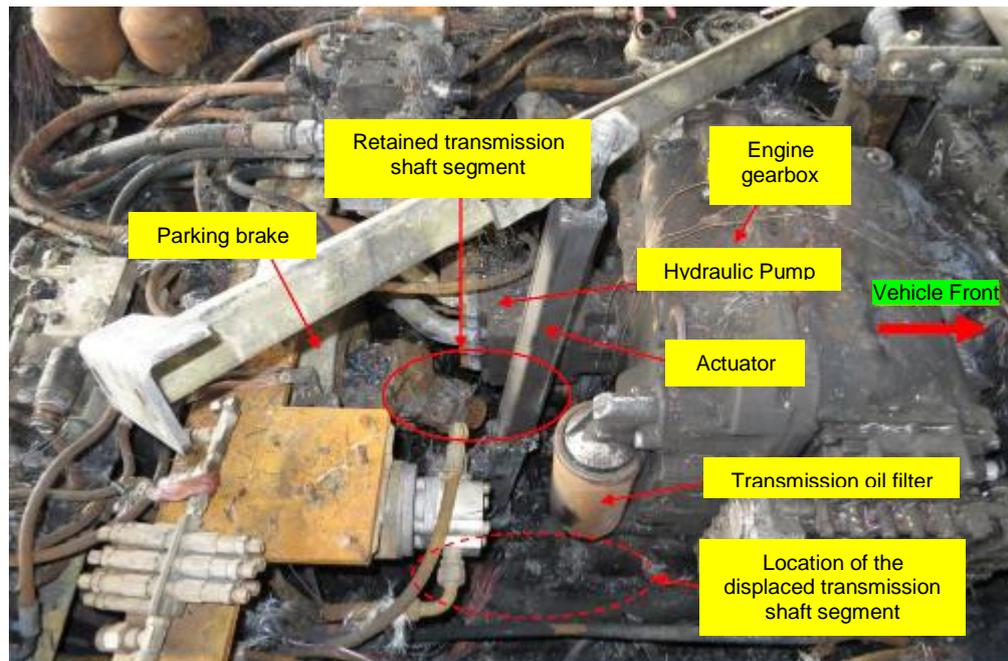
Figure 11: Damage to components under the engine hood

- 1.9.2.1 **Figure 11** shows the damage to engine components under the engine hood. The transmission oil filter, made of steel, had the underside of its casing punctured (see **Figure 12**), resulting in oil leakage from the casing.

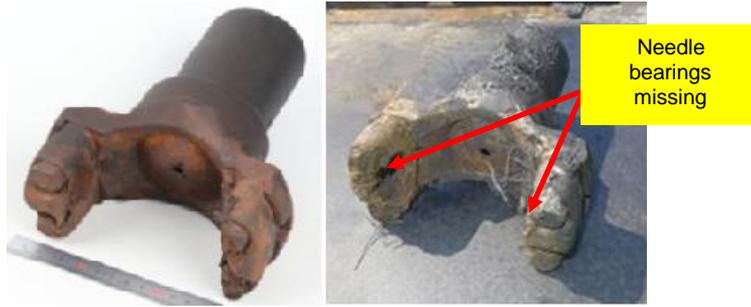
Figure 13: Fixed yoke segment of the transmission shaft assembly (left photo showing the component after cleaned-up)

- 1.9.2.2 The hydraulic oil tank was almost empty. Some hydraulic hoses had been burnt off.
- 1.9.2.3 There was evidence of transmission oil loss.
- 1.9.3 Transmission shaft assembly
 - 1.9.3.1 The fixed yoke segment of the transmission shaft assembly was separated from the splined yoke (see **Figure 13**).

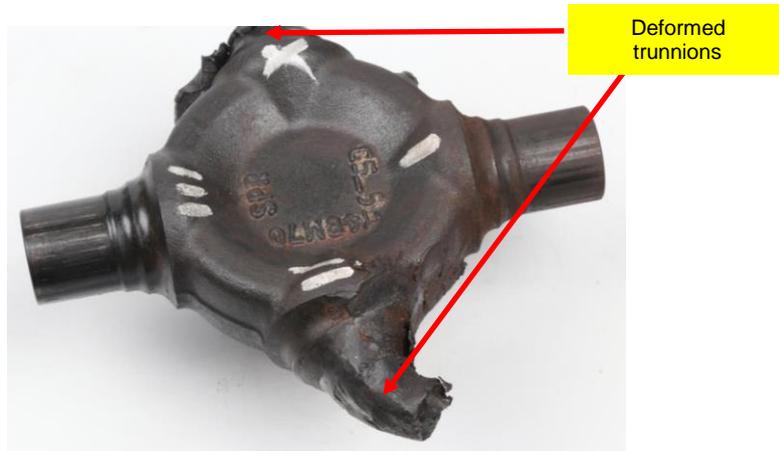
Figure 14: Damaged spider of the universal joint connected to the output flange

1.9.3.2 The spider of the universal joint at the engine side connecting the fixed yoke and the transmission output flange was still in place but one of the two pairs of trunnions of the spider was deformed (see **Figure 14**).

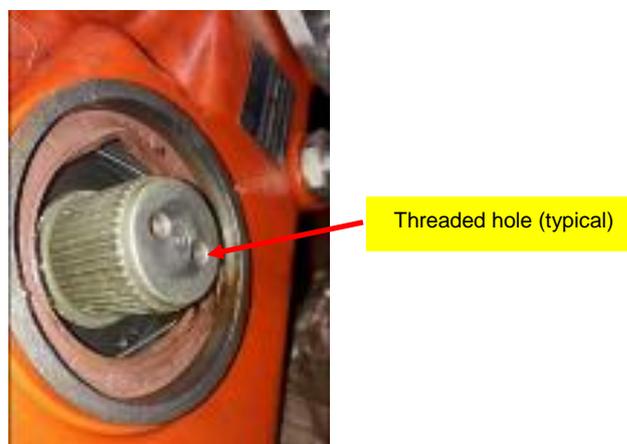
Figure 15: Output shaft of the engine gear box (output flange removed for clarity)

1.9.3.3 The needle bearings in the corresponding pair of bearing caps on the fixed yoke were missing. The two retainer plate bolts were found to be loose from the threaded holes of the output shaft (see **Figures 15 and 16**). As a result, the retainer plate was not fully secured against the output flange.

- (a) Replacing all the transmission shaft assemblies with new ones and lubricating them.
- (b) Rechecking the alignment³⁷ of the transmission and output flange assemblies of each TBL 190 tow tug if necessary.
- (c) Re-installation of all the retainer plate bolts with the torquing performed in two phases: a first round of torquing to 39 Nm and without application of thread locker (a kind of grease that, when hardened, could resist loosening of the bolts) and a second round of torquing at 53 Nm. (Previously, torquing was done to 47 Nm with thread locker.)

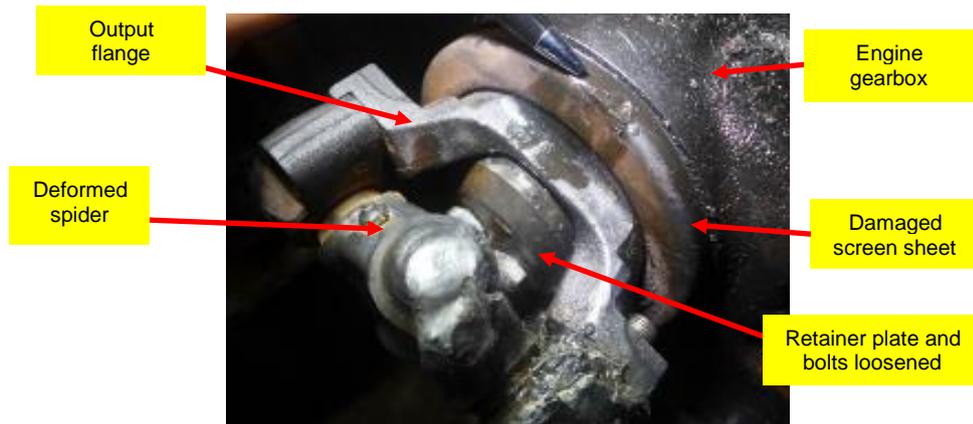
Figure 16: Deformed spider of universal joint

- (a) The disintegration of the needle bearings of the universal joint at the engine side of the transmission shaft assembly resulted in metal-to-metal rubbing of the bearing caps and trunnions. The rubbing caused the deformation of the bearing caps and trunnions under short-term frictional heating, resulting in the liberation of the fixed yoke (which could have a temperature of 500-700°C or higher) and engine stoppage³².
- (b) The liberated fixed yoke flung and hit the transmission oil filter casing, which was punctured as a result.
- (c) The transmission oil sprayed out from the transmission oil filter casing

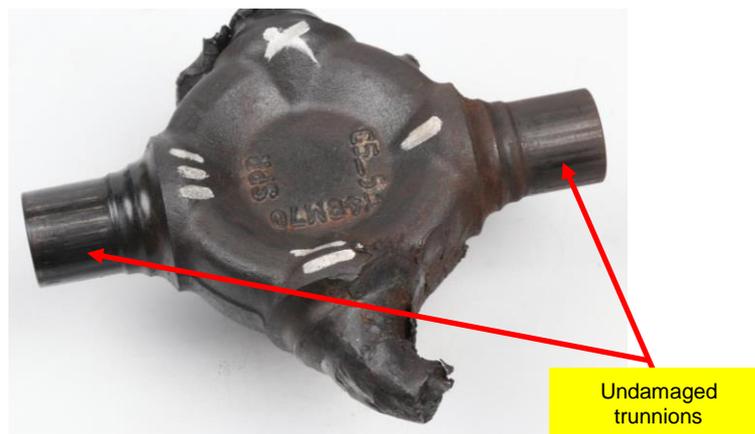
Figure 17: Undamaged trunnions

- 1.9.3.4 The other pair of trunnions on the spider of the universal joint at the engine side connecting the output flange was not damaged (see **Figure 17**). No abnormalities were found on the corresponding pair of bearing caps and the needle bearings inside. Grease was found on these bearings²³ and within the grease channels in the universal joint spider.

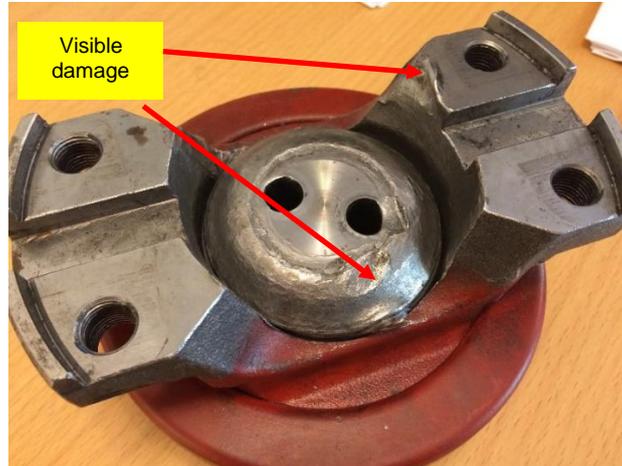
Figure 18: Damage on output flange and retainer plate

through its local agent. The damaged output flange, retainer plate and bolts, and associated seals were replaced by the LMSP as recommended by the tow tug manufacturer. The tow tug manufacturer mentioned to the investigation team that it was not aware of any case of bolt loosening prior to this 14 August 2017 case that occurred to the LMSP.

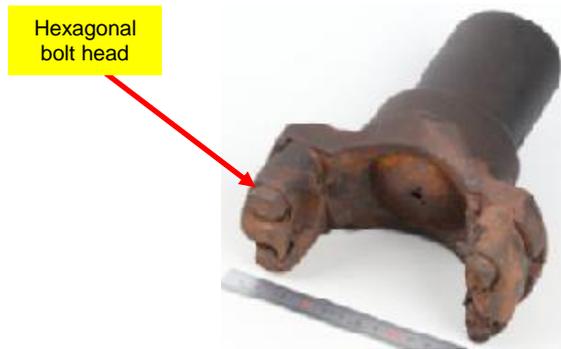
Figure 19: Hexagonal bolt heads on the fixed yoke of the cleaned-up transmission shaft assembly

- (c) There was evidence of zinc material transfer, on the hexagonal shaped puncture, from the head of a hexagonal bolt securing the fixed yoke to the bearing cap. This suggested that the fixed yoke had hit the casing.
- (d) The transmission oil filter operated at a high pressure of 20 bars. Thus, a puncture of the casing could result in the spraying out of the pressurised oil through the punctured area.
- (e) The temperature of the fixed yoke was well above the flash point of the transmission oil²⁹ when the transmission oil from the transmission oil filter was sprayed over it.
- (f) The pair of damaged trunnions of the universal joint spider at the engine

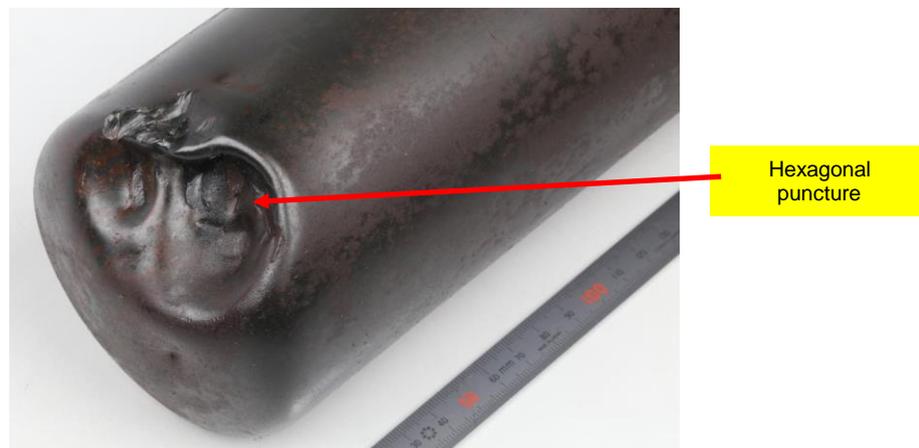
Figure 20: Hexagonal shaped puncture on the transmission oil filter casing

- (b) The puncture on the casing of the transmission oil filter had an indentation that appeared to be hexagonal in shape (see **Figure 20**).
