Final Report

FATALITY OF CREW ON BOARD NOZOMI IN BANGKA STRAIT, INDONESIA 1 APRIL 2022

TIB/MAI/CAS.122

Transport Safety Investigation Bureau
Ministry of Transport
Singapore

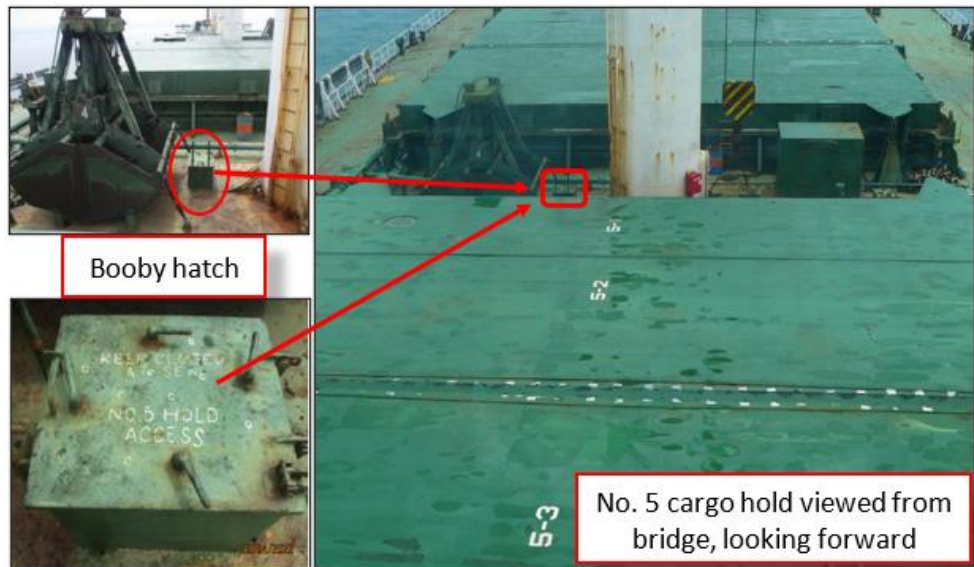
Figure 2 - No.5 cargo hold forward booby hatch - Source: the Company (Annotated by the TSIB)

1.1.4 The Bosun and the three ASDs transferred the grease and tools to the forward booby hatch (for accessing No.5 cargo hold, see **figure 2**). While turning the external dog handles to open the booby hatch cover, two out of the four were found to be seized. The deck crew used a short pipe to slot into the external dog handles and managed to turn them, and thereafter were able to lift open the booby hatch cover.

1.4.2 The outer side of the booby hatch was marked “KEEP CLOSE AT SEA” and “NO.5 HOLD ACCESS” (see **figure 2**). On the inner side, a red metal plate on the hatch marked the number of the cargo hold for access together with “CHECK SAFETY BEFORE ENTRY” (see **figure 6**). These markings were a part of the ship’s original design from the shipyard. There was no other sign or notice in the vicinity indicating that the cargo hold was an enclosed space or that the cargo hold was carrying coal at the material time.

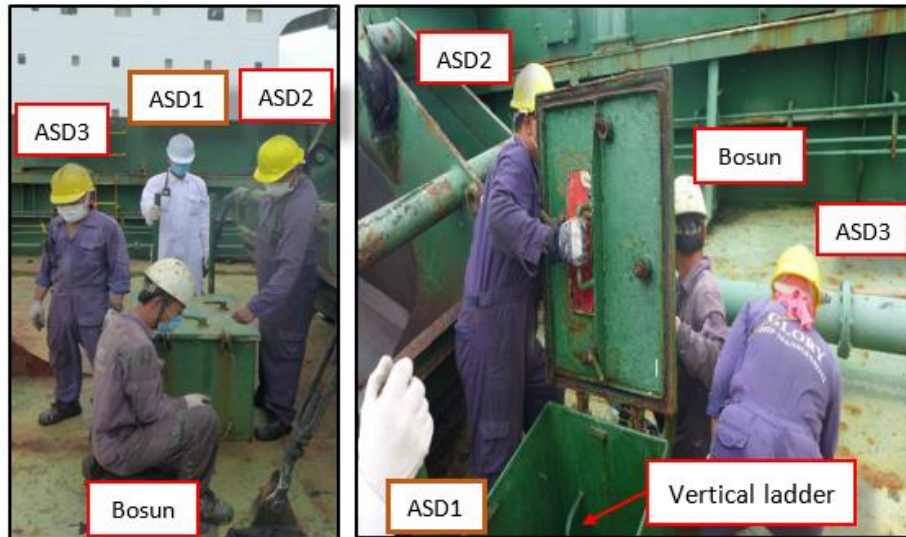
Figure 3 - Enactment of the positions of the deck crew
(Source: the TSIB)

in open position, the ASD1 used a hammer to strike the internal dog handle of the other set of seized-up dog handles. After a few strikes, the external dog handle dropped onto the main deck and was picked up by the ASD3. **Figure 3** shows the enactment of the crew's positions at the booby hatch freeing up the dog handles prior to the external dog handle dropping on deck.

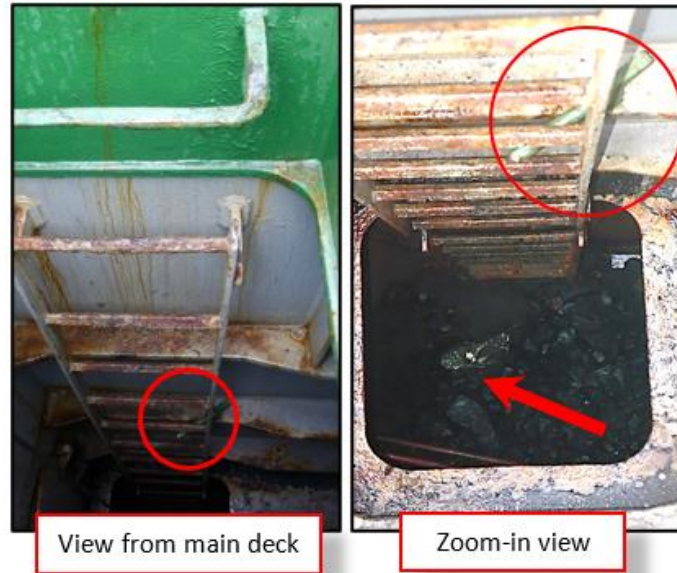
Figure 4 - Red-coloured circles indicating the dog handle and the arrow points to the safety shoes of ASD1 inside the cargo hold
(Source: The TSIB)

- 1.1.6 At about 1030H, the ASD2 heard a sound from No. 5 cargo hold, he looked over the booby hatch and saw the ASD1 lying on the coal cargo. An internal dog handle⁷ was found wedged between the vertical ladder and the side stringer of ship's structure (see **figure 4**). No one was aware that the ASD1 had entered the cargo hold. The deck crew assessed that the ASD1 could have dropped the internal dog handle into the cargo hold while hammering it and tried to retrieve it without informing anyone.

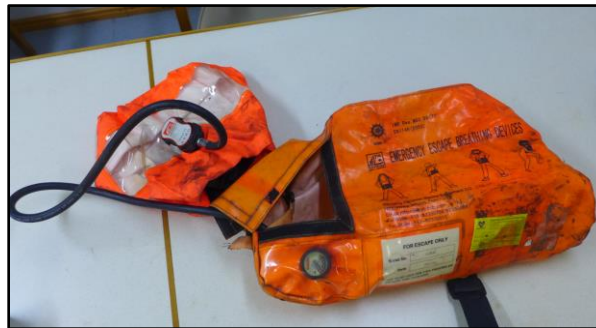
Figure 5 - EEBD set used by the 3O

- 1.1.11 When the 3O arrived at the booby hatch, he put on the EEBD (see **figure 5**) hood and entered the cargo hold through the vertical ladder while the two air hoses were being connected to the air supply. The investigation team gathered that the 3O subsequently came out of the booby hatch, citing that it was difficult to breath and hot in the cargo hold.

for escaping from a compartment that has a hazardous atmosphere and should not be used for entering oxygen deficient voids or tanks on board ships. In the attempt to rescue the ASD1, the 3O used the EEBD to enter the cargo hold and subsequently had to leave the cargo hold due to difficulty in breathing, in addition to the hot environment.

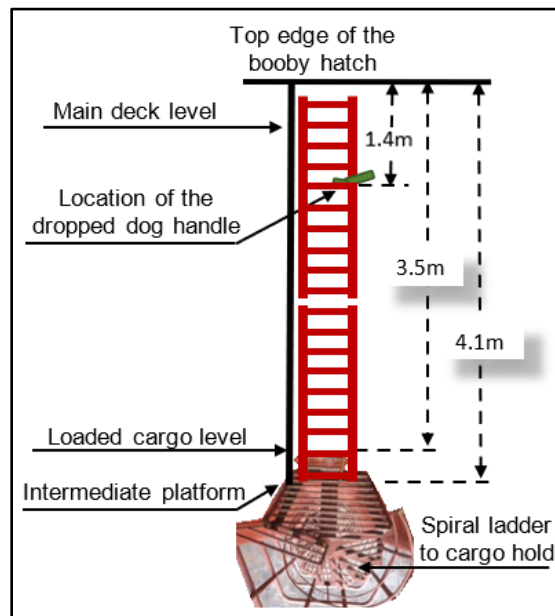
Figure 7 – Illustration of various heights (not to scale)

3.5m from the hatch cover, where the ASD1 was seen lying. The intermediate platform is about 4.1m from the hatch (see **figure 7**).

2.1.6 This hypothesis is further corroborated by the height of the ASD1 and the location where the dog handle was found. From the location where the dog handle was found to the coal level, it is about 2.1m (see **figure 7**). When a person climbs up a vertical ladder, both hands are extended to hold the sides of the ladder. With the height of 1.70m and the arms' length of about 0.5m, it is likely that the ASD1 was either about to climb up the ladder or making the first couple of steps on the ladder, before losing consciousness. The fall was from a low height which explains the reason for no visible injuries sustained by the ASD1. The investigation team opined that the ASD1 might have deemed the cargo hold to be safe for entry and that retrieving the dog handle was a simple task which could be done quickly.
