FINAL REPORT

CAPSIZE AND SINKING OF THE AGGREGATES CARRIER CAI JUN 3 IN SINGAPORE TERRITORIAL WATERS ON 13 MARCH 2017

MIB/MAI/CAS.015

Transport Safety Investigation Bureau
Ministry of Transport
Singapore

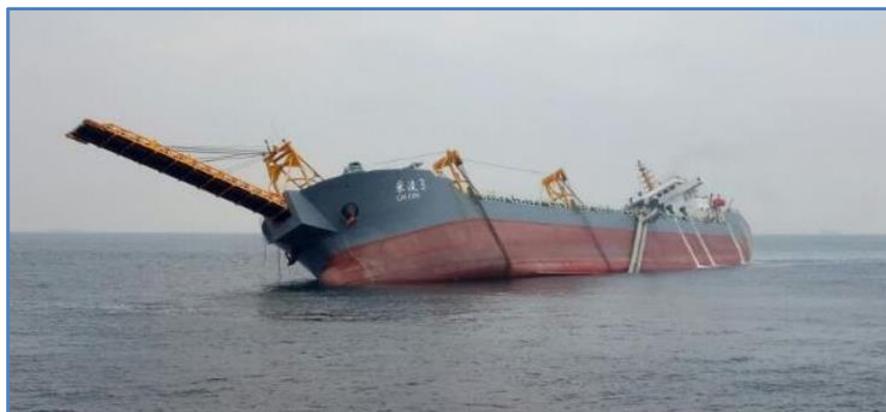
- 1.1.9 Meanwhile, CJ3's starboard list briefly reduced to about 25°-30°, before increasing again. The Master, in anticipation of worsened conditions, and fearing for his crew's safety, raised the emergency alarm and ordered for CJ3 to be abandoned. The crew panicked on hearing the alarm and went towards the work boat which was initially stowed on CJ3's starboard side at the aft part of the ship, but had slipped off its stowed location into the water. Some of the crew started boarding the work boat directly, while a few others, including the Second Officer, jumped into the sea before boarding the work boat. The Master was the last person to abandon CJ3. He also jumped into the sea before boarding the work boat.

Figure 2 – CJ3 listing on 13 March 2017
(Source: Maritime and Port Authority of Singapore)

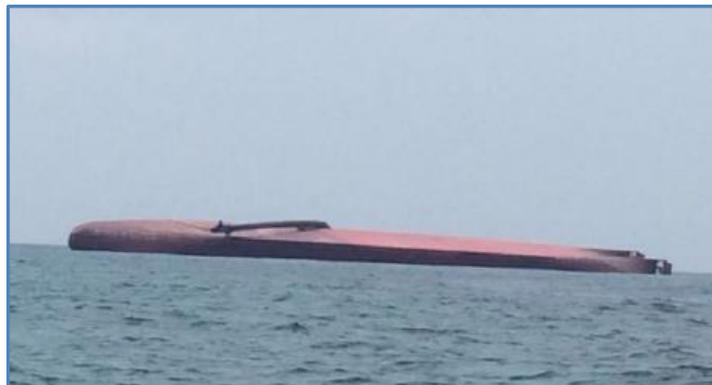
- 1.1.12 At about 1405H, i.e. about one hour from the time of initial listing, CJ3 was seen floating with her bottom hull visible above the water surface (see **Figure 3**) within Singapore Territorial Waters. The suction pipe was seen extending downward at an angle and resting on the ship's bottom. There appeared to be no signs of hull failure.

Figure 3 – Capsized CJ3 on 13 March 2017
(Source: Maritime and Port Authority of Singapore)

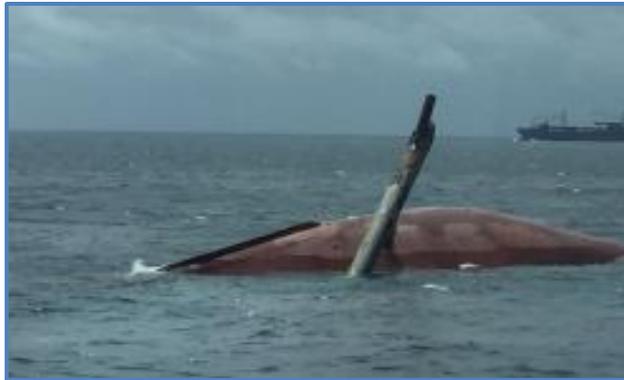
- 1.1.16 On the next day, 14 March 2017, the capsized CJ3 was still free floating with a small portion of the bottom hull visible above the water surface (see **Figure 4**).

Figure 4 – Capsized CJ3 on 14 March 2017
(Source: Maritime and Port Authority of Singapore)

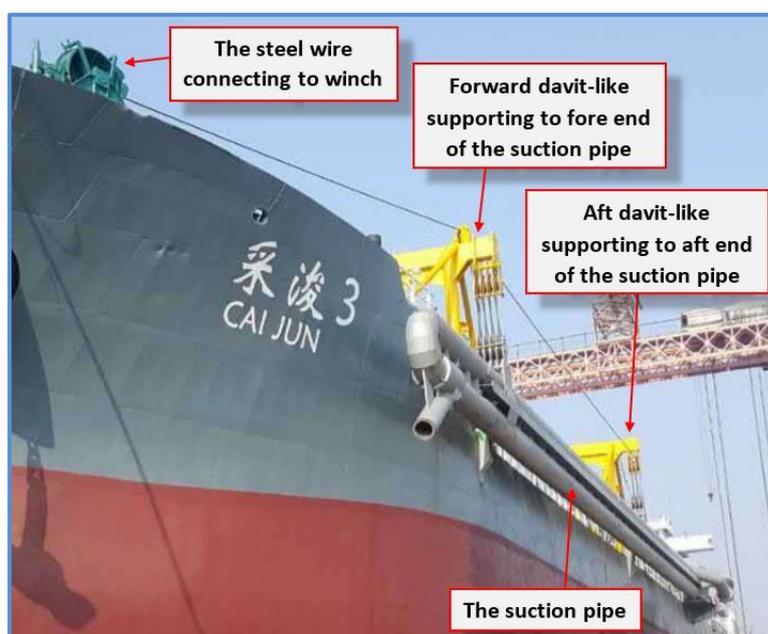
- 1.2.6 The ISM Manager was unable to provide information of the actual modification¹⁴ date. The ISM Manager could only indicate that CJ3 had undergone modifications at a shipyard in China in 2016 and that the modifications included the installation of a suction pipe on the vessel's port side at the main deck level, davit-like supports and sheaves fitted with steel wires connected to winches to facilitate lifting and lowering of the pipe, and 14 pumps connected to the suction pipe with a capacity of 22 KW each. The pipe was installed at Frames 82 to 203, and was about 72 metres in length with an approximate weight of about 100 metric tonnes (see **Figure 7**). According to the Designated Person Ashore (DPA), the chain links and shackles were new, having been renewed in the last quarter of 2016.

Figure 7 – CJ3's suction pipe, two davit supports and winch wires
(Source: ISM Manager)

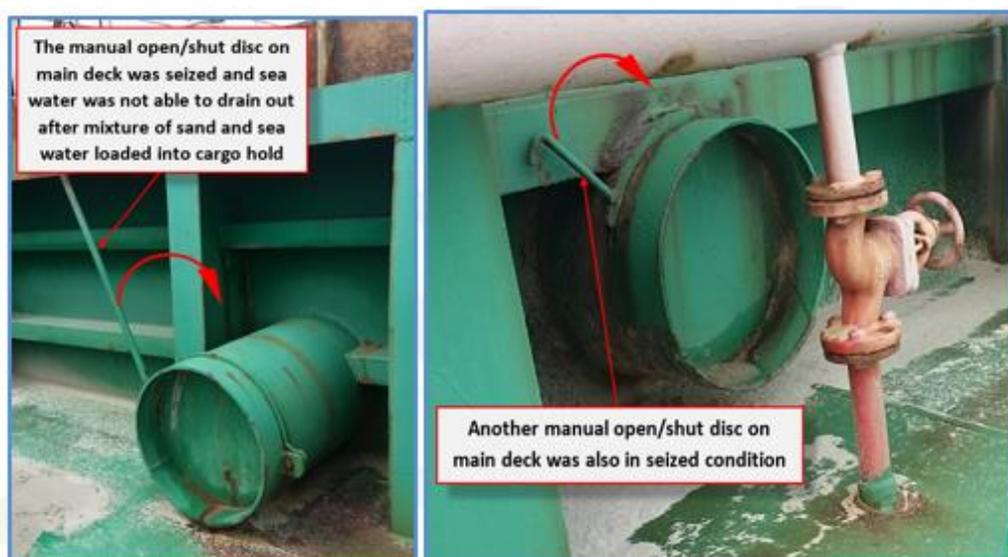
1.7.3.2 All manual disc valves (see **Figure 13**) on CJ2's main deck was observed to be seized in the shut position preventing water from the cargo holds to drain out. It could not be established since when these valves had been in this condition.

Figure 13 – Manual disc valves on main deck level

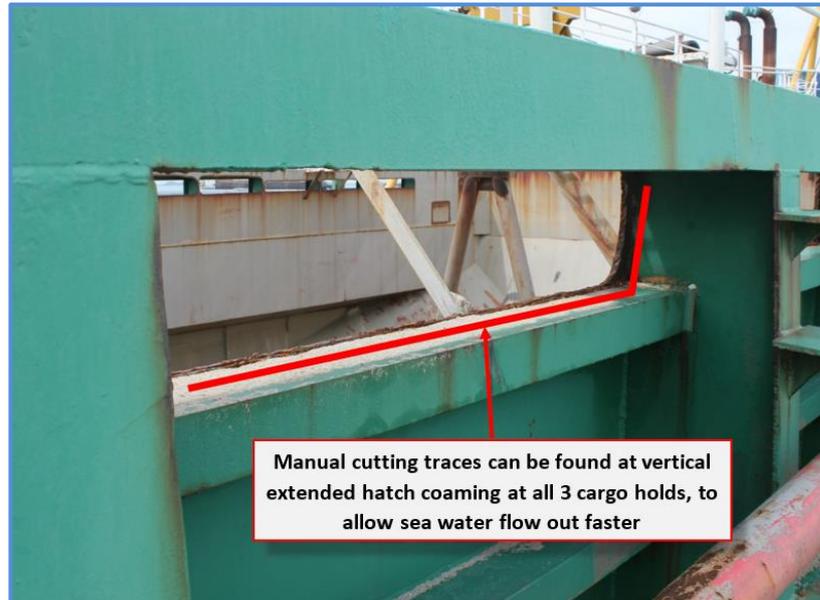
1.7.3.3 There were cut-outs observed in the hatch coaming about one metre above CJ2's main deck near the edge of the coaming (see **Figure 14**). These were reportedly to facilitate draining of water from the cargo holds, which would have normally been from the manual disc valves shown in Figure 13. It could not be established when these cut-outs were made.

Figure 14 – Manual cut-outs on hatch coaming on all sides

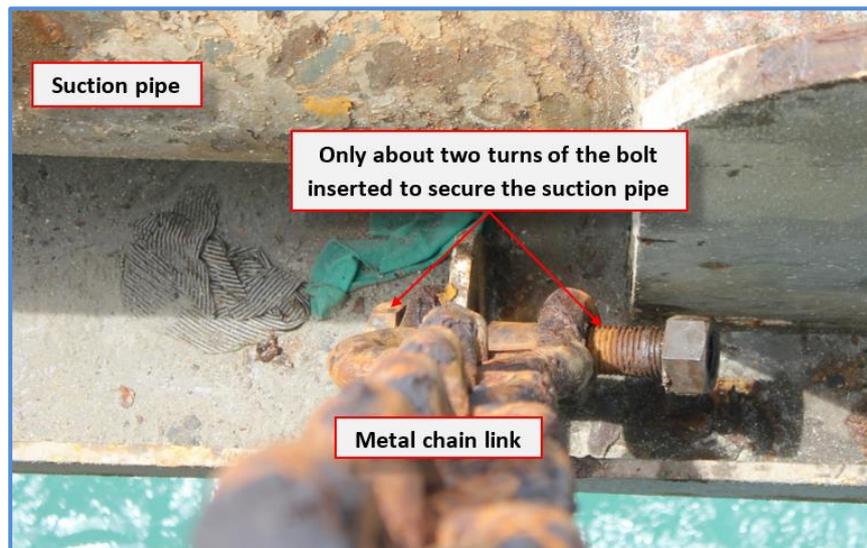
- 1.7.3.4 The securing chain and shackle for CJ2's suction pipe was rusted (see **Figure 15**). The bolt was engaged to the nut by two to three turns of the bolt thread.

Figure 15 – Chain link from main deck to suction pipe

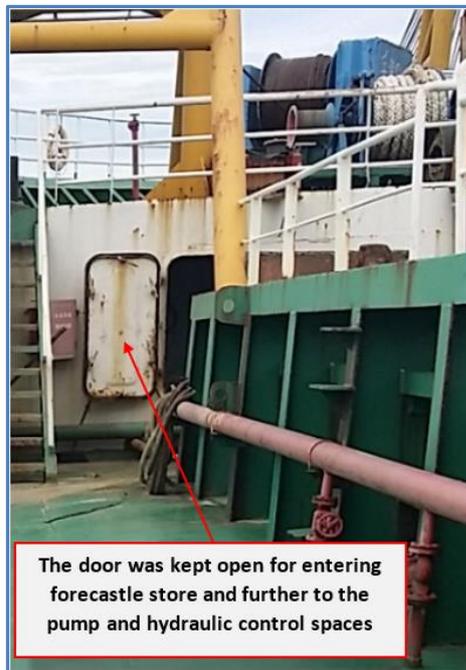
- 1.7.3.5 According to its crew, the door for the forecastle store on CJ2 was always lashed in the open position. The door led directly to the forward access to the pumps and hydraulic control space³⁹, where the hydraulic system for controlling the slats of the conveyor belt system was located (see **Figure 16**). Similarly, the weather tight door at the aft main deck leading to the aft

access to the pumps and hydraulic systems space was lashed in the open position. Transverse bulkhead doors underneath the cargo holds (below the waterline) were also lashed in the open position.

Figure 16 – Weather tight door accessing to forecastle store

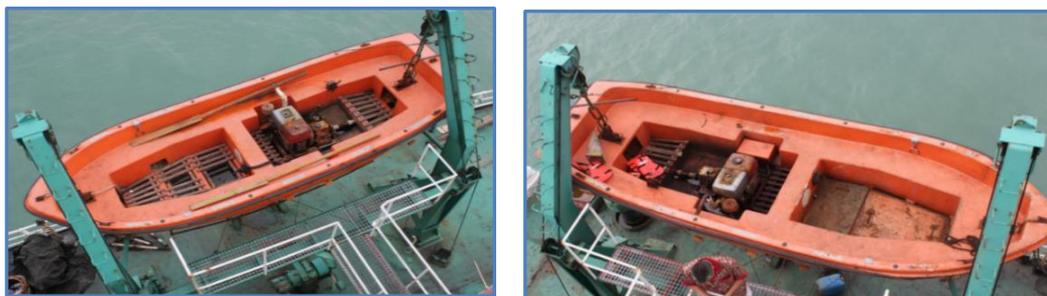
- 1.7.3.6 Both lifeboats on CJ2 were in poor condition (see **Figure 17**). Water was trapped inside. Life vests (non-SOLAS type) were lying around loose. The lifeboats' engines appeared rusty and inoperable. The lifeboat davit hook and boat falls' block were rusty. The port side lifeboat was partially cracked.

Figure 17 – General condition of CJ2's lifeboats

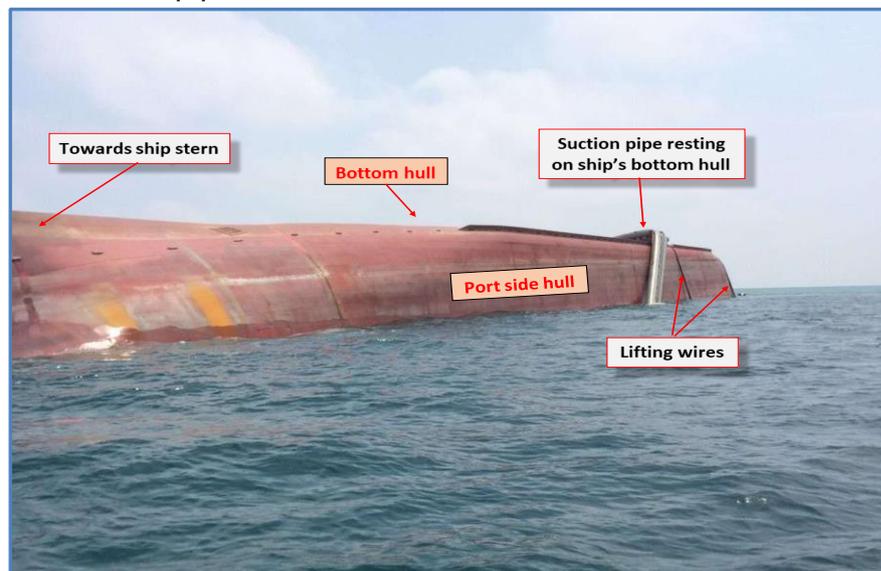
1.8.2 It was also noted that the suction pipe was heavily deformed (see **Figure 18**). This suggested that it had been subjected to substantial loads. Calculations by LRCS suggested that the impact force along the longitudinal axis of the suction pipe was of the order of 10000-32000 kN⁴¹.

Figure 18 – Close-up photograph annotated by TSIB indicating bent suction pipe (Source: Maritime and Port Authority of Singapore)

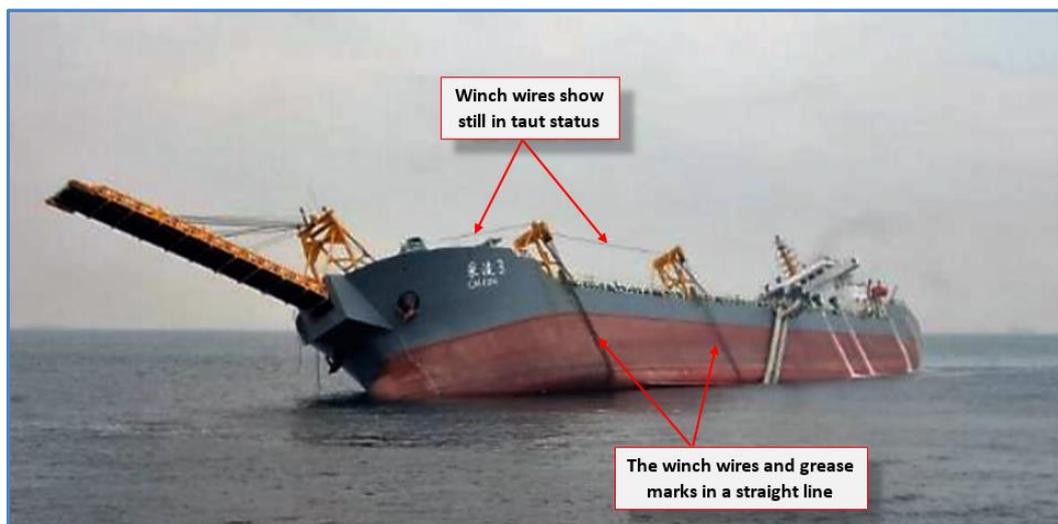
2.1.3 If the power to the winches was turned off, then the hydraulic pressure acting on the drum, as a failsafe (see 1.7.2.2), would not allow the winches to turn causing slackening of the wires and lowering of the pipe if it was not secured with the shackles. The wires suspending the suction pipe from the winch appeared intact and taut when the vessel was seen in the heeled position (see **Figure 20**).

Figure 20 – CJ3 listing to her starboard side
(Source: Maritime and Port Authority of Singapore)

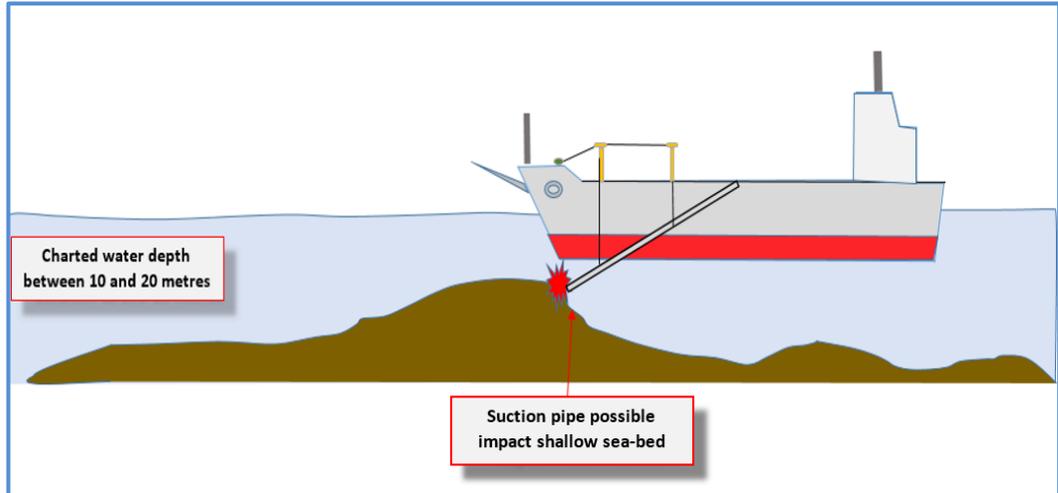
(b) The suction pipe's impact with the sea bed likely resulted in forces acting in an upward direction resulting in a "grounding effect"⁴³, causing a disruption to the original hydrostatic equilibrium and initiating a heel to starboard. Although a righting moment would allow the ship to return to its upright position, the ship did not return freely to an upright position due to the pipe being "grounded".

Figure 21 – Illustration of the suction pipe contacting the sea bed
(Not to scale)

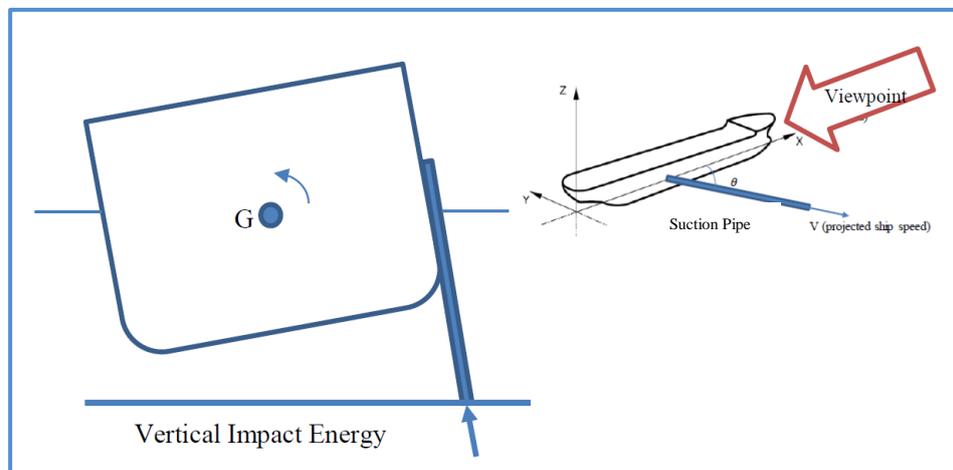
- (c) The impact force on the suction pipe was substantial (see paragraph 1.8.2). This force would cause the ship to swerve towards the port side. The swerving to the port side would result in a centrifugal force due to the turning about the pipe and cause a rolling motion to the starboard (see **Figure 22**). This rolling to the starboard would in turn induce the cargo of sand and water to shift in the same direction and aggravate further heeling to starboard.

Figure 22 – Schematic illustration of heeling moment
(Source: Lloyds Register Consultancy Services)
