# **Final Report**

## **Capsize of Barge CB100-01 towed by ASL Osprey off the Indian Coast on 7 July 2022**

TIB/MAI/CAS.128

Transport Safety Investigation Bureau  
Ministry of Transport  
Singapore

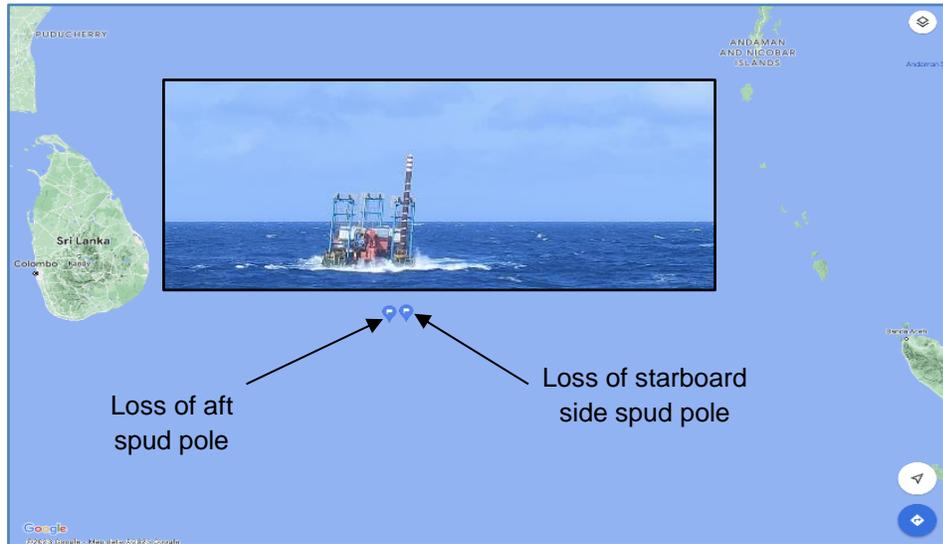
- 1.1.4 On 12 May 2022 the tug and tow were on their westerly route in the Indian Ocean towards Sri Lanka after passing North Sumatera. The length of the tow<sup>13</sup> at the time was recorded to be at 450m and the weather was logged as cloudy sky with south-westerly wind at speed of about 24 knots and wave height of 3.5m (BF<sup>14</sup> 6) with the average towsing speed over 24 hours at 2.62 knots.
- 1.1.5 At about 0448H in position Latitude 05°55.77’N and Longitude 086°26.22’E, AO’s Master noticed the starboard side spud pole missing from CB and informed the Operator of the incident. At about 1550H in position Latitude 05°54.82’N and Longitude 086°08.43’E the OOW noticed the aft spud pole was missing as well and advised the Master accordingly who in turn advised the Operator again (see **figure 5**).

Figure 5 – View of CB’s bow from AO with both spud poles missing (Source: the Operator – annotated by the TSIB. Not to scale)

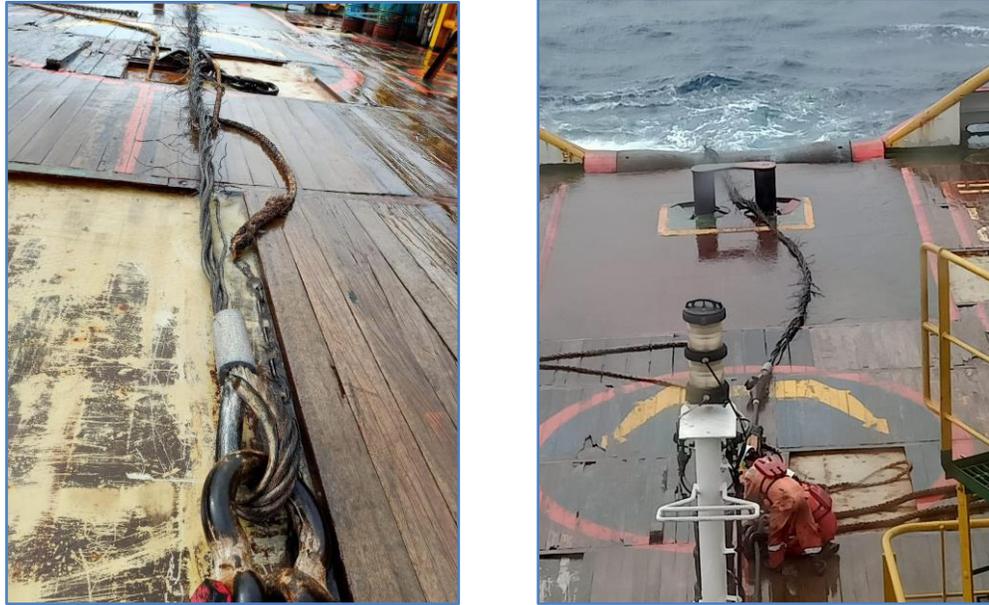
<sup>20</sup> The portion of the pennant wire rope remaining onboard AO was noted to have strands which had unravelled.

Figure 6 – The damaged towing pennant wire rope showing unraveled strands (*Source: the Operator*)

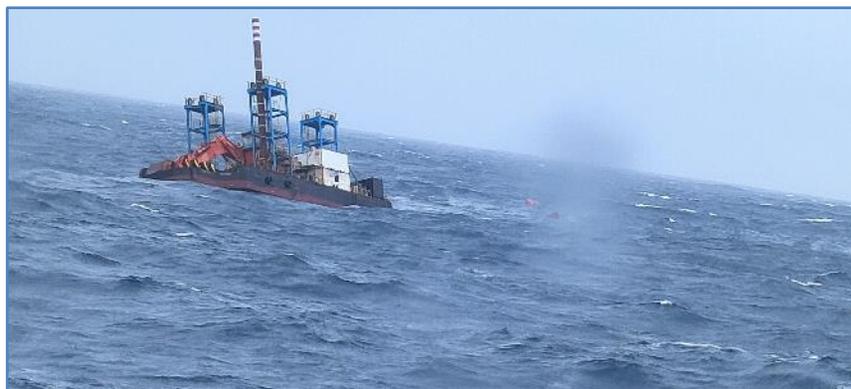
about 230nm west of Mumbai. Around 1750H the Master noticed that CB had developed a list to starboard (see **figure 9**).

Figure 9 – CB listing to starboard as observed by AO (*Source: the Operator*)

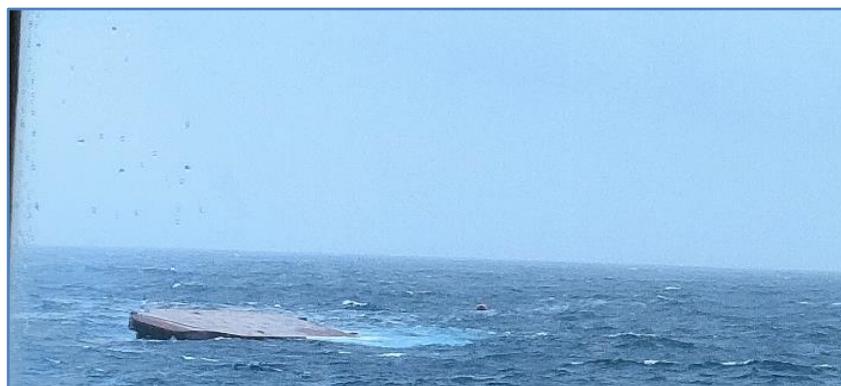
1.1.16 About an hour later, the Master noted that CB had capsized but remained afloat. The crew of AO continued to monitor the capsized CB. On 8 July 2022 at 0658H the 12-inch polypropylene rope tow line parted at a position about 206nm west of Mumbai. The Master notified the Operator who in turn notified Mumbai MRCC at about 1505H (see **figure 10**).

Figure 10 – Capsized CB (*Source: the Operator*)

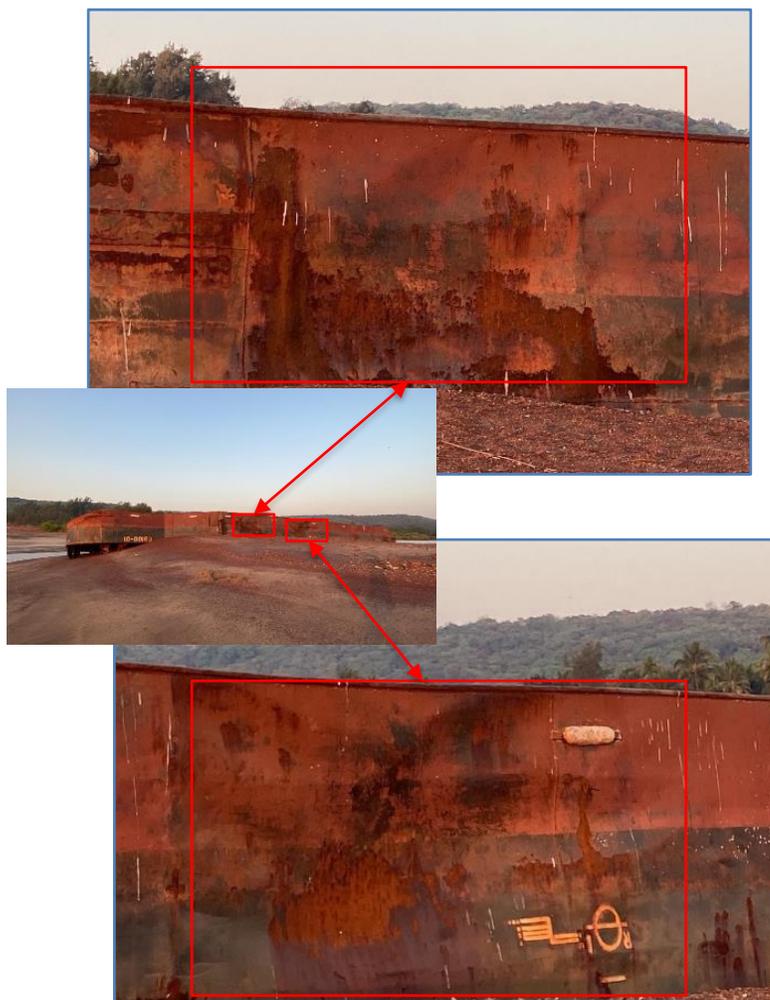
- 1.1.20 Close-up photographs of the barge's condition were provided by the Operator to the investigation team on 11 January 2023, which indicated that the hull was largely intact, with the exception of the starboard side which showed indentation in way of Frames 9 through 16 (see **figure 12**). The entirety of the hull was not

Figure 12 – Indentation on CB's starboard hull (*Source: the Operator*)

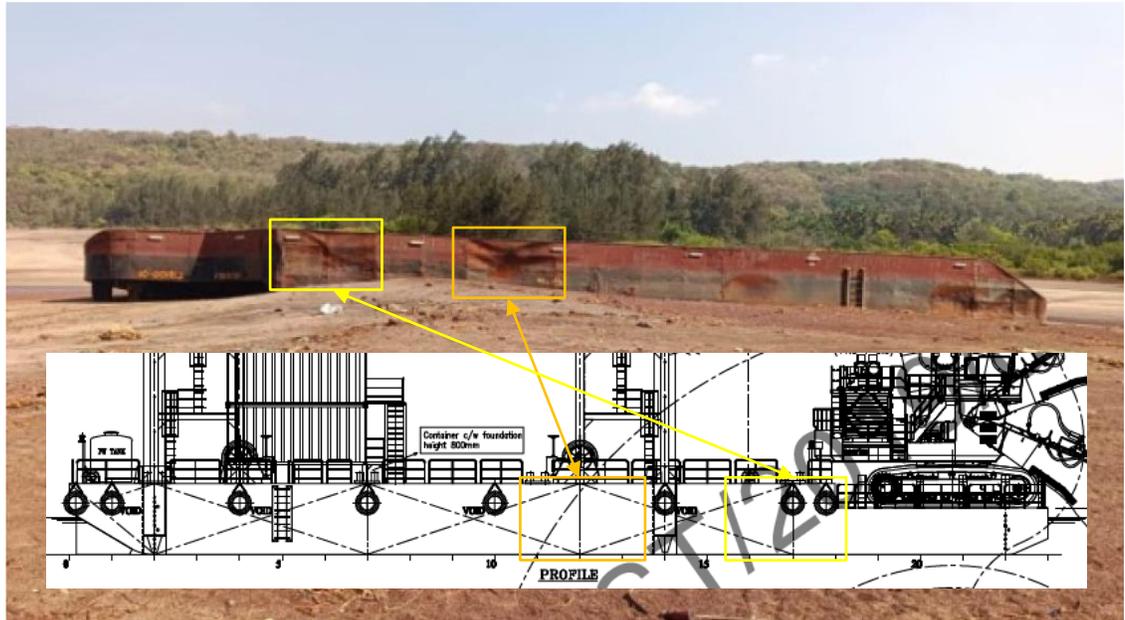
1.1.21 When asked, the Operator confirmed that according to the Master, during the attempt(s) to connect to CB between 5 July 2022 and 7 July 2022, CB's starboard hull made heavy contact with AO's stern and CB's hull may have been breached. A picture available to the investigation team dated 29 March 2023 indicates heavy indentation on CB's starboard hull (see **figure 13**).

Figure 13 – Heavy indentation found on CB’s starboard hull in way of Frames 11 to 13 and 16 to 18 – see annotation on General Arrangement (GA) Plan  
(Source: the P&I Club)

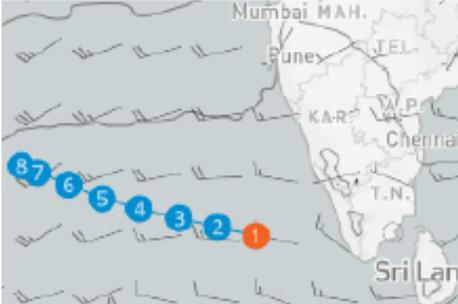
1.7.6 The forecast dated 20 June 2022, for the period 21 June till 27 June 2022, took into account the deviated passage of AO, indicated the weather to be BF 6/7 along the deviated route (see **figure 33**).

Figure 33 – Weather forecast along the deviated route provided by DTN, which was available onboard AO (Source: the Operator).

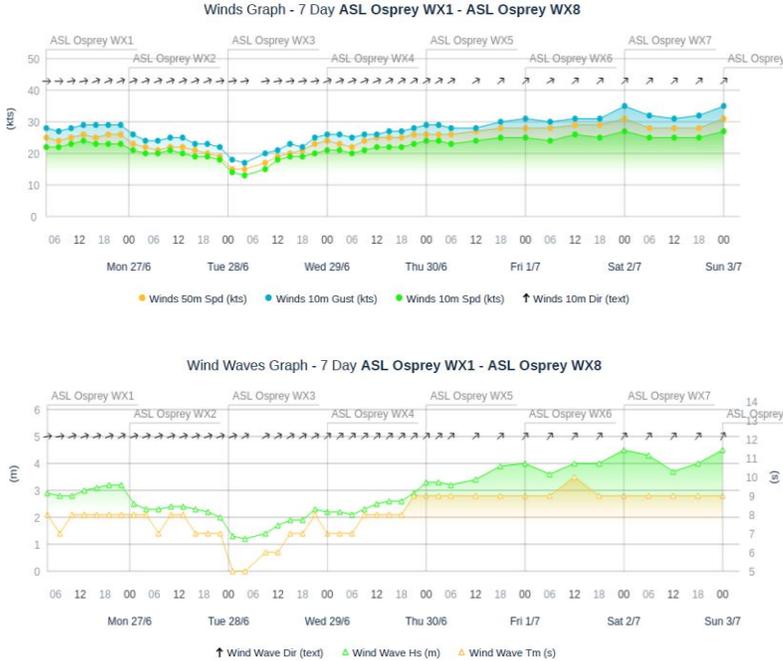
1.7.7 The weather forecast for subsequent period 27 June till 3 July 2022 indicated the weather to worsen to BF 7 (see **figure 34**, showing the conditions of the expected weather, i.e., Wind, Waves, Currents with forecast times indicated in UTC prior to the towing pennant wire rope parting).

Figure 34 – Weather forecast provided by DTN, which was available onboard AO (Source: the Operator)

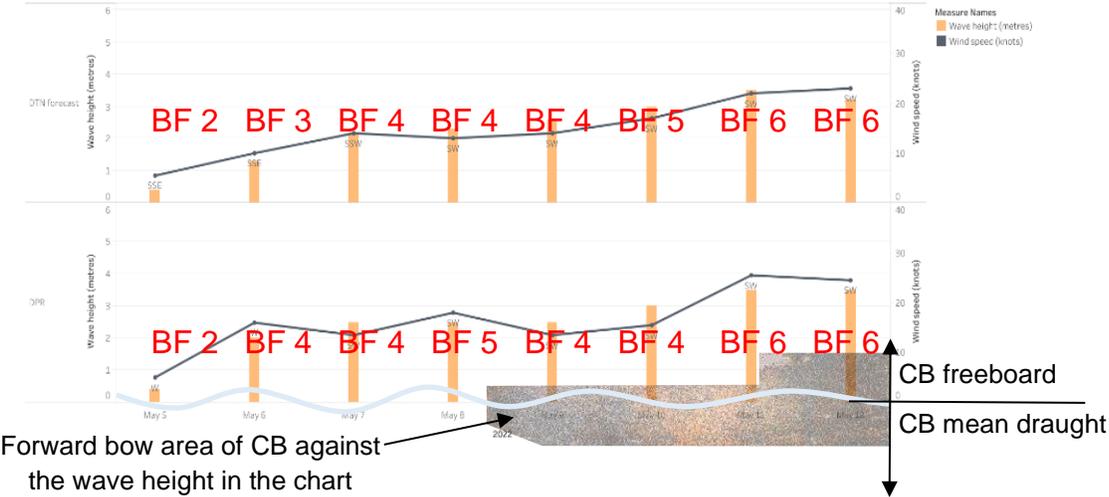
1.7.8 Preceding the loss of the aft and starboard spud poles on 12 May 2022, the Master had made visual observations of the weather which were recorded<sup>73</sup> in the DPR. Together with the DTN forecast, from 5 to 12 May 2022, weather conditions indicated consistent occurrences of high waves with maximum wave height at 3.5m and prevailing winds from SW with wind speed up to 25.5 knots. These are captured<sup>74</sup> in **figure 35**.

Figure 35 – Wind and waves data preceding the loss of the spud poles  
(Source: the Operator – annotated by the TSIB)

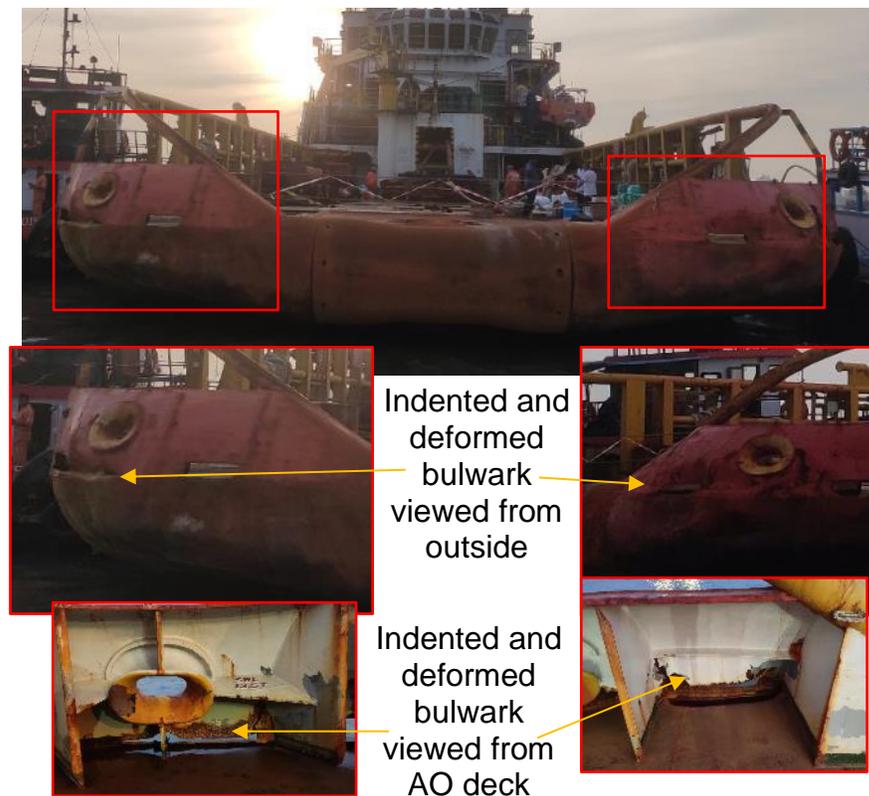
1.8.1.2 AO had damage onto her stern area, as reported by the survey report, both the aft port and starboard bulwark had been indented and deformed (see **figure 38**).

Figure 38 – AO viewed from the stern (Source: Class RINA – annotated by the TSIB)
