Final Report

FATALITY OF CREW ONBOARD CHEMICAL TANKER CONCERTO AT SEA ON 1 JUNE 2022

TIB/MAI/CAS.126

Transport Safety Investigation Bureau
Ministry of Transport
Singapore

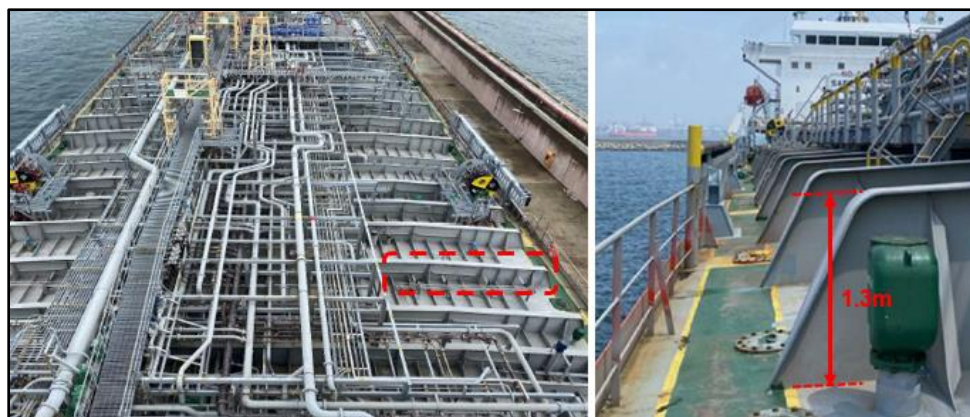
Figure 2 – View of the deck and raised deck frames
(Source: the Company)

1.2.3 Concerto, a typical chemical tanker of a similar design like others, has external raised deck frames of about 1.3m high all along the deck above the cargo tanks (see **figure 2**). These deck frames extend on deck athwartships from one side to the other.

(c) The OTH of COTs had been cracked open at the time of setting up for the gas-freeing on the previous day. The deck frames of about 1.3m height extending athwartships could have caused the formation of pockets of vapours (like a temporary confined space due to the still air condition), to accumulate around the deck area between the COTs.

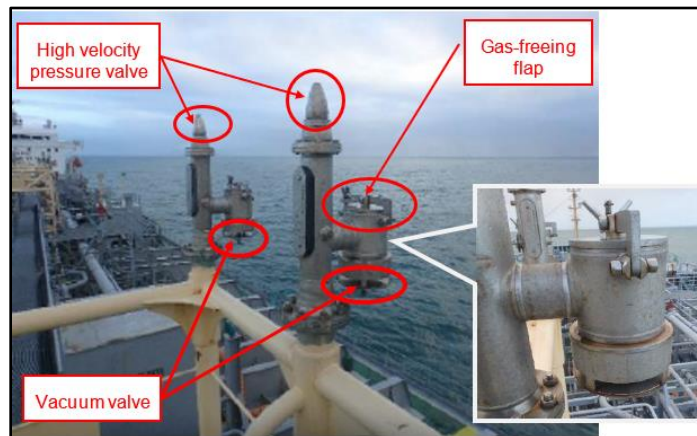
Figure 3 – PV valve with gas-freeing flap
(Source: the Company, annotated by TSIB)

- 1.6.3 On the same structure of the PV valve, a gas-freeing flap (see **figure 3**) is designed to be used during purging and gas-freeing operations. It consists of a cover which is manually open/shut using a wingnut. At the time of the occurrence, the gas-freeing flaps for the six COTs were kept open.

2.2.1 According to the Company's SMS procedures on gas-freeing operation, venting of flammable and/or toxic gases from the tank was only permitted through the approved tank venting system, i.e. the PV valves and gas-freeing flap. However, at the time of line-up for preparation of gas-freeing operation, the OTH had been cracked open, presumably to expedite the gas-freeing process.

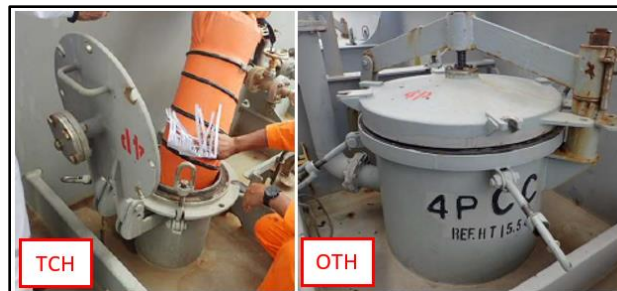
Figure 4b – Portable air chute connected the TCH and OTH cracked open (*Source: the Company*)

1.8.6 The gas-freeing operation section also highlighted venting of flammable and/or toxic gases from the COTs shall be carried out only through the approved tank venting system. All openings (such as TCH and OTH) at the deck level should be kept closed until the gas concentration within the COT was below 30% low explosive limit (LEL)⁴² and the toxic vapour was below TLV-TWA limit (the safe limits). The Company was not aware of the practice (see paragraph 1.7.2) on Concerto to keep the TCH open and OTH cracked open when lining-up COTs.

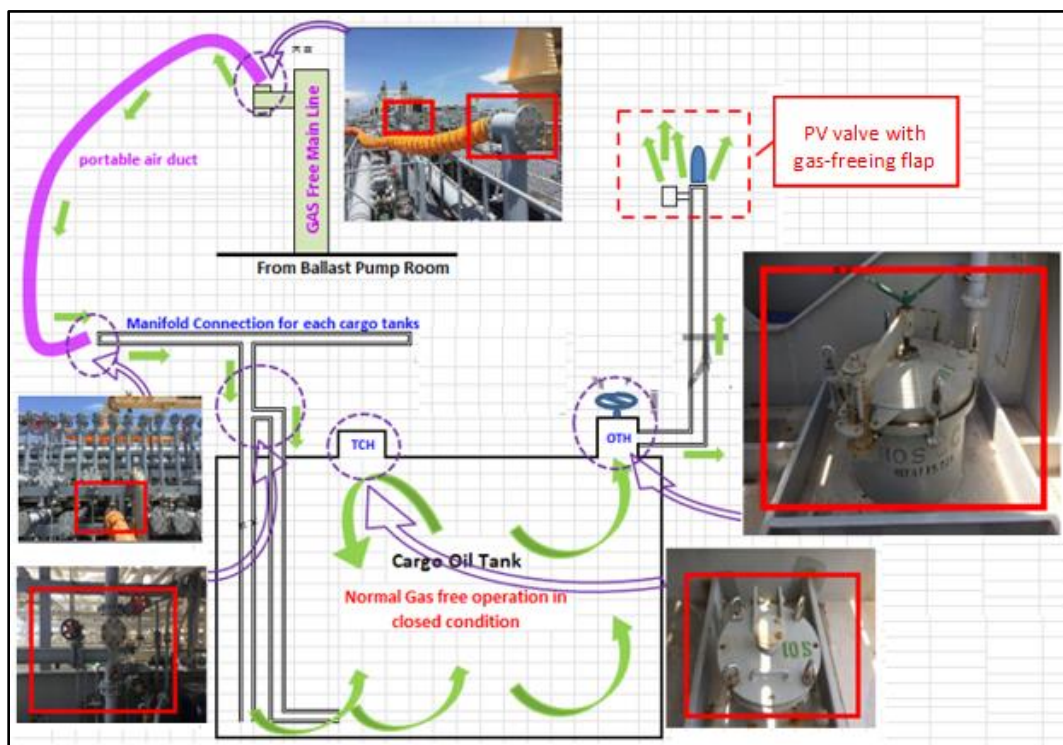
Figure 6 – Illustration of a closed setup of gas-freeing operation of a COT without the need to open the TCH and OTH
(Source: the Company)

- 1.10.2 In response to the investigation team's query on using the approved tank venting system before achieving the safe limits (paragraph 1.8.6), the Company clarified that a closed setup for gas-freeing operation without opening the TCH and OTH of the respective COT is possible⁵⁰. This is done by joining a portable air chute⁵¹ to the manifold connection (for the respective COT) from the fixed gas-freeing pipeline on deck, and to release the tank vapours from the PV valve and gas-freeing flap (see **figure 6**).

- 1.10.3 The investigation team noted that the illustrated closed setup for gas-freeing operation was not specifically mentioned in the gas-freeing operation section

- 2.2.4 As per the CO's account, the crew deemed the closed setup for gas-freeing operation to be cumbersome and taking a longer period to achieve a gas-free COT. The investigation team noted that after the occurrence, the Company's verification of the closed setup confirmed compliance with its SMS procedures. However, as there was no such verification done prior to the occurrence, the investigation team opines that the crew onboard Concerto, had normalised and deviated from the Company's established procedures and IBC Code and Tanker Safety Guide on the need to ensure that the gas concentration of the COT is within the safe limits before opening the TCH and OTH.

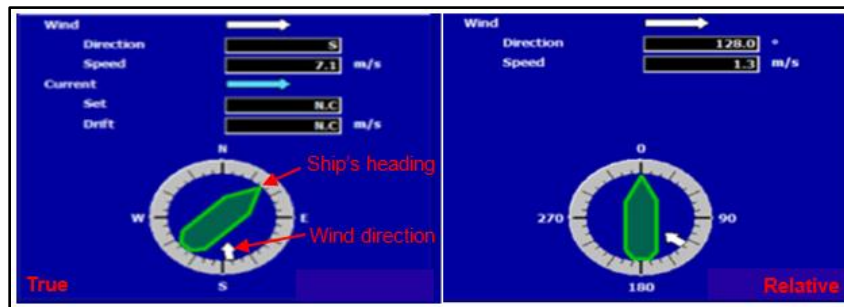
Figure 7 – The true and relative wind direction from ship's heading at 0200H, 1 June 2022 (Source: the Company, annotated in red by TSIB)

- 1.12.2 The ship's heading was maintained at 053° since 1730H on 31 May 2022 without alteration. During this period, the wind direction had changed from a direction of SSE to southerly at about 0200H on 1 June 2022.
- 1.12.3 The ship's VDR records of the wind direction and speed at 0200H (about the time that the ASD1 went on deck) on 1 June 2022, which corresponds to the ship's logbook records, is indicated in **figure 7**.
