# **Final Report**

## **FATALITY OF CRANE OPERATOR ONBOARD JACK-UP RIG WEST COURAGEOUS IN THE GULF OF MEXICO ON 24 NOVEMBER 2022**

TIB/MAI/CAS.136

Transport Safety Investigation Bureau  
Ministry of Transport  
Singapore

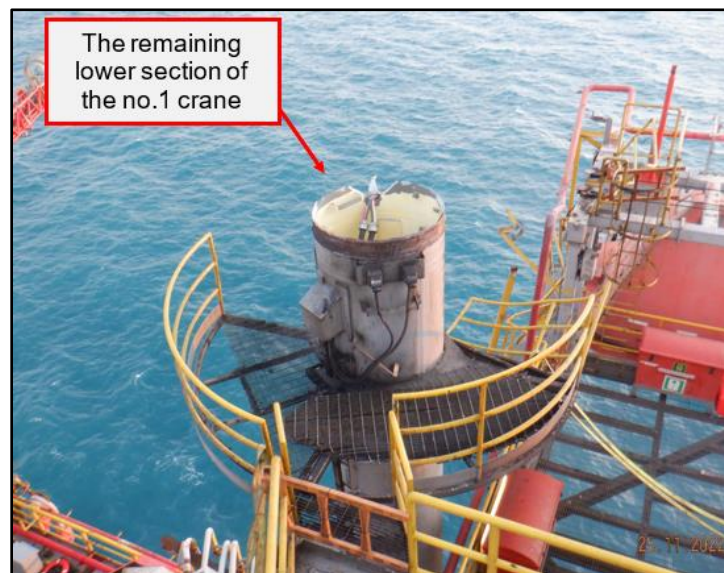
1.1.2 At about 1743H, the crane operator (OP1) was operating the no.1 crane from its cabin for his first lift after taking over from the out-going crane operator (OP2). When raising the lift for about half meter above the deck of the work boat, the upper section of the crane's pedestal broke off<sup>8</sup> and fell into the sea (see **figure 1**) together with the crane cabin with the OP1 in it.

Figure 1 – View of the remaining lower section of the no.1 crane  
(Source: the Company)

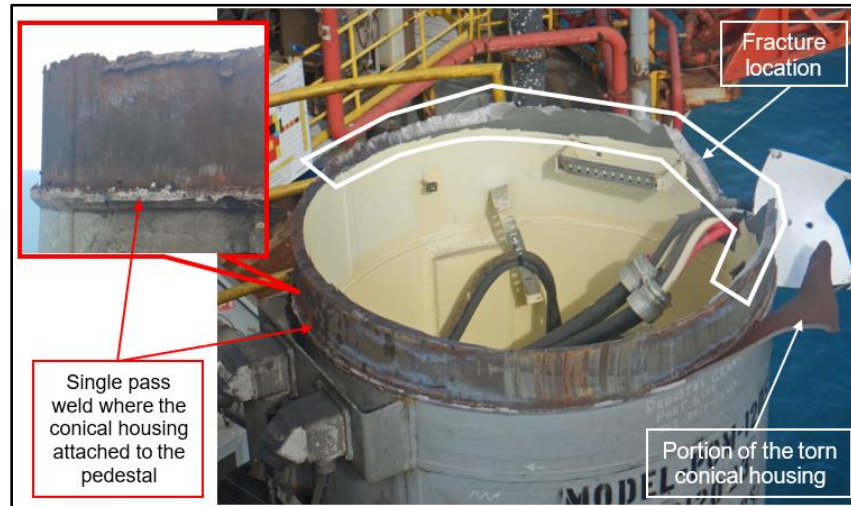
1.10.4 The preliminary findings from the metallurgical analysis indicated that the pedestal had likely failed due to a fatigue initiated at the toe of a single pass weld (see **figure 9a**), which acted as a stress concentrator. The evidence for the fatigue included the presence of beach and ratchet marks (see **figure 9b**) on the fracture surface of the pedestal. There were no unusually high hardness values measured within the base metal of the pedestal. High hardness values up to 48 Rockwell C Hardness<sup>41</sup> were measured within heat affected zones

Figure 9a – View of the single pass weld and fracture location at incident crane pedestal (*Source: the Company*)

- 3.4 The pedestal failure of the no.1 crane was likely due to a fatigue initiated at the toe of a single pass weld at the lower part of the pedestal of the no.1 crane. The single pass weld was covered by the welded conical housing and was not visible during daily checks by the crane operators.

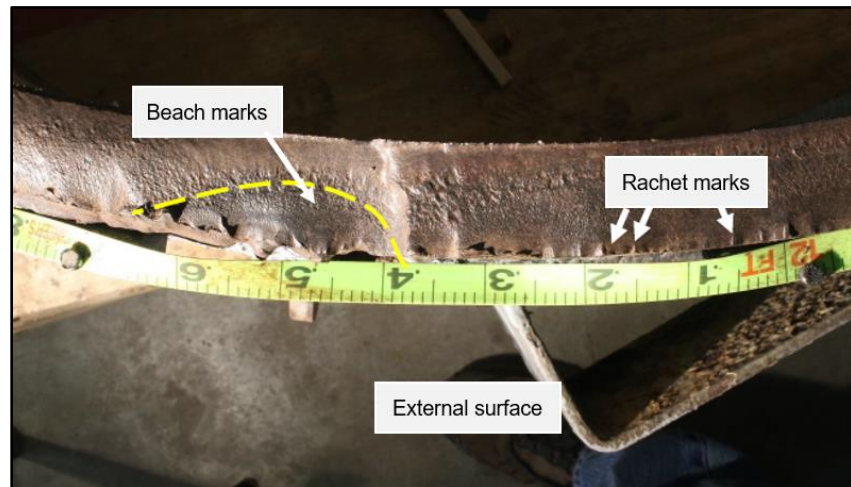
Figure 9b – Presence of the beach and ratchet marks on the fracture surface of the pedestal (*Source: the laboratory's metallurgical analysis report*)

2.2.2 Beach marks are macroscopic fatigue features marking an interruption in the propagation of a fatigue cracking progress, the present of these features are evidence to identify fatigue fractures. Ratchet marks are formed when multiple fatigue origins are near each other. A crack starts at each origin and a ridge is formed creating the ratchet mark when cracks meet. High stress levels and sharp stress concentrations often result in a series of ratchet marks. The preliminary findings of the metallurgical analysis indicated a fatigue initiated at the toe of a single pass weld as evidenced by these marks on the fracture surface of the pedestal of the no.1 crane.

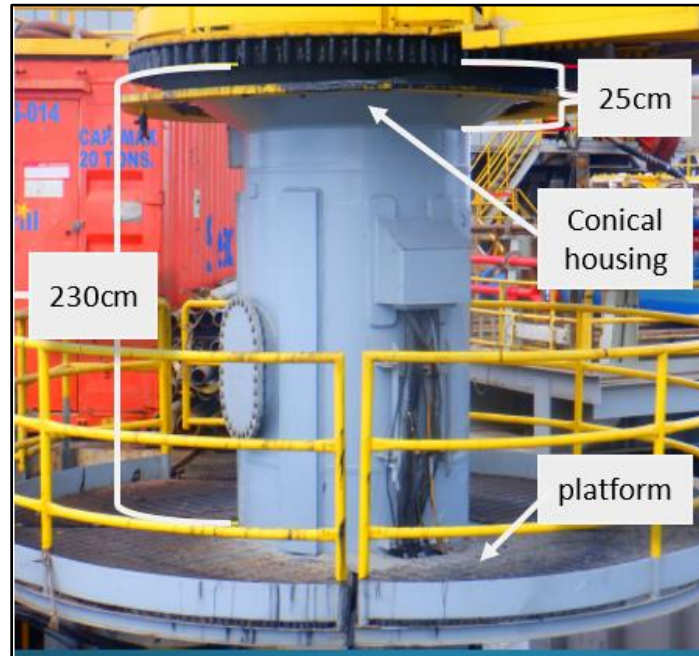
- 1.10.5 According to the Company, the single pass weld, about 20cm in length, at a position of about 230cm above the platform which was on the external surface of the pedestal and suspected to be a repair weld. This single pass weld was covered by a welded conical housing which was at a vertical height of 25cm (see **figure 10**) and was not visible during the daily checks. An external surface

Figure 10 – Height and location of the welded conical housing of the no.3 crane on WC for illustration (*Source: the Company*)

2.3.4 Although daily visual checks are to be performed by the crane operators, being covered by the welded conical housing, it is not possible for the crane operators to find out the crack developed on the single pass weld.

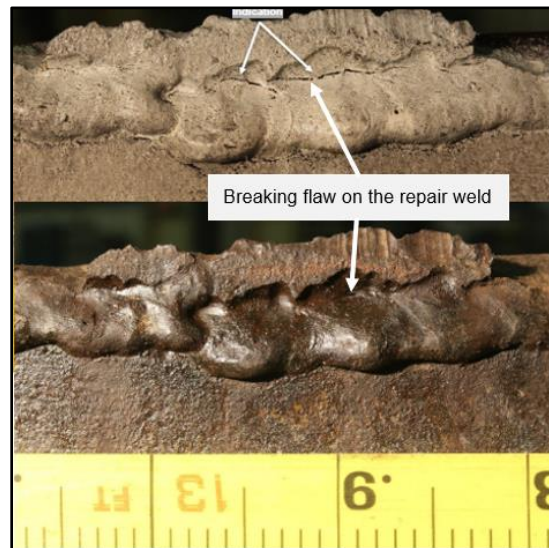
breaking flaw (see **figure 11**) of about 3cm was visible on the single pass weld during the magnetic particle testing after the occurrence.

Figure 11 – Presence of the breaking flaw on the repair weld (*Source: the laboratory's metallurgical analysis report*)
