# **Final Report**

## **FATALITY AND INJURY OF CREW ON BOARD CONTAINER VESSEL LUCIE SCHULTE IN ATLANTIC OCEAN ON 3 APRIL 2023**

TIB/MAI/CAS.141

Transport Safety Investigation Bureau  
Ministry of Transport  
Singapore

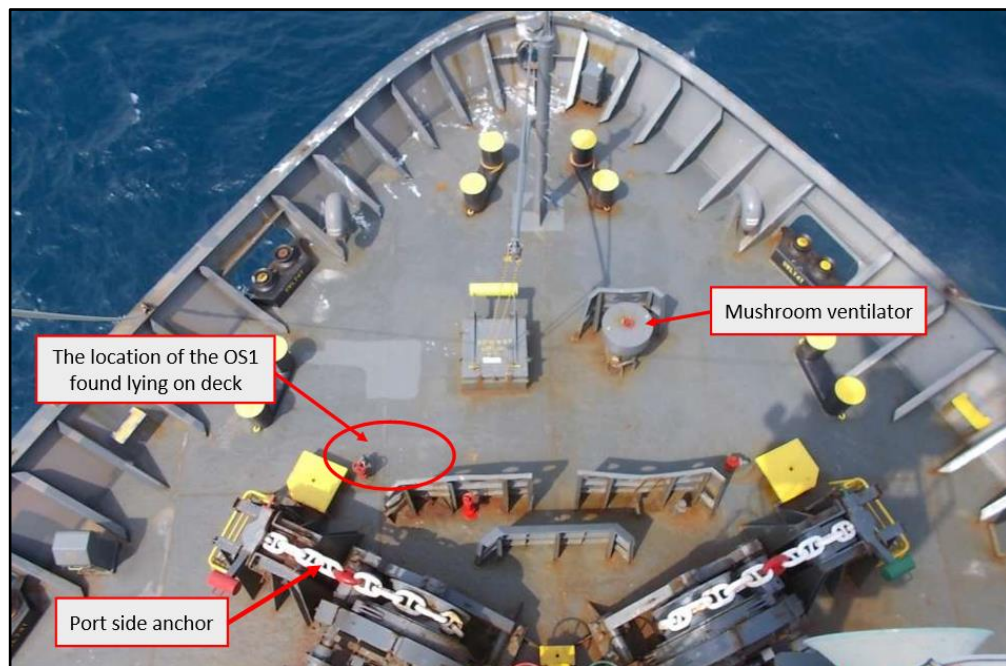
1.1.7 After a headcount, at about 1412H, the OS1 was unaccounted for<sup>6</sup>. At about 1416H, the crew discovered the OS1 lying unconscious on the forecastle deck, near the port side anchor hawse pipe (see **figure 1**) bleeding from his nose, mouth, and ears. The OS1 was not breathing and did not have a pulse. He was brought back to the infirmary on stretcher where the OS1 was rechecked and found not having any vital signs. The ship's crew administered CPR on the OS1 and treated the Bosun's head injury.

Figure 1 – Location where the OS1 was found  
(Source: the Company) – Annotation by the Company and TSIB

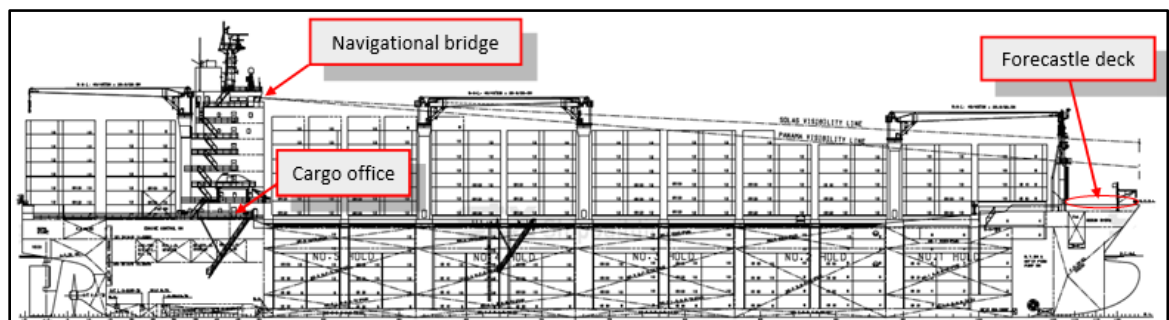
- 1.2.2 At the time of the occurrence, LS was in laden condition drawing a forward draft of 9.63m and an aft draft of 10.18m, i.e. half metre trim by its stern. Its freeboard at the bow was about 7m.
- 1.2.3 According to ship's loading condition calculated by an approved loading software onboard LS, the longitudinal strength and stability of the vessel were within the required criteria for the intended voyage (crossing the Atlantic Ocean). There was no structural damage reported on LS following the heavy weather encountered during the incident voyage.
- 1.2.4 The forecastle deck is located at most forward part which is typically blocked by containers on deck and a breakwater<sup>10</sup>. The OOW would not have a direct line of sight of the forecastle deck from the bridge (see **figure 2**).

Figure 2 – Starboard side view of LS from the General Arrangement plan  
(Source: the Company)

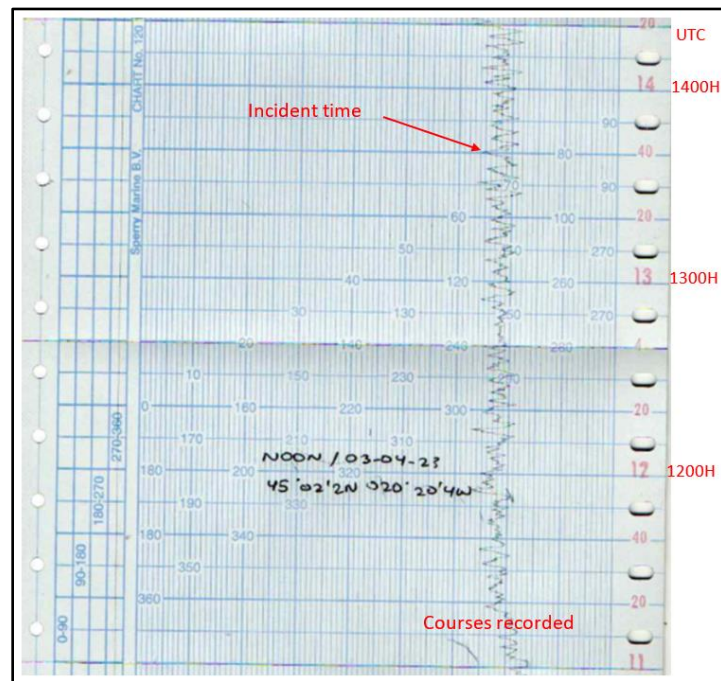
- 1.5.3 Since 1 April 2023 LS was on a planned course of 247° (T) and there was no major manual course alteration in the two hours preceding the occurrence. The gyro courses steered on autopilot were continuously recorded against a time scale on the ship's course recorder<sup>21</sup> as shown in **figure 3**. The wagging line<sup>22</sup> marked on the paper was due to the counteractions made against the sea swell by the ship's autopilot steering system, to maintain the course set by the OOW.

Figure 3 – Ship's gyro courses recorded on course recorder  
(Source: the Company)

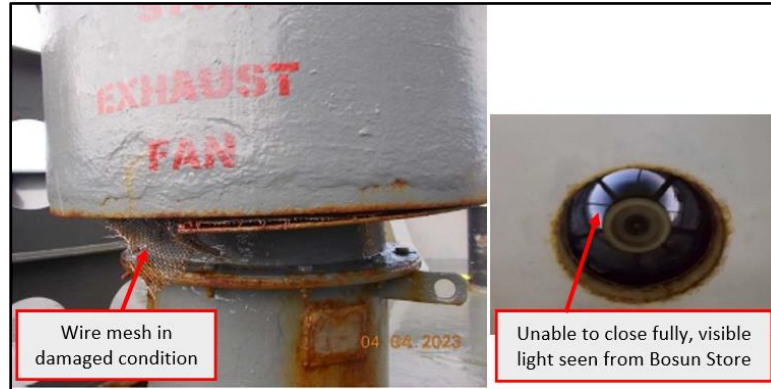
- 1.7.4 The mushroom ventilator on forecastle deck reportedly had some issues as it could not be closed<sup>31</sup> (see **figure 4**) and had not been closed at the time of securing all deck items for the preparation of heavy weather. There was no repair work planned or discussed for the mushroom ventilator on the day of the occurrence and there was no PTW issued, or RA conducted or recorded.

<sup>31</sup> This ventilator was reportedly not able to be closed properly due to its poor condition. This deficiency was registered in the work plan onboard with a due date of 9 May 2023 and the rectification had been delayed as the vessel had been engaged voyages across the Atlantic Ocean which considerably impaired the planning during the winter season.

Figure 4 – view of the mushroom ventilator  
(Source: the Company)

- 2.4.1 The mushroom ventilator on the forecastle deck had been unable to close for a period and was registered as a pending task to be rectified by 9 May 2023. The investigation team recognised the challenge of repairing it during the winter season when the vessel was crossing the Atlantic Ocean.
- 2.4.2 The checklist for heavy weather preparation listed ventilators as one of the items to be secured. Given that an unsecured ventilator poses the potential risk of water ingress when sea sprays come on deck during heavy weather period, temporary control measures could have been taken before the vessel departed Bremerhaven, such as covering it with canvas to prevent water from entering the Bosun store.

- 3.7 The mushroom ventilator had been defective and resulted in sea water entering and flooding the Bosun store. The ventilator was not identified as an item to be secured (covered with a canvas) during the heavy weather preparation prior to departing the previous port, Bremerhaven.

- 4.1.2 The Company reviewed its SMS on heavy weather procedures and relevant checklists after the occurrence. A warning note in the heavy weather procedures is included for not sending any crew to go on deck in heavy weather unless it is to prevent an imminent danger to crew and ship. The revised procedures also caution that shipping seas can cause flooding through defective ventilation heads, hatches, which were not able to close. A verification is required on the securing status of all openings (including ventilators) on deck when preparing the vessel for heavy weather.

5.1.1 To establish an effective monitoring system to track and support the vessels to deal with shipboard defects in timely manner. [TSIB Recommendation RM-2023-10]

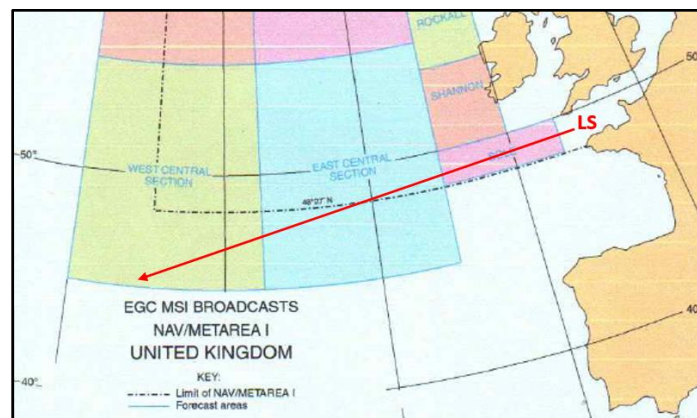
1.9.1 The meteorologic weather forecast received as maritime safety information (MSI)<sup>34</sup> on 1 April 2023, 2000UTC indicated that within 24 hours of LS' route passing area (see **figure 5**) of Sole, LS would likely experience rain showers, moderate to rough sea condition, north-westerly wind with force 5 to 7. At the Atlantic Ocean East Central area, cyclonic force 6 to gale force 8, occasionally severe gale force 9 later, sea would be rough to very rough, rain to thundery showers later.

Figure 5 – EGC MSI broadcasts covering areas of the LS' planned passage (inserted the approximate route in red by TSIB for illustration purpose)
