Final Report

BOEING B737-700, REGISTRATION VP-CAM DAMAGE TO APPROACH LIGHTS DURING TAKE-OFF AT SELETAR AIRPORT

16 NOVEMBER 2017

AIB/AAI/CAS.154

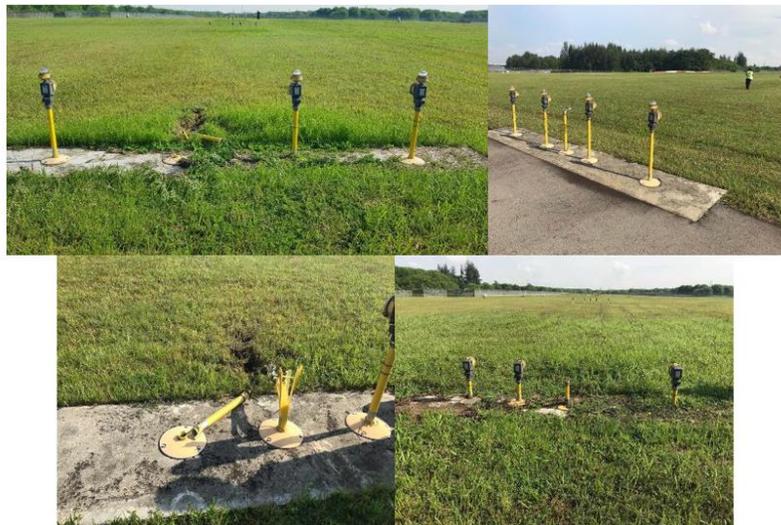
Figure 1. Damaged approach lights

After the take-off, the tower controller ordered an inspection of the runway. Ten approach lights at the end of Runway 03 were found damaged¹⁶.

1.3.2 Ten approach lights were damaged. Eight had their supporting structure broken (see **Figure 1**. Damaged approach lights) and two had their top covers damaged (see **Figure 2**).

¹⁶ The approach lights were about 60m beyond the end of the runway. Data from the aircraft's flight data recorder showed that the aircraft was about 1 m above ground where the approach lights were located.
