## **DIAMOND DA42, REGISTRATION N181CW DOOR DETACHMENT DURING TAKE-OFF**

**15 OCTOBER 2019**

AIB/AAI/CAS.186

Transport Safety Investigation Bureau  
Ministry of Transport  
Singapore

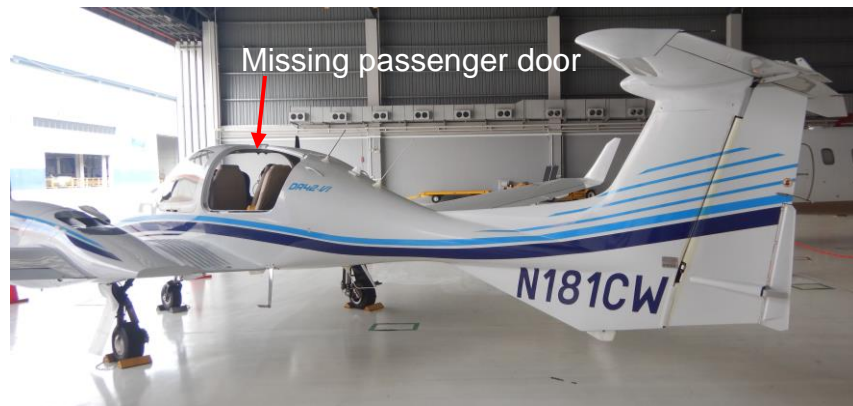
- 1.1.6 The aircraft slowed down, vacated the runway via Taxiway W3 on the left and stopped on Taxiway W3. The pilot shut down the engines and exited the cockpit. He then noticed that the passenger door was missing (see **Figure 1**).

Figure 1. Passenger door detached from aircraft

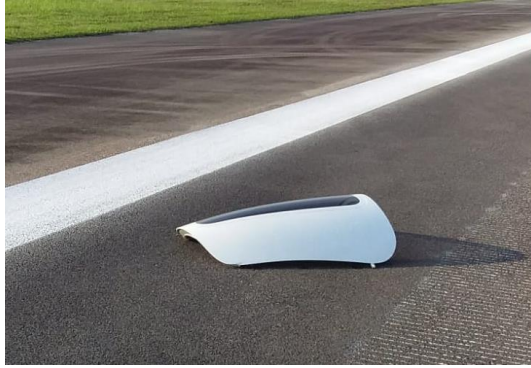
- 1.1.7 The detached passenger door was subsequently recovered from the runway (see **Figure 2**).

Figure 2. Detached door found on the runway

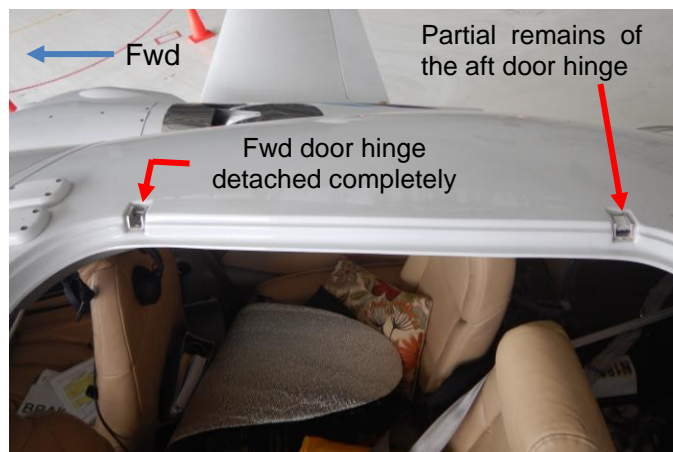
1.3.1 The passenger door, together with the forward door hinge and part of the aft door hinge, was completely torn off from the door frame (see **Figure 3**). Part of the aft door hinge remained on the door frame (see **Figure 4**).

Figure 3. Damages on the hinges of the door

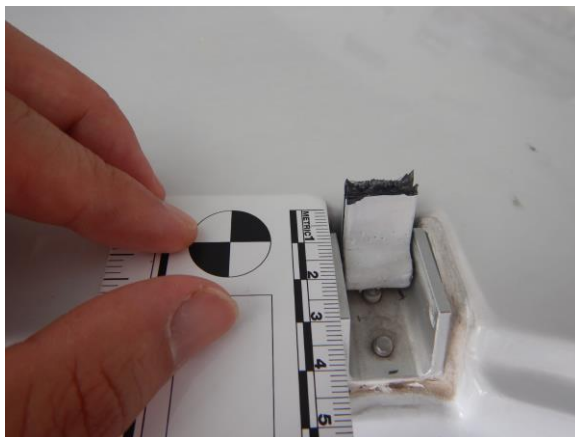
Figure 4. Close-up of the damage on the remaining aft hinge on the door frame

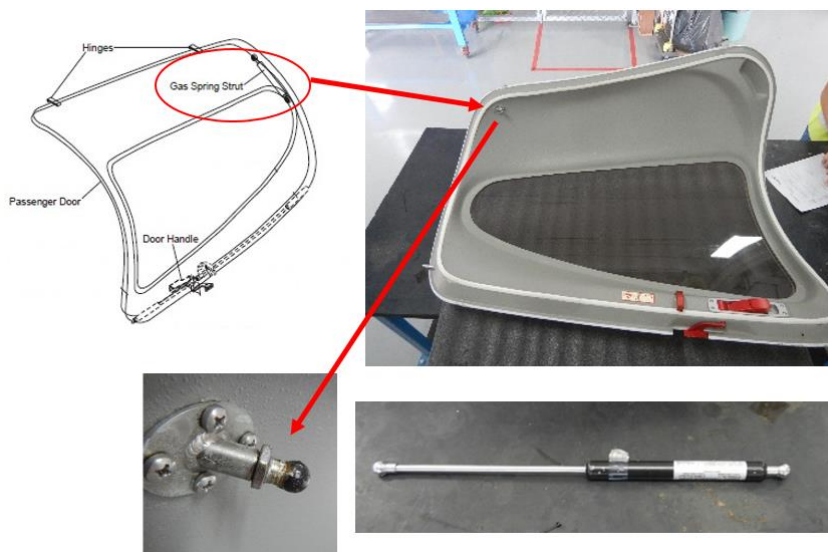
1.3.2 The compression gas spring strut connecting the passenger door to the door frame on the fuselage was broken (see **Figure 5**).

Figure 5. Gas spring strut detached from the door

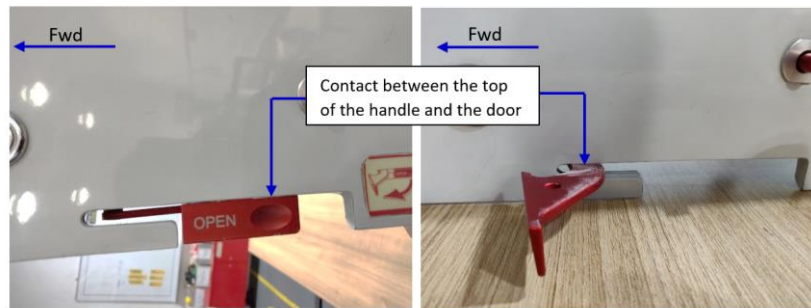
1.3.4 The detached door and its locking mechanism were examined. Although the top surface of the door handle had signs of chafing against the door (see **Figure 6**), the door latch mechanism was smooth.

Figure 6. Signs of chafing between the top surface of the handle and door

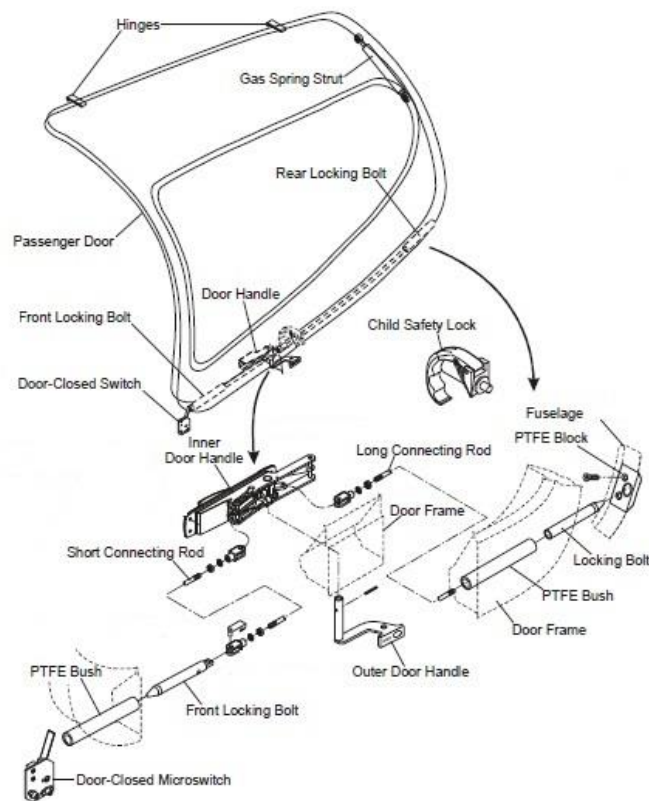
Figure 7. Parts of a Passenger Door

1.5.1.1 The passenger door (see **Figure 7**) was on the left side of the fuselage, behind the pilot's seat, and was hinged at the top of the fuselage in the front and rear. The passenger door was opened by lifting the door handle at the bottom of the door to unlatch the door. When the handle was released, the door opened outwards and upwards and a gas spring strut prevented the door from lowering.

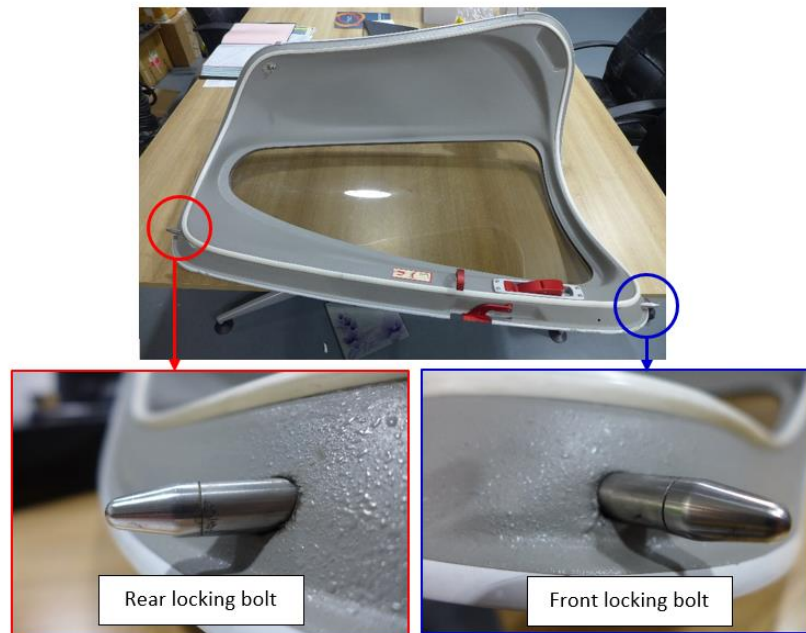
- 1.5.1.3 The passenger door handle operated on a compression gas spring mechanism such that the door handle would snap into the close position by itself at least 10mm before reaching the end position.
- 1.5.1.4 Post-occurrence inspection revealed that the two locking bolts (see **Figure 8**) and the PTFE blocks (see **Figure 9**) on the passenger door had no signs of damage.

Figure 8. No damage on the locking bolts

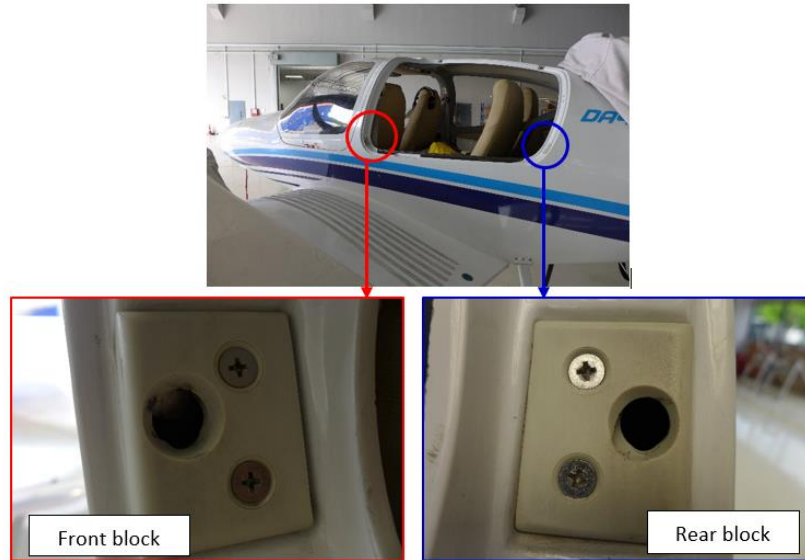
Figure 9. No damage on PTFE Blocks

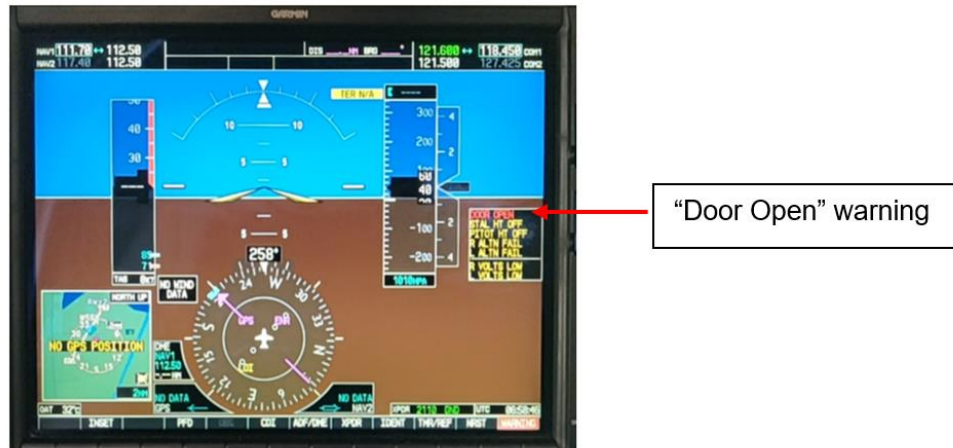
Figure 10. "Door Open" warning on the PFD

1.5.2.2 A visual “Door Open” warning would appear on the PFD (see **Figure 10**), whenever the front canopy, the passenger door or any of the cargo doors were not closed and latched.

- (b) If the passenger door was closed and not properly latched, then the door warning chime system would not have been energised and naturally there would not have been any warning chimes generated when the passenger door opened. If this had been the case, there would have been a visual “Door Open” warning on the PFD. This visual warning could have been missed by the pilot during the execution of the TAKE-OFF CHECKLIST.

- 5.1 It is recommended that the aircraft manufacturer review the door aural warning chime system, so that there will be chimes whenever a door is not closed and latched after the engine starts. [TSIB RA-2020-008]

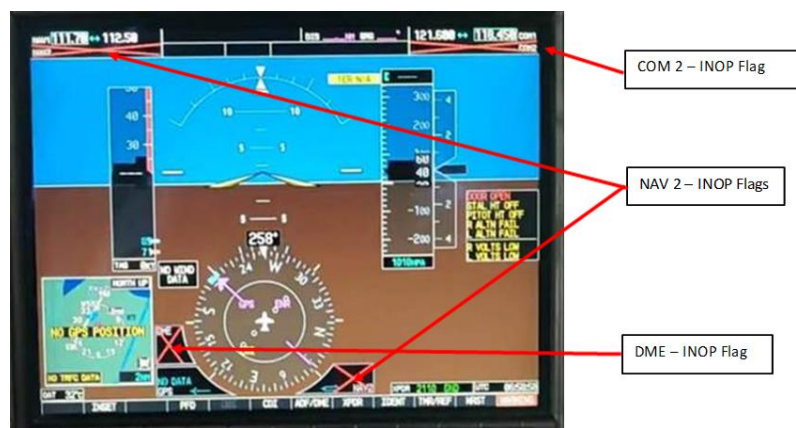
Figure 11. INOP flags on the PFD when the AMS is not switched on

- (a) If the AMS had not been switched on, there would have been multiple INOP flags on the PFD that were unlikely to be missed by the pilot (see paragraph 1.5.2.5).
