Final Report

DASSAULT FALCON 7X, REGISTRATION VQ-BLP GROUND FIRE

25 JUNE 2018

AIB/AAI/CAS.164

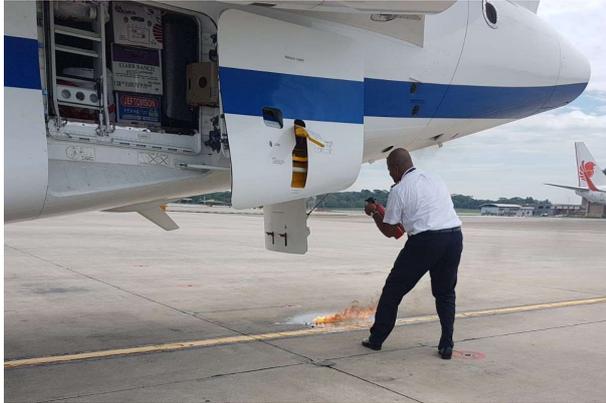
1.1.11 After grabbing a fire extinguisher from the cockpit, the Co-pilot went back to the tail of the aircraft to put out the fire on the ground (see **Figure 1**) as well as the fire in the mechanic service compartment. The PIC also came up with another fire extinguisher and discharged it into the compartment.

Figure 1: Pilot putting out the fire on the ground

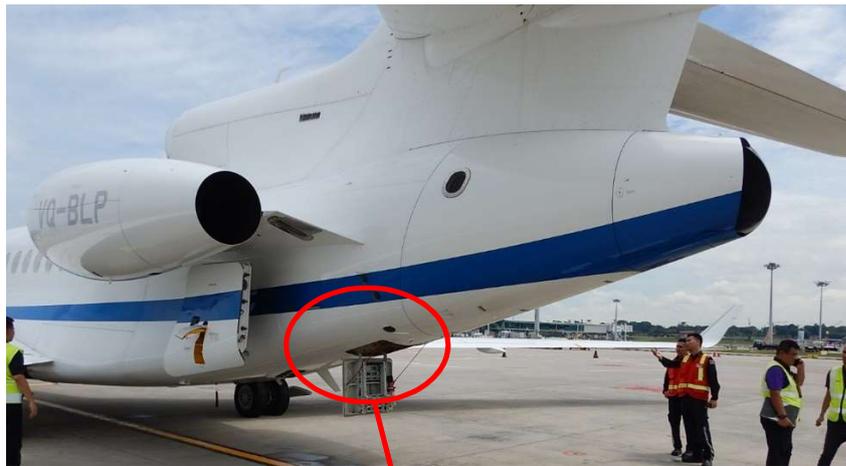
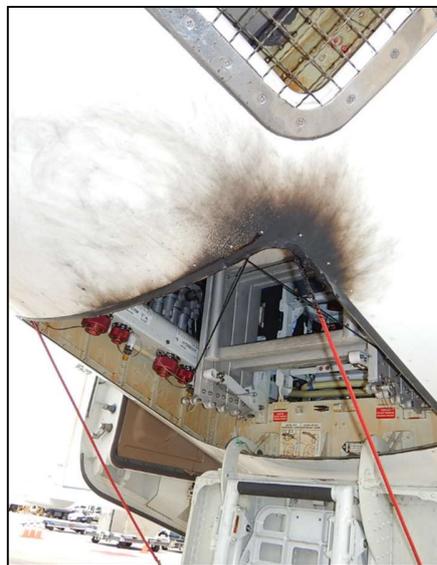
1.3.1 The damages were limited to some components and adjacent structure within the mechanic service compartment (see **Figure 2**).

1.3.2 The mechanic service compartment was inspected by the local maintenance operator's mechanic for any source of leak that could have contributed to the fire. The mechanic found hydraulic wetness on the backup hydraulic pump pressure line. There was no other leak found in the compartment.

Figure 2: Damage to mechanic service compartment

2.1.1 The investigation team believe that the area around the motor of the backup hydraulic pump had become overheated and the fire was likely a result of the hydraulic fluid leaking from the pressure line and being exposed to high temperature in the area around the motor.

- 3.4 A fire in the mechanic service compartment was discovered and put out by the flight crew. The fire was likely a result of hydraulic fluid leaking from the pressure line of the backup hydraulic pump and being exposed to high heat generated by the overheated pump motor.

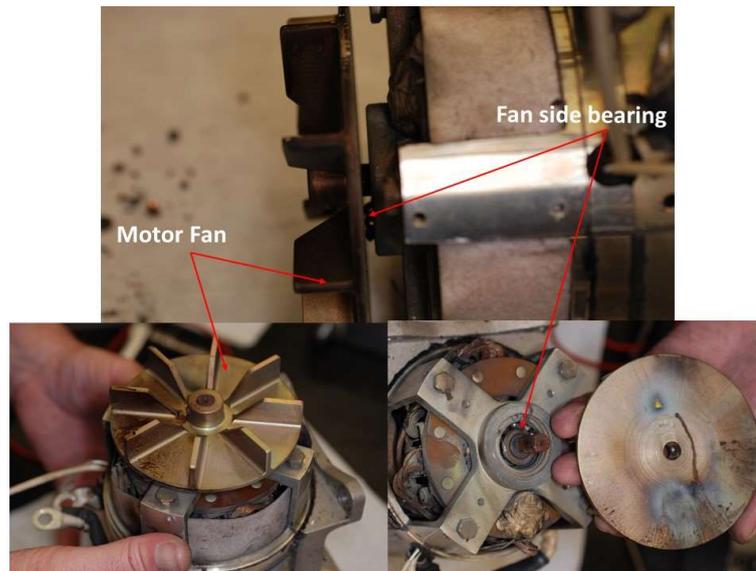
- 1.16.2 The key findings by the backup hydraulic pump manufacturer were as follows:
- (a) The fan side of the motor bearing assembly (made up of seven ball bearings) had failed (**Figure 3**). While all the seven ball bearings were accounted for, some parts of the bearing seal and cage were missing. There was no sign of grease on the ball bearing surface.
 - (b) The failed bearing assembly caused the motor to seize.
 - (c) The positive electrical terminal of the pump motor was found shorted to the casing through the armature.
 - (d) There were loose melted copper beads from the melted armature windings, indicating that the motor interior had experienced high temperature. The pump manufacturer opined that the high temperature was most likely a result of an electrical shorting condition¹⁸.
 - (e) The motor brushes were not worn down.

¹⁸ Typical melting point of copper wire is 1083°C. Pump manufacturer opined that the high temperature was very localized from an occurrence such as arcing, otherwise the varnish within the motor would have not been severely degraded.

Figure 3: Fan Side Bearing

- 1.16.3 The ball bearings and their outer and inner ring raceways were sent to an independent test service centre for inspection. The outer and inner ring raceways were found worn with areas of electrical arcing and pitting that had been rolled over by the ball bearings. The ball bearings were found worn and showed areas of arcing similar to the raceways. The dark straw discoloration on the ball bearings and the raceways suggests that the ball bearing assembly had been exposed to temperature up to 204°C (400°F).

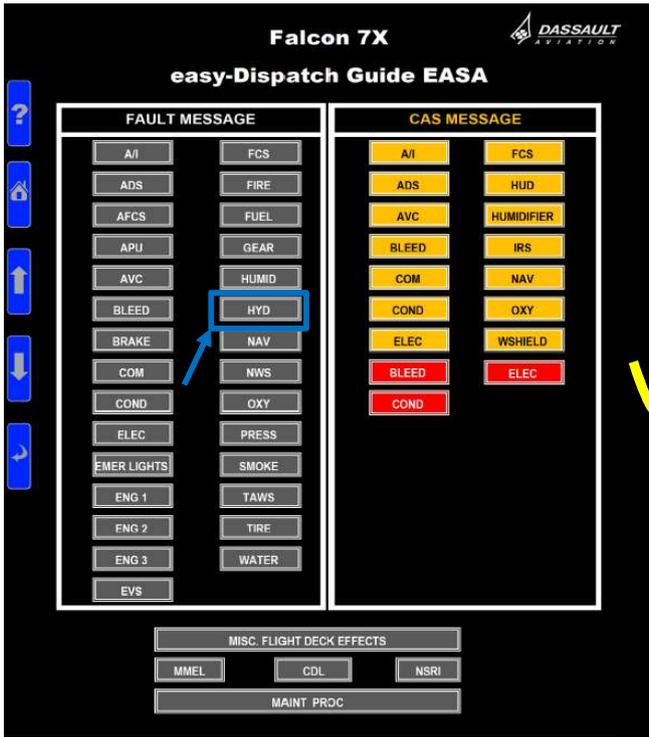
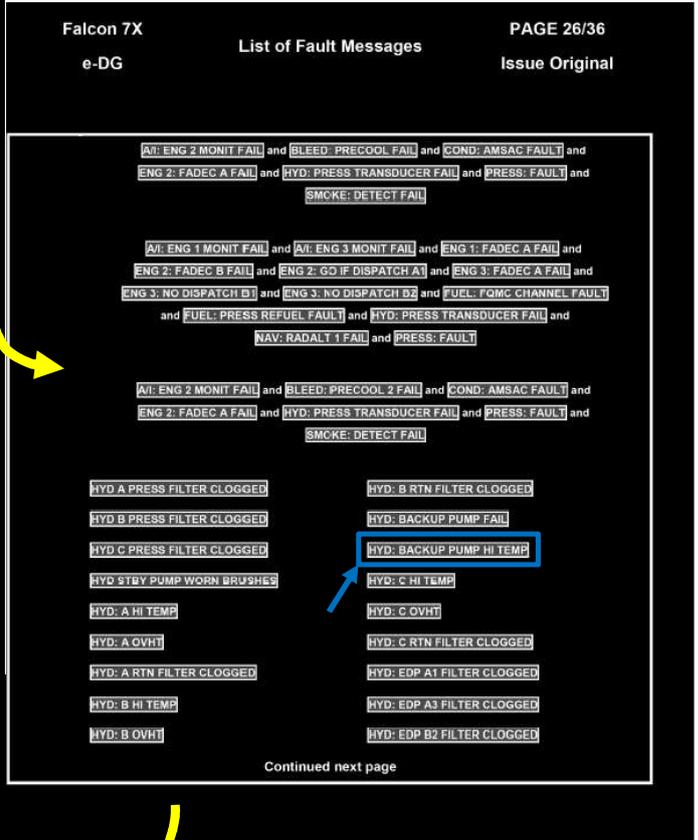
PUMP HI TEMP” would bring up a Fault Orientation Table showing the list of hydraulic related messages and the corresponding root cause and decision to be taken. The root cause indicated for the message “HYD: BACKUP PUMP HI TEMP” was “BACKUP PUMP DEGRADED” and this would result in a NO GO decision. This means that there would be no need to further troubleshoot the backup hydraulic pump. The pump would have to be replaced.

Figure 5: E-DG process

2.2.1 As far as the message "HYD: BACKUP PUMP HI TEMP" is concerned, as per the e-DG, it has to be resolved before the next flight. Based on the Root Cause information in the e-DG, the backup hydraulic pump has been degraded if there was a confirmed high temperature event affecting it. In this case, the backup hydraulic pump was hot to the touch, evident that a high temperature event had taken place. A pump replacement was unavoidable.
