FINAL REPORT

CESSNA 350, REGISTRATION N1222G

WHEEL FIRE

AIB/AAI/CAS.131

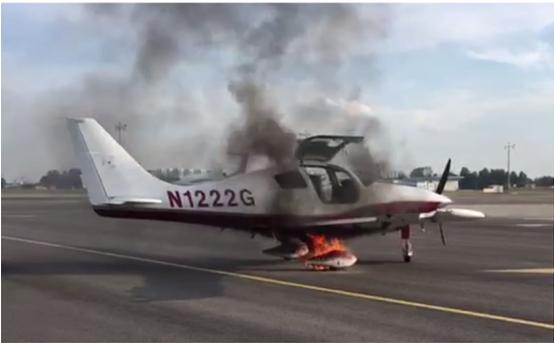
1.1.11 After the aircraft had stopped, there was smoke from the main landing gears. The tow crew of the jet aircraft that was being towed into parking bay B2 saw a fire on the right main landing gear of the Cessna 350 and quickly brought a powder extinguisher over to the aircraft and discharged it at the main landing gears. The fire was not extinguished. At about the same time, the pilot noticed a burning smell in the cockpit and ordered an evacuation. After the pilot and the A&P mechanic had evacuated from the aircraft, both main landing gears caught fire, which generated black smoke (see **Figure 3**).

Figure 3: Fire at the main landing gears of the aircraft

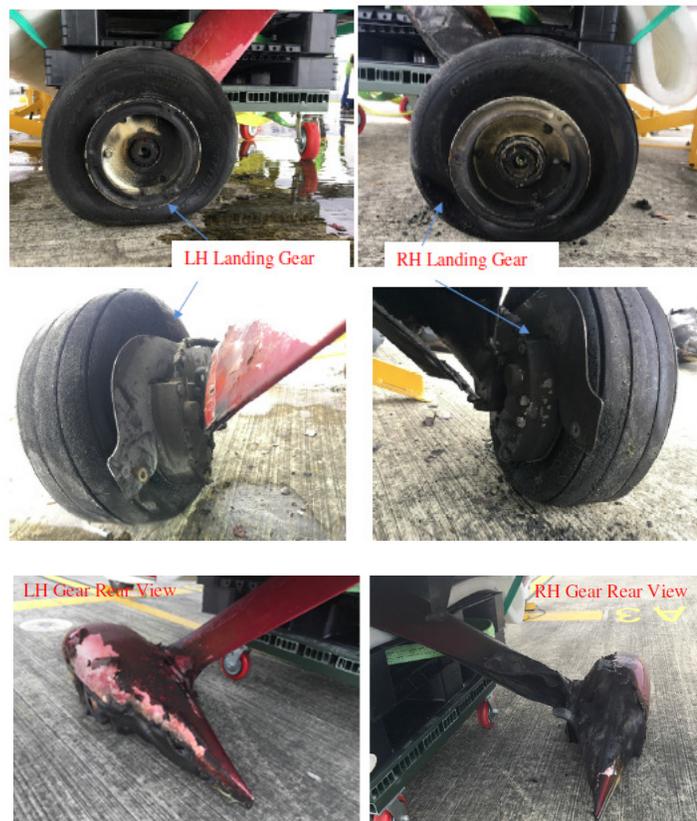
- Both landing gears sustained heat damage (see **Figure 4**).

Figure 4: Damage to the landing gears

- The brake fluid reservoir in the engine compartment was found to be totally dry.
- The brake housing and discs had uneven wear and were charred from the fire.
- Brake debris was found in both brakes.
- Black fluid was found on the brake components.

2.1.1 Post-accident examination of the aircraft did not reveal any anomaly of the brake system, engine and flight control surfaces. The cause of the wheel fire is most likely the overheating of the brakes.

2.1.2 The overheating probably compromised the integrity of the hydraulic lines associated with the left and right brakes. It could not be ascertained how exactly the hydraulic lines were compromised. One possibility is that the O-rings within the cylinder assemblies in the brakes could have failed because of the overheating, thus allowing hydraulic fluid to leak onto the overheated brake components, thereby igniting to develop into a fire.

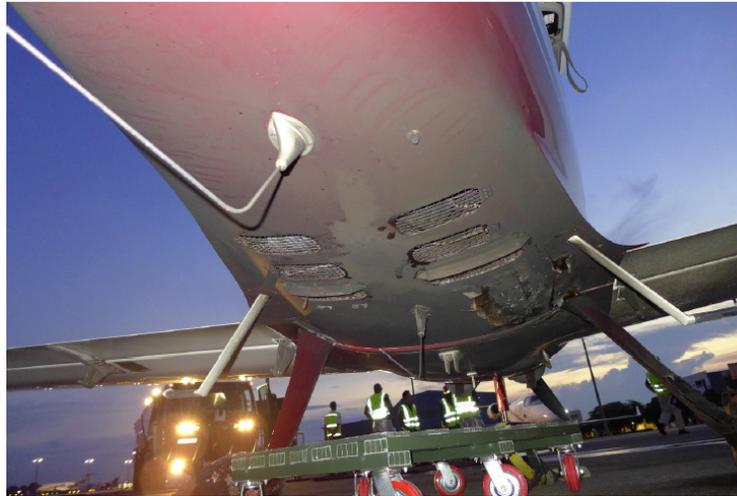
- The right side of the lower fuselage sustained more heat damage than the left side, including some blistering of paint (see **Figure 5**).

Figure 5: Heat damage on the lower fuselage of aircraft
