FINAL REPORT

**SAFETY INVESTIGATION INTO
COLLISION BETWEEN ALNIC MC AND THE USS JOHN S MCCAIN
IN SINGAPORE TERRITORIAL WATERS
ON 21 AUGUST 2017**

MIB/MAI/CAS.021

**Transport Safety Investigation Bureau
Ministry of Transport
Singapore
8 March 2018**

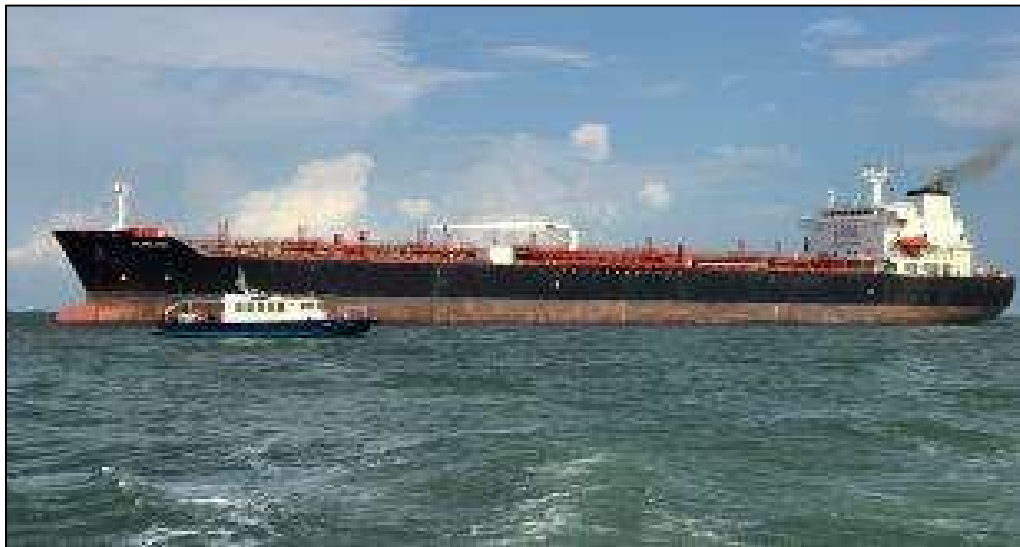
Figure 1 - ALNIC MC at Singapore anchorage after the collision

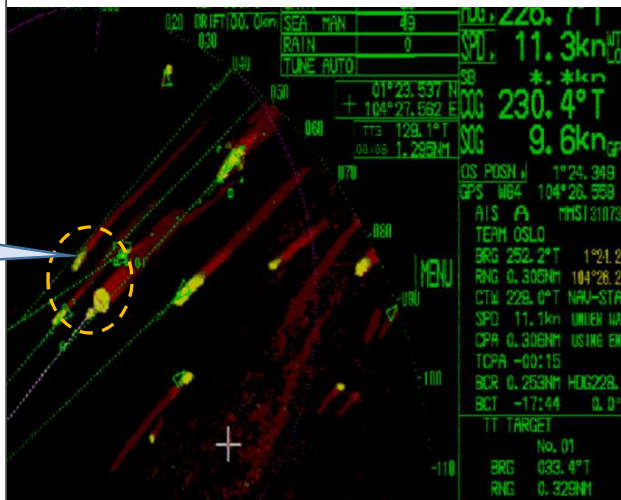
5:21:17	Master attempts to call JSM on Ch 20. No response recorded.	
5:22:04	JSM abeam of AM at a range of 0.27 nm showing a slight turn to Port.	AM's position – 1° 24.349'N 104° 26.558'E Course 230° (T) Speed 9.6 knots JSM not acquired on ARPA.
	JSM abeam of AM showing a slight turn to Port

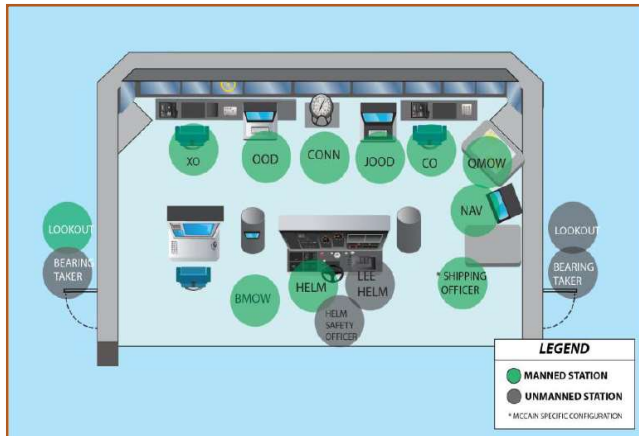
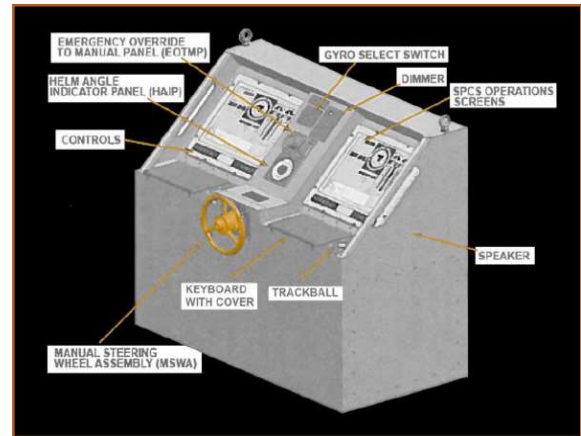
Figure 5 – JSM's Steering and Propulsion Control System (source: the US Navy's report)

- 2.2.3 JSM's difficulties began with the transfer of propulsion control from the "Helm" station to "Lee Helm" station. Until then the "Helm" station had been controlling the steering of the vessel and concurrently handling the propulsion of the vessel. When the CO noted the Helmsman struggling to perform both tasks, he ordered the propulsion to be taken over from him. While this unplanned shift was not abnormal, it was not properly executed, and resulted in the transfer of steering control from the "Helm" station to the "Lee Helm" station⁵⁴.

- 2.2.6 The “Aft Steering” took over the controls from the “Helm” station twice at about 0523H within a span of 17 seconds. During the second takeover, the rudder position was at Port 33° as a result of the conduct of a positive steering test at the “Aft Steering” station. The rudder was not returned to zero prior to the change from backup manual mode to computer assisted manual mode at the “Aft Steering” station. This caused an increase in JSM’s rate of turn to Port.

- 2.2.8 Meanwhile a speed reduction was ordered⁵⁵ on the Bridge. When propulsion controls were transferred from the “Helm” station to “Lee Helm” station, the system caused the “ganged” throttle positions to be disengaged from the “gang” and they had to be ganged manually again by the user of the taking-over station. When “Lee Helm” took over the propulsion, he did not recognise that the throttles had disengaged from the “gang”. A speed reduction initiated on the screen using the slider bar would have caused only one of the engines (the Port engine throttle in this case) to be reduced, while the Starboard engine throttle remained at its original position, exacerbating JSM’s turn to Port. It is not clear at what stage the throttles on JSM were “re-ganged” before the collision.

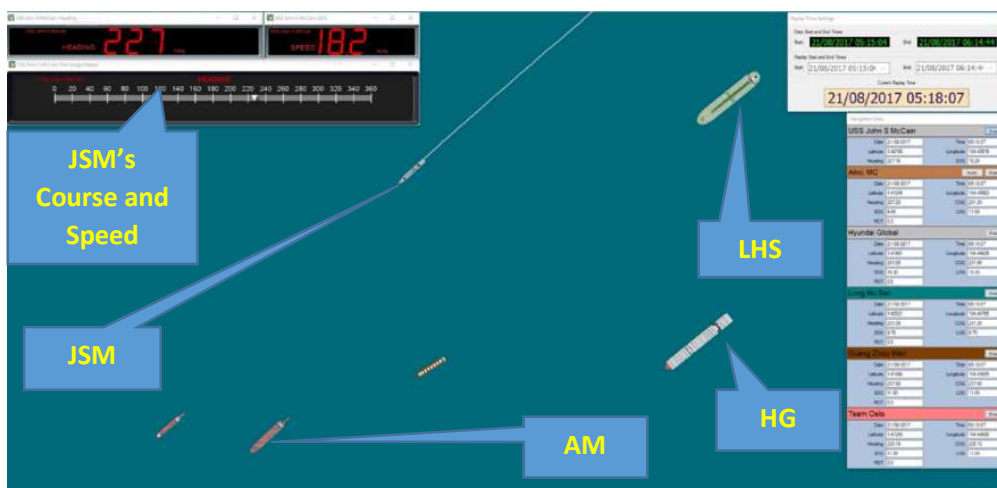
Figure 6 - Graphical representation of position of AM in relation to JSM at about 0518H

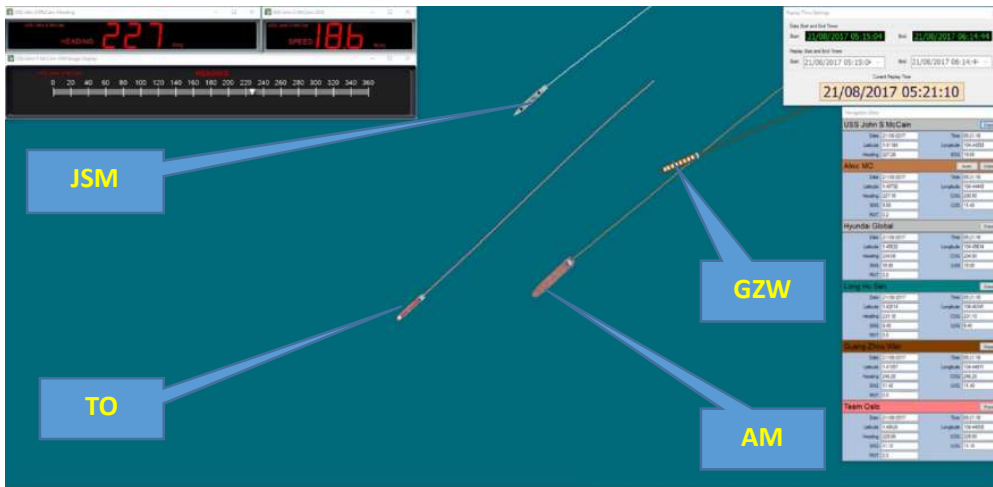
1.7.2 At 0521H, JSM was on a course of 227.8° (T) and engines were full ahead for 20 knots. At 0522H, JSM was making 18.4 knots. About five seconds later, the CO ordered a speed of 10 knots. At 15 seconds prior to 0523H, the CO further ordered a speed of 5 knots. About 15 seconds before the collision, JSM had slowed to 11.8 knots.

Figure 7 - Graphical representation of position of AM in relation to JSM at about 0521H

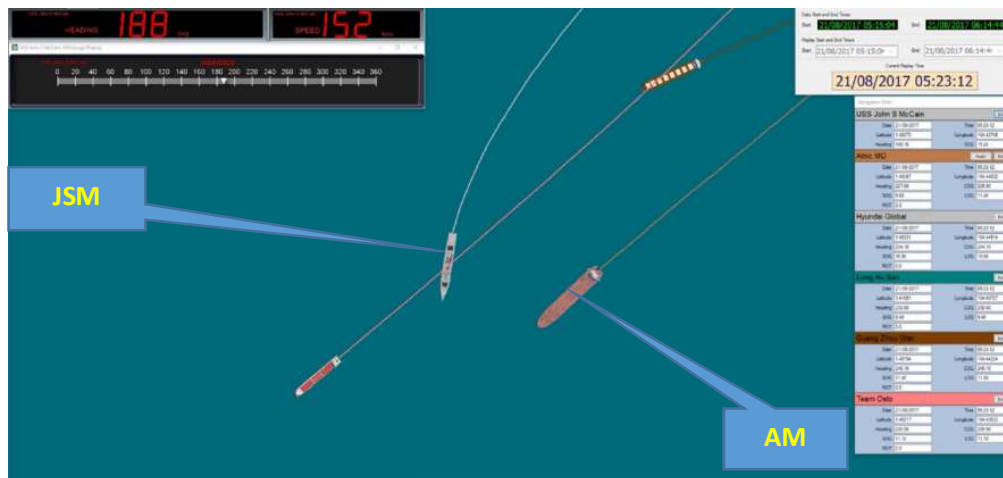
- 1.7.3 Logged data indicates that the first reduction of propulsion took place at about two minutes before the collision. The operating revolutions³⁹ at this time for Port engine and Starboard engine were 66 SRPM and 90 SRPM respectively. Both engines were operating with 100% pitch⁴⁰.

Figure 8 - Graphical representation of position of AM in relation to JSM at about 0523H

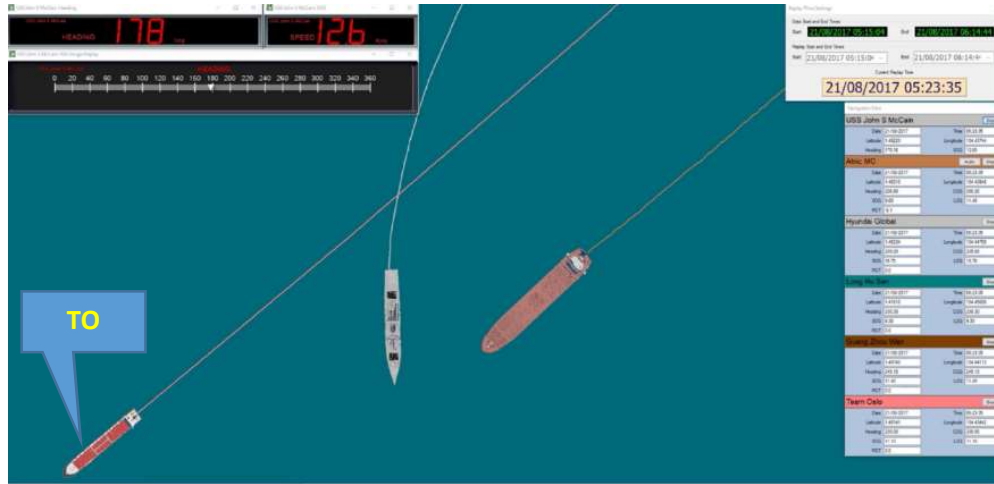
- 1.7.4 Thereafter, command revolutions⁴¹ for the engines were 32 SRPM⁴² with 87% pitch followed by an order of 38 SRPM with 48% pitch on both engines⁴³.

Figure 9 - Graphical representation of position of AM in relation to JSM at about 0523H

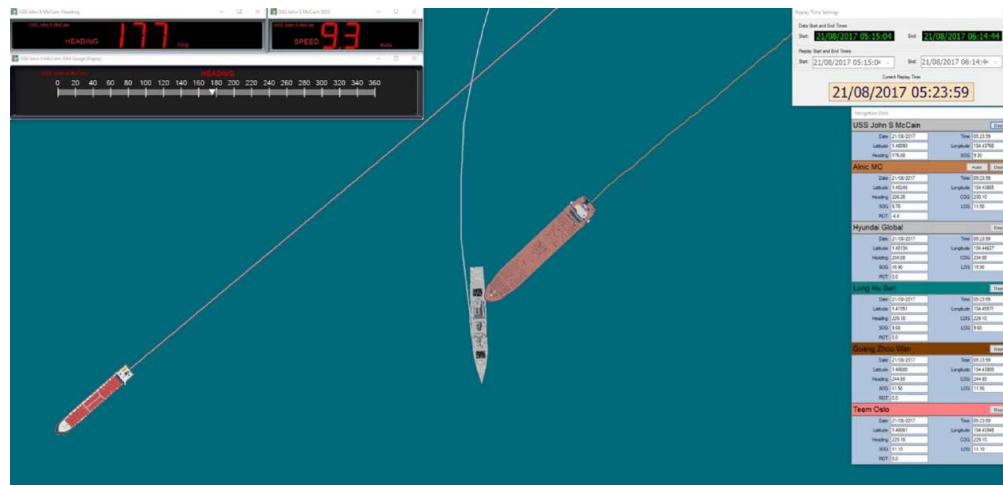
- 1.7.5 Prior to the collision the command revolutions remained as 36 SRPM with 59% pitch and the operating revolutions were at 63 SRPM with 60% pitch on the Port engine, and 64 SRPM with 59% pitch on the Starboard engine.

Figure 10 - Graphical representation of collision between AM and JSM at about 0524H

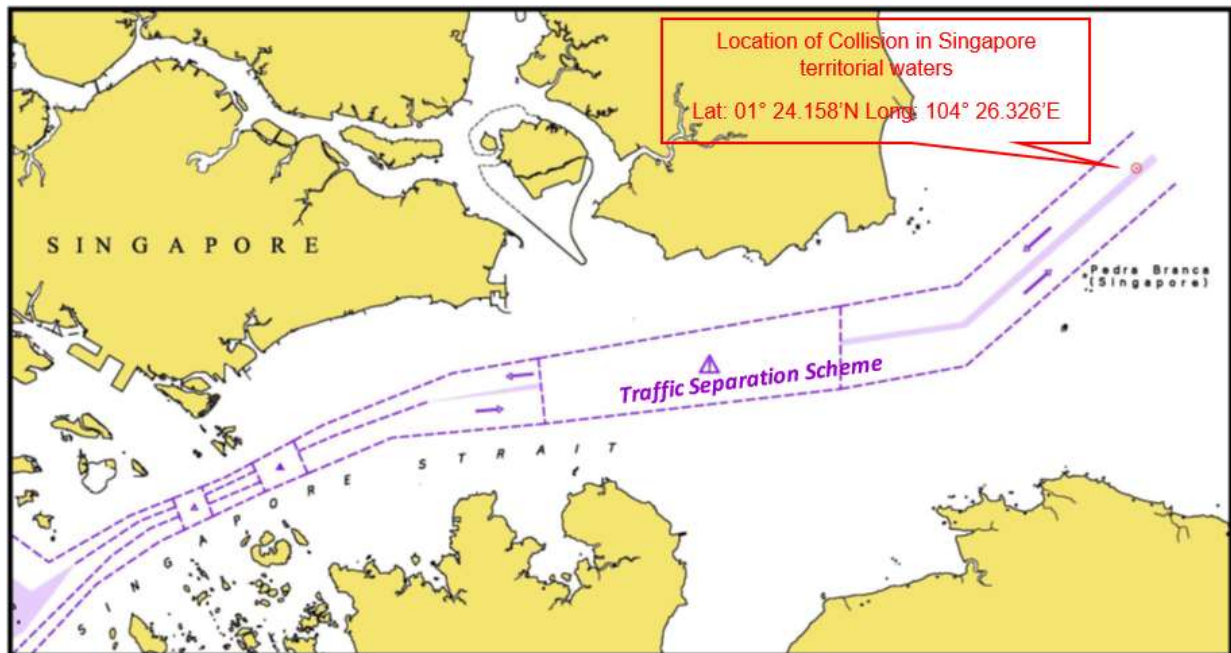
Figure 11 – Collision location (source: Maritime and Port Authority of Singapore)

- 1.8.1 The collision occurred in the westbound lane of the Singapore Strait TSS adopted by the IMO, in Singapore territorial waters in position Lat: 1° 24.158'N Long: 104° 26.326'E, at about 4.6 nm NNE of Horsburgh Lighthouse (Pedra Branca).

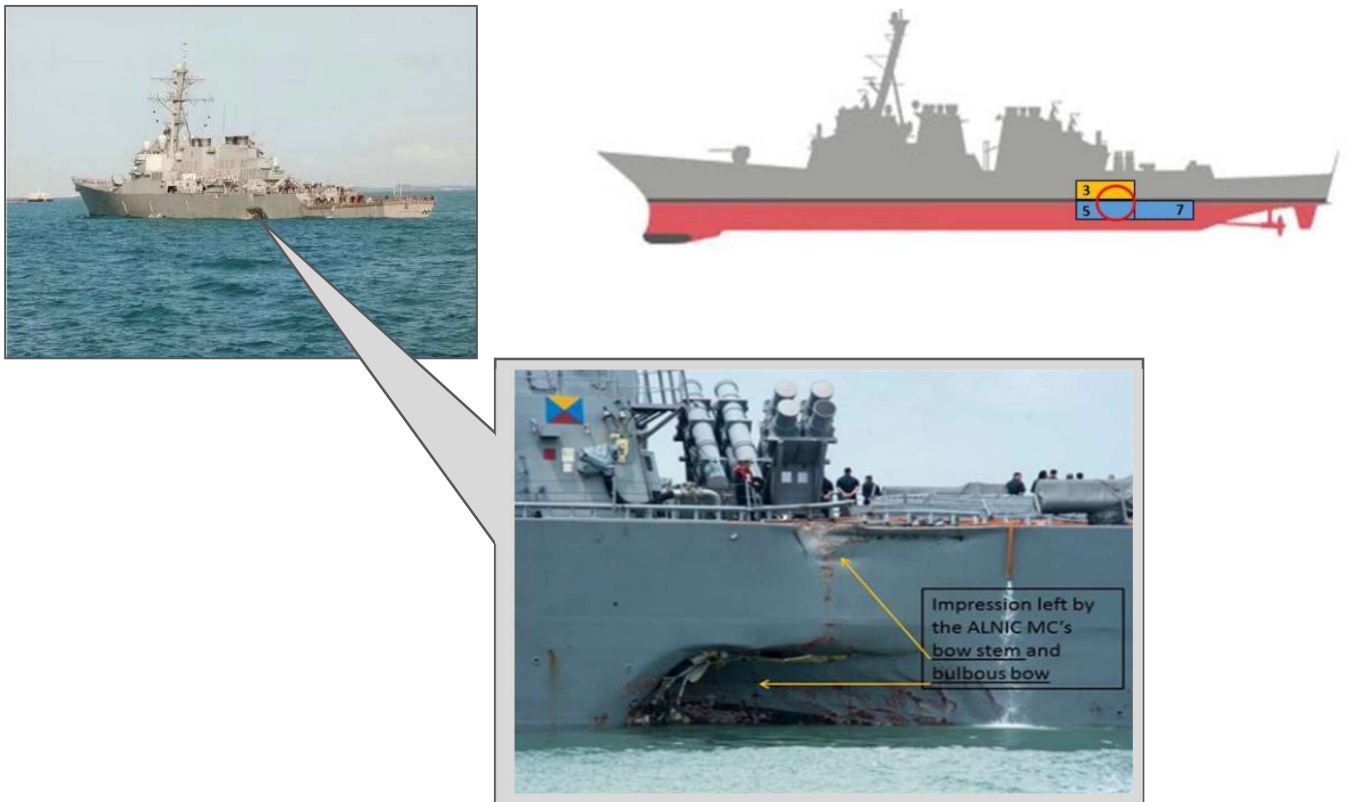
Figure 12 – Source: US Navy

- 1.9.1 The bow of AM collided with the Port aft of midship section of JSM, impacting her berthing 3 and 5 below the waterline (see **Figure 12**).
- 1.9.2 As a result of the collision, AM sustained damages on its Starboard bow (holed about two to three meters long and about seven meters above water level) and some indentation along the Port side. There was no reports of pollution from AM.
- 1.9.3 10 sailors from JSM were reported to be unaccounted for, and five sailors sustained injuries that required medical attention. Search and rescue (SAR) efforts and MEDEVAC procedures were initiated.
