# **FINAL REPORT**

**COLLISION BETWEEN SRS  
MV APL SOUTHAMPTON AND  
CHINESE FISHING VESSEL (ZHE LING YU 52035)  
OFF WENZHOU-ZHEJIANG, CHINA  
ON 15 MARCH 2018**

**MIB/MAI/CAS.038**

**Transport Safety Investigation Bureau  
Ministry of Transport  
Singapore**

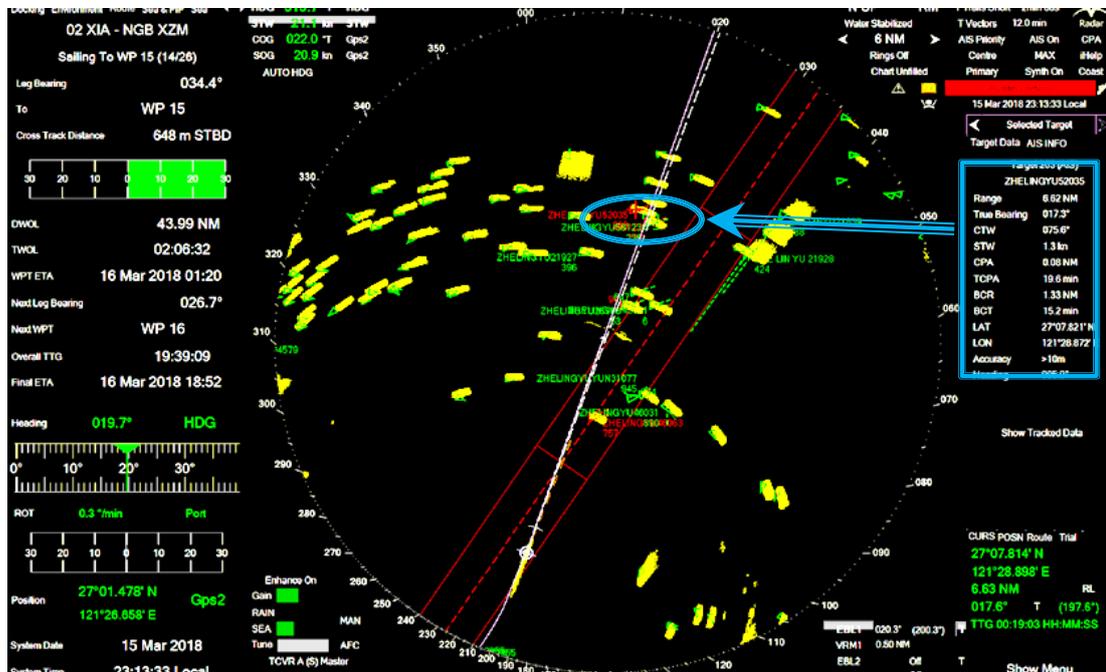
**Figure 1:** X-band radar acquired the presence and identity of fishing vessel ZLY annotated in blue by TSIB, and other vessels in APLS' route at about 2313H.

1.1.6 The red dotted line in the figure above shows APLS' planned passage with 0.5nm cross track safety margins on either side. At this time APLS was on a heading of 020°(T), and 0.3nm to the starboard side of the planned passage. The target acquisition data at 2313H showed that a fishing vessel (later identified to be the ZLY) was heading east, at a speed of over 1kt and indicating a bow crossing range of 1.3nm (referenced to APLS). Time to this crossing was about 15 minutes.

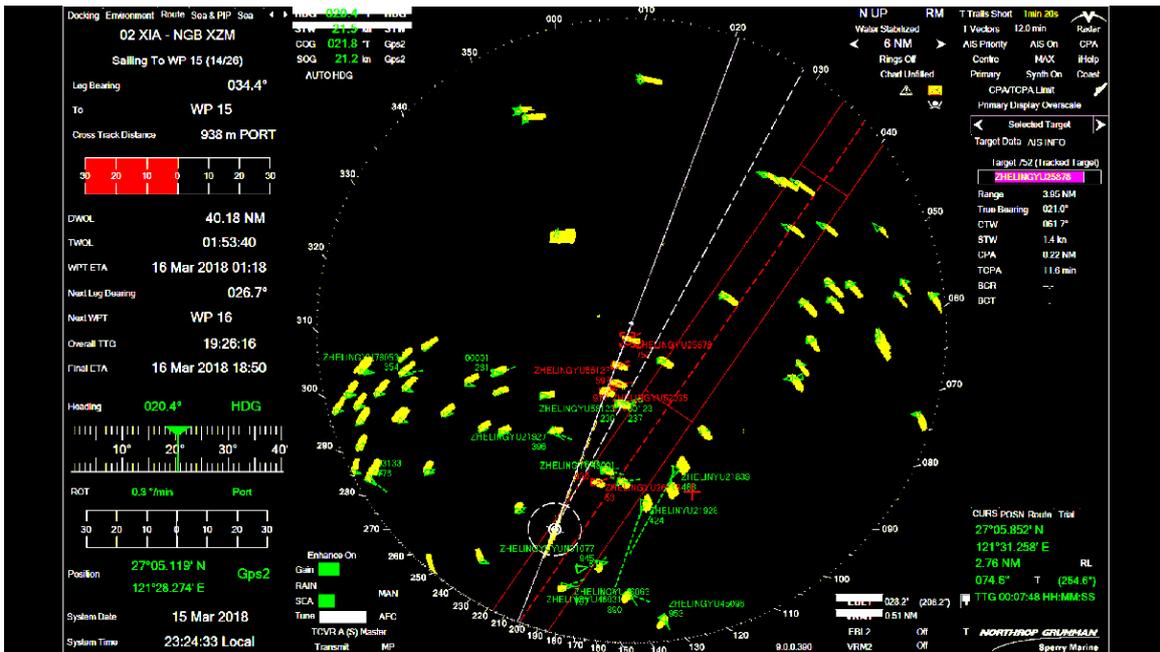
1.1.7 At about 2323H, an automated<sup>11</sup> collision warning directed to APLS (using the call sign) was heard over the VHF. About two minutes later, the ASD asked 3O whether to call for the Master, which was turned down by the latter. APLS was on the port side of its course line at a cross track distance of about 0.5nm and its heading remained unchanged at about 2324H. A group of fishing vessels remained ahead of APLS' path at this time (see **Figure 2**).

Figure 2: APLS' X-band radar screen display at 2324H

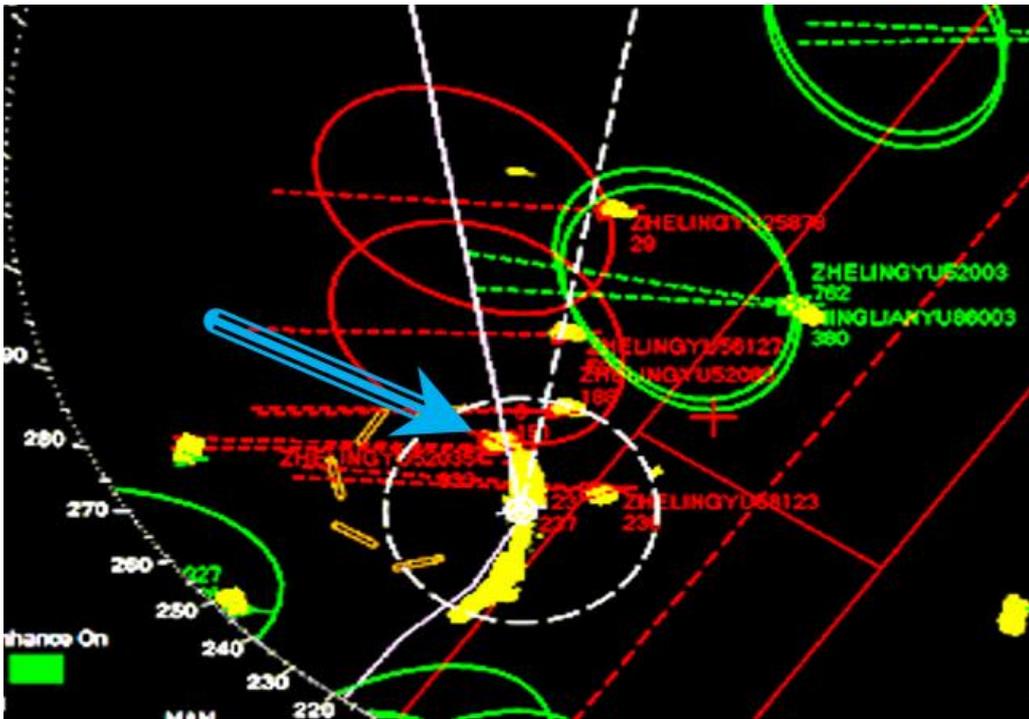
**Figure 4:** Zoomed-in radar display at about 2333H - fishing vessel ZLY, indicated by blue arrow

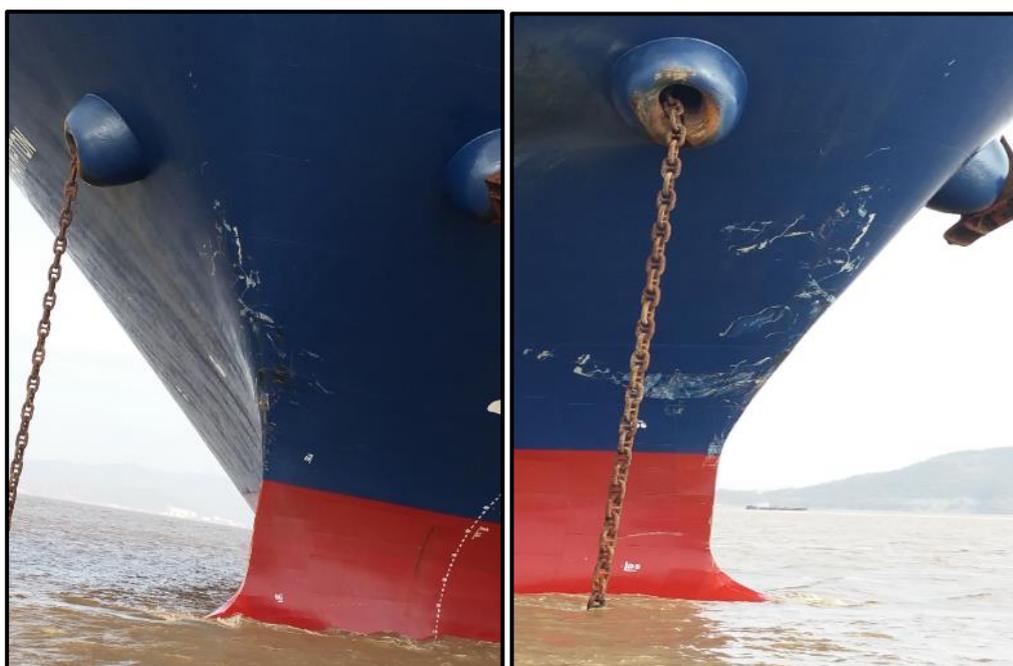
- 1.1.16 The Chief Officer accompanied the MSA officers and took pictures of the forward hull of the vessel, above the bulbous bow (See **Figure 5**). The Master, 3O and ASD were later briefed that the fishing vessel sank. There were 10 crew, 8 were injured, one was missing and one had died as a result of the collision.

**Figure 5:** Paint scratch marks and minor indentations on the forward hull, above waterline.  
(Photo source: the ISM Manager)

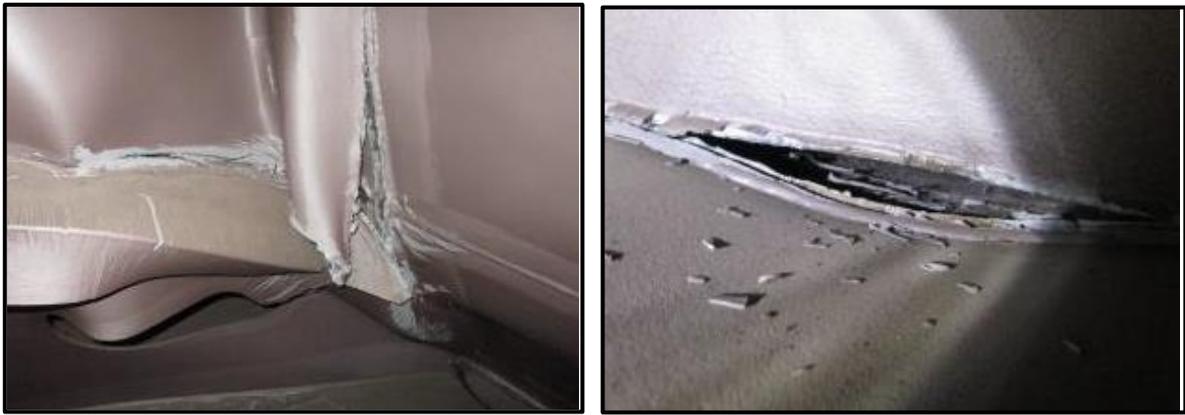
- 1.1.18 The Class surveyor's report on the damages sustained on the bulbous bow (See **Figure 6**) which did not compromise hull integrity, indicated a condition of class<sup>19</sup> for the repairs.

**Figure 6:** Buckled frames and fractured welding seams on the port side to forward of the bulbous bow (*Photo source: ISM Manager*)

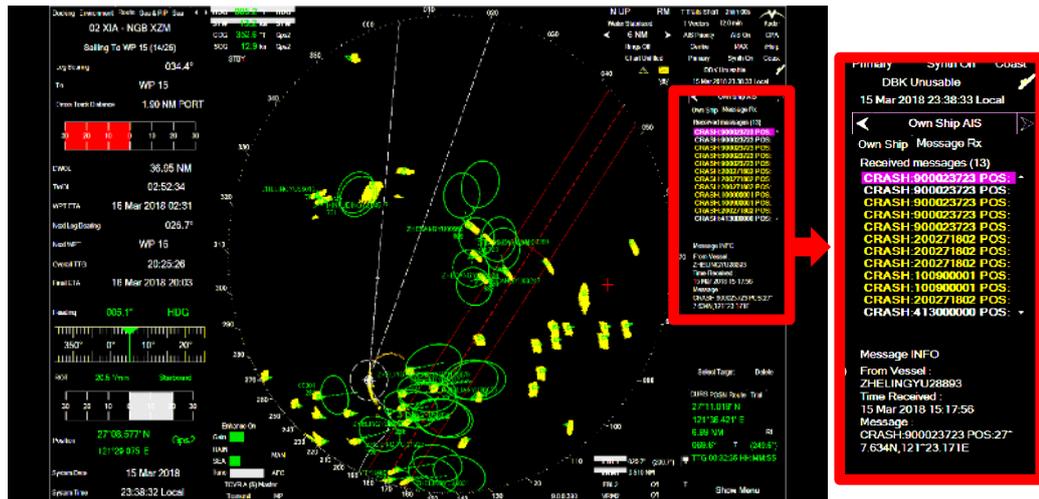
Figure 8: AIS broadcast messages on APLS' S-band radar display

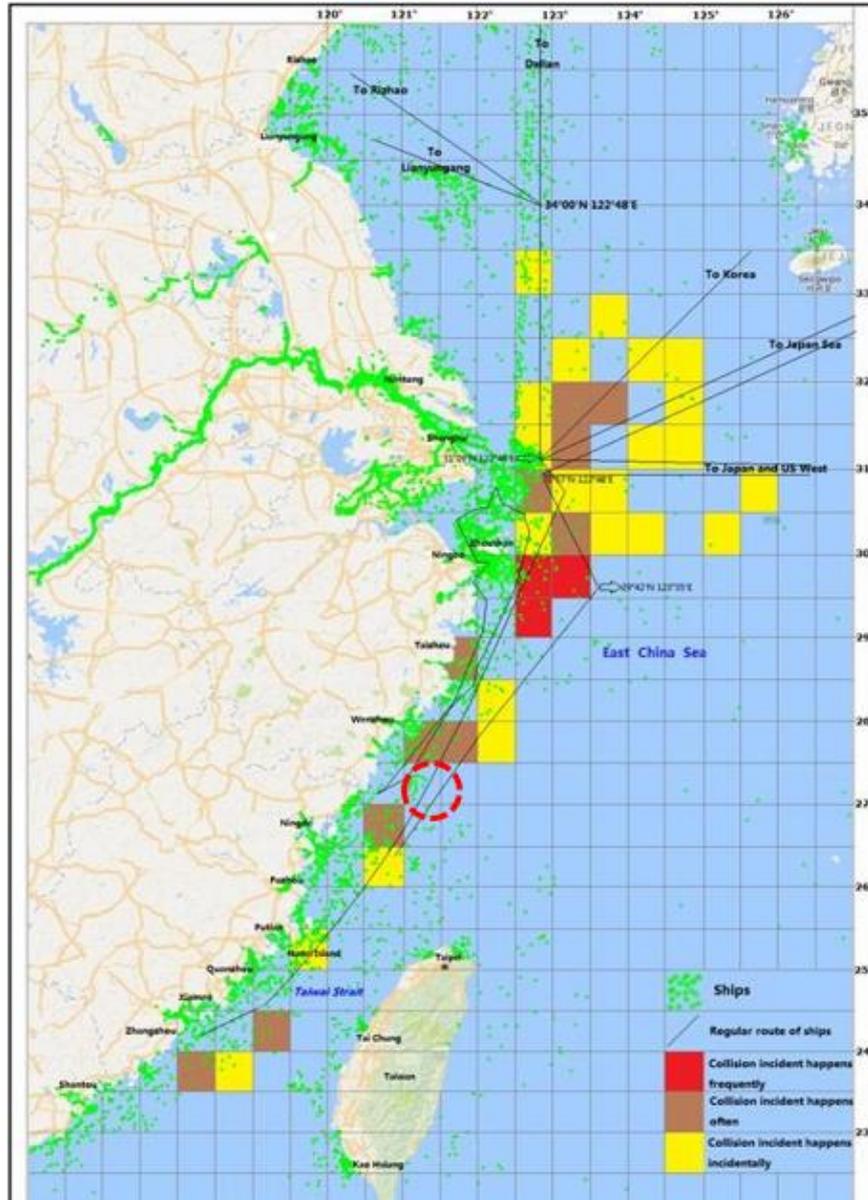
- 1.5.1 The incident occurred in the East China Sea, about 27nm east of Wenzhou, Zhejiang. The concentration of fishing vessels in this region was known to be heavy and was also an area along the typical routes for cargo vessels transiting between the north and south of China ports. The area was known to be where numerous collisions (and near misses reported) with fishing vessels had occurred (see **Figure 9** and **10**).

**Figure 9:** The incident location annotated by a red circle. Bottom picture shows the frequency of incident involving fishing vessels along the common routes taken by cargo ships and tankers in the East China Sea, China. (Source: Huatai Insurance Agency & Consultant Service Ltd - China, - through Gard A.S. – Norway)

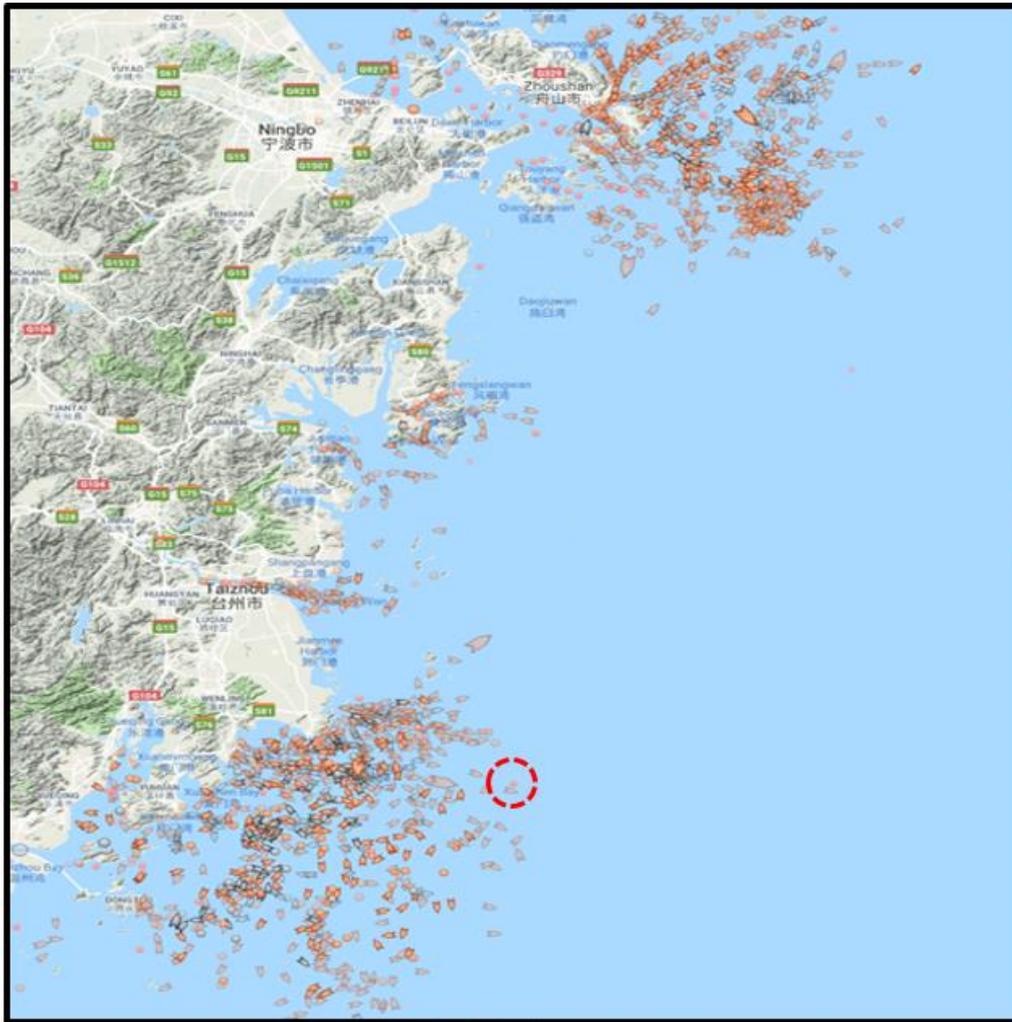
**Figure 10:** The heavy concentration of fishing vessels in the Ningbo-Zhoushan region (North) and the Zhejiang coastal region (South) on a (random) single day, in the month of March 2018

Red dashed circle indicates location of collision - (Source: Marine Traffic)
