# **Final Report**

**COLLISION  
BETWEEN  
CHEMROAD MEGA AND SINICA GRAECA  
OFF HORSBURGH LIGHTHOUSE  
SINGAPORE TERRITORIAL WATERS  
17 AUGUST 2017**

MIB/MAI/CAS.020

Transport Safety Investigation Bureau  
Ministry of Transport  
Singapore

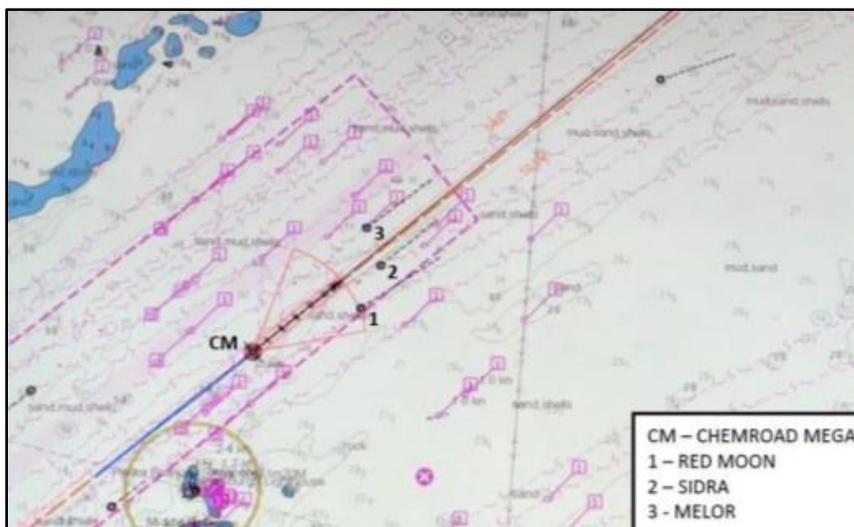
Figure 1: CM's ECDIS display with AIS and ARPA overlay at 2000H

- 1.1.8 At about 2000H, the Third Officer set the main engine for sea passage as instructed. The Third Officer, after scanning the horizon and consulting the Electronic Chart Display and Information System (ECDIS) with the AIS and automatic radar plotting aid (ARPA) overlay, had also identified the three targets ahead. (see **Figure 1**).

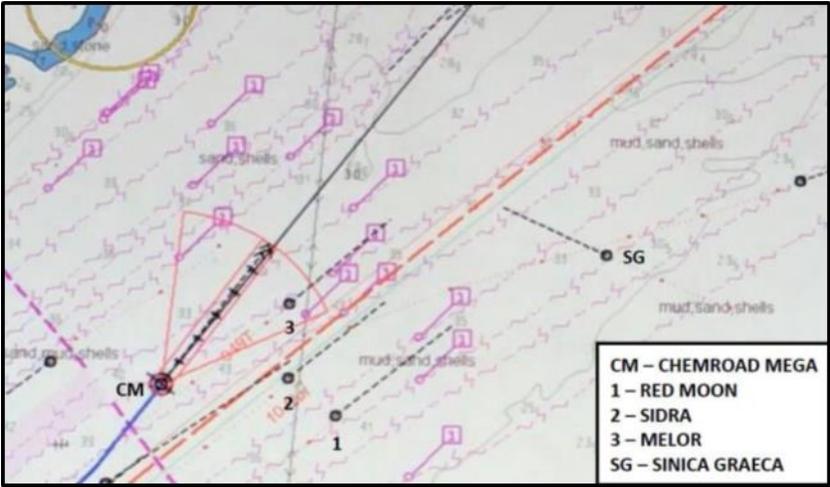
Figure 2: CM's ECDIS showing vessels of interest at 2016H

- 1.1.12 By about 2010H, the Third Officer observed that visibility had reduced to less than 5nm as a result of light rain. The Third Officer, using the binoculars, scanned the horizon and having satisfied that the stern lights of the three vessels ahead were still visible, did not notify the Master of the change in weather conditions<sup>13</sup>.
- 1.1.13 At about 2016H, the Third Officer observed a new target on the ECDIS, about three points on CM's starboard bow, identified as SG at about 3.7nm. The ECDIS information further indicated that SG's closest point of approach (CPA) with CM would be 0.5nm (crossing CM's bow), in about 12 minutes. (See **Figure 2**).

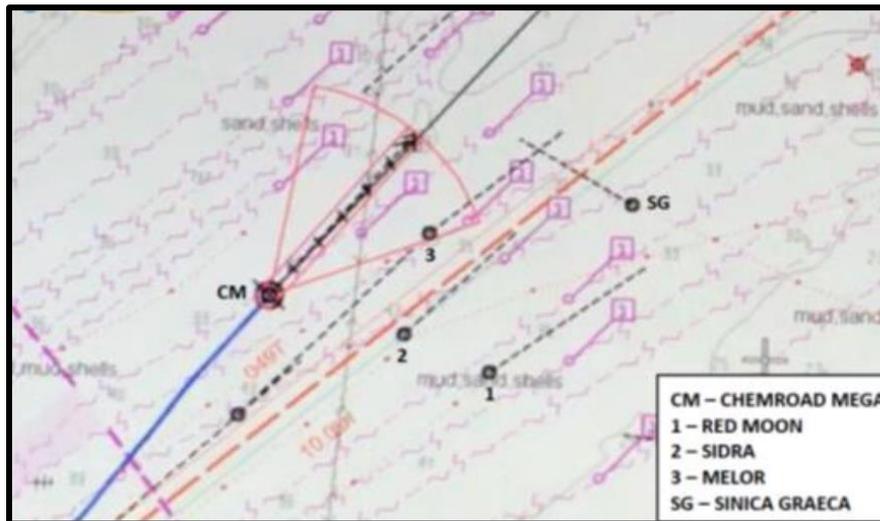
Figure 3: CM's ECDIS showing vessels of interest at 2020H

- 1.1.17 Satisfied that Melor, Sidra and Red Moon would not pose any problem, the Third Officer instructed the ASD to put CM on hand steering with the intention<sup>16</sup> to alter course to starboard to pass SG's stern. (See **Figure 3**).

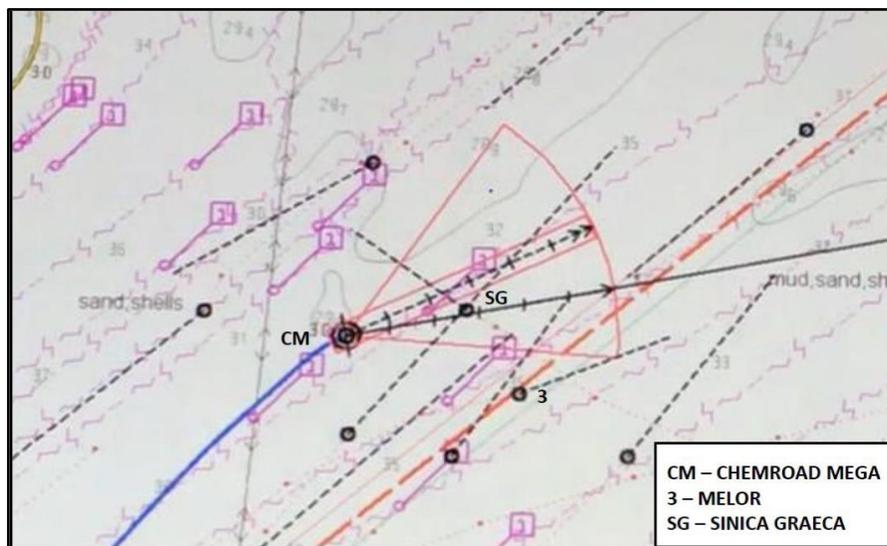
Figure 4: CM's ECDIS showing SG nearly ahead (bow crossing aspect)

- 1.1.18 At around 2021H, the Third Officer ordered a helm of about five degrees to starboard towards SG's stern. The Third Officer intended to turn CM slowly towards starboard while maintaining a passing distance of about 0.5nm with Melor. At around 2024H, the Third Officer ordered an amendment to the helm to 15 degrees. By this time, CM was on a heading of about 044°T and doing about 14.2 knots.
- 1.1.19 By about 2025H, the Third Officer confirmed that SG at 0.8nm away was at two points on the starboard bow and was visually seen displaying two white masthead lights and a red sidelight. CM's heading continued to turn to starboard, as planned. (See **Figure 4**).

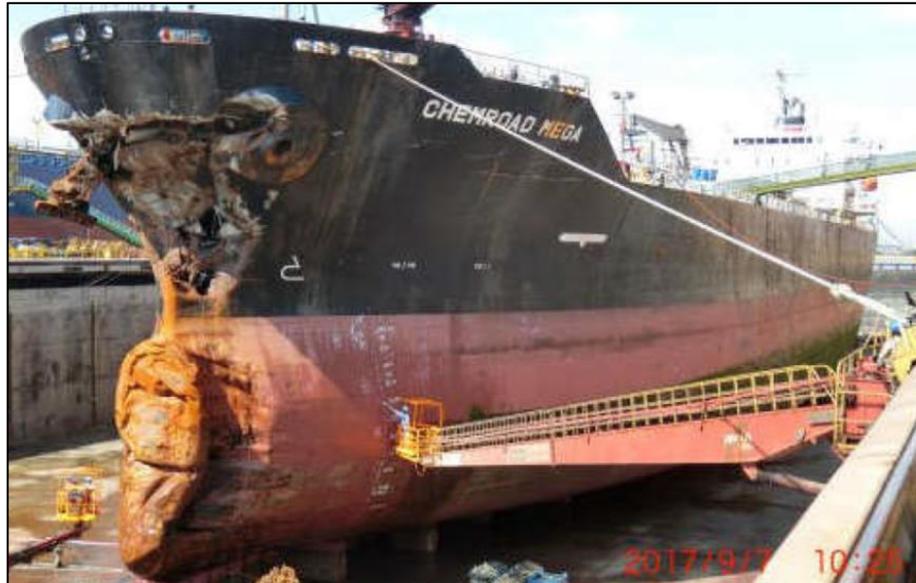
Figure 5: CM undergoing repairs in dry-dock

- 1.2.1 Immediately after the collision, the Master arrived on the bridge and took over the con. He stopped the engines and sounded the ship's general alarm followed by an announcement on the public address system, informing the crew of the collision.
- 1.2.2 The Master then notified the Singapore Vessel Traffic Information System<sup>17</sup> (VTIS) and made a general safety broadcast on VHF Ch.16 and Inmarsat-C<sup>18</sup>.
- 1.2.3 A damage inspection carried out on-board CM indicated that there were no injuries or oil pollution. As a result of the collision, CM lost both anchors and sustained a hull breach above the water line in-way of the bow, which in the opinion of the Master rendered the vessel unfit to continue its passage. (see **Figure 5**)

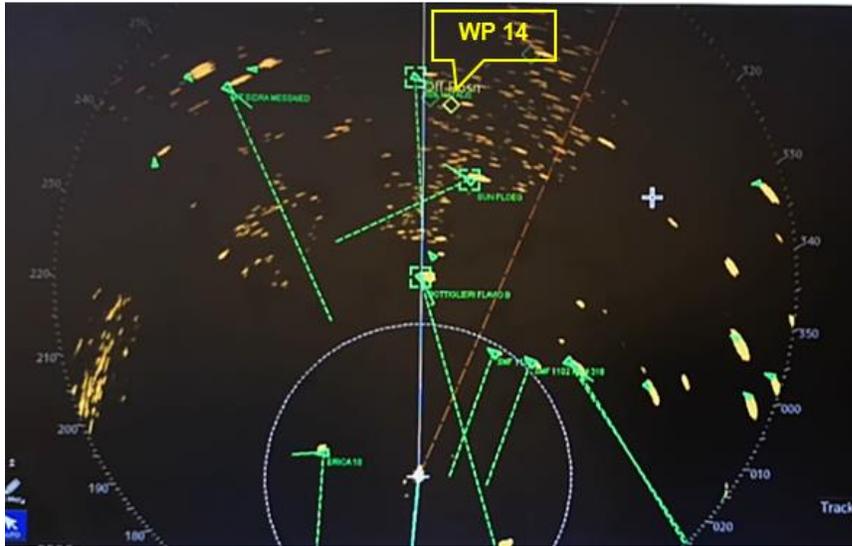
Figure 6: SG's X-Band radar display at 2000H on head-up display

- 1.3.7 The Third Officer, upon taking over watch, observed from the radar display several vessels within the clutter of rain clouds near WP-14 and informed the Master accordingly. (see **Figure 6**).

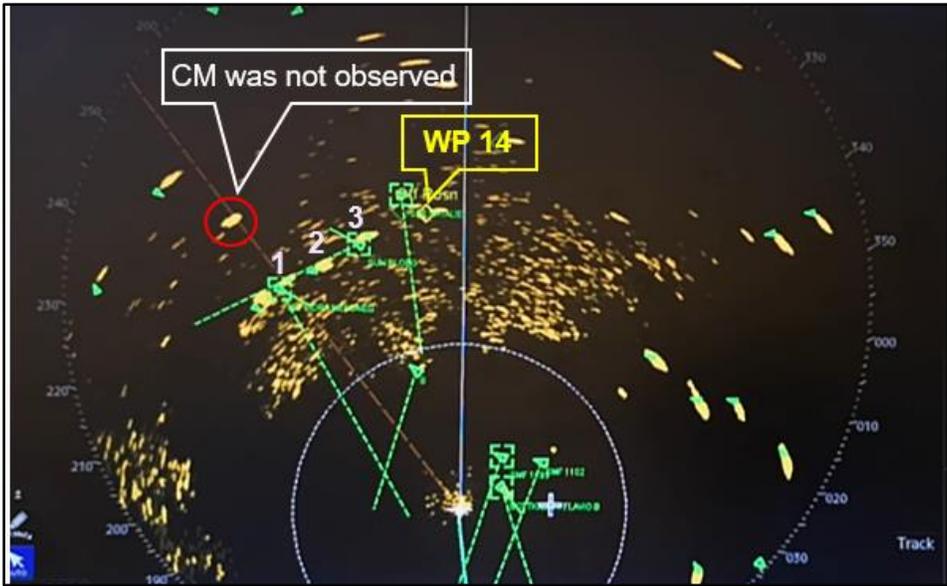
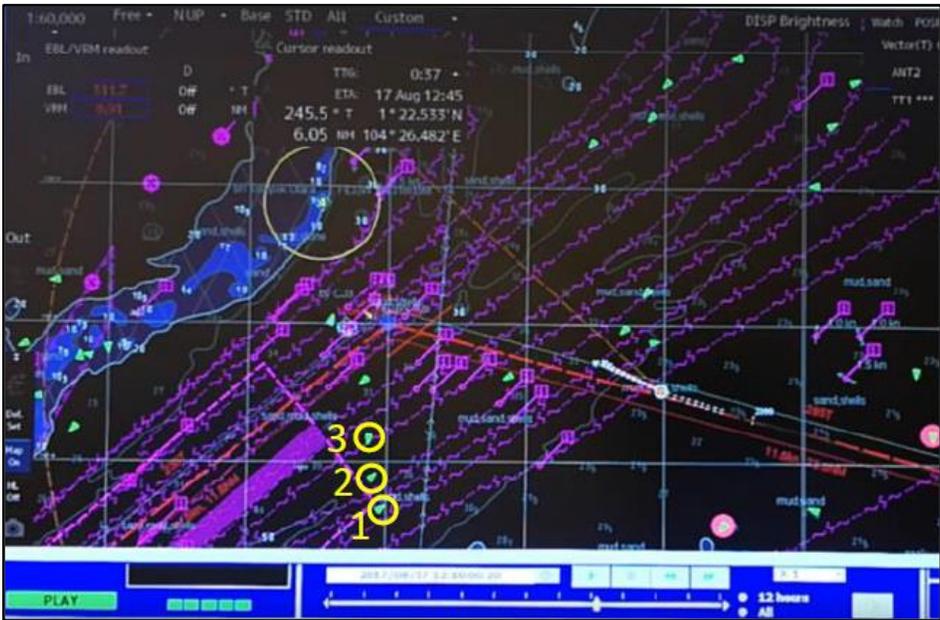
1.3.10 A radar target (without an AIS triangle) which appeared on the X-band radar, later identified as CM (circled red in **Figure 7**), was not observed or tracked by the bridge team. This target was not visible on the ECDIS display (see **Figure 7a**).

Figure 7: SG’s X-Band radar display at 2010H showing CM (annotated red circle by TSIB)

Figure 7a: SG’s ECDIS display (with AIS overlay) at 2010H

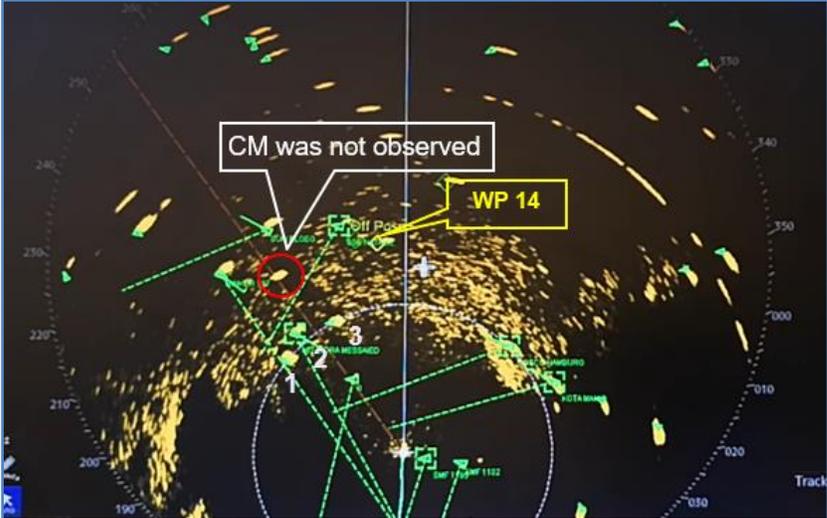
Figure 8: X-Band Radar display at 2016H

1.3.11 Of the three targets displayed on SG’s radar, the Master deemed target No.3 (Melor) to be of concern which could develop into a close quarters situation (see **Figure 8**). The Master communicated with Melor on VHF Ch.16 and both vessels agreed that SG was to keep course and speed, while Melor would alter course to starboard, so as to pass astern of SG.

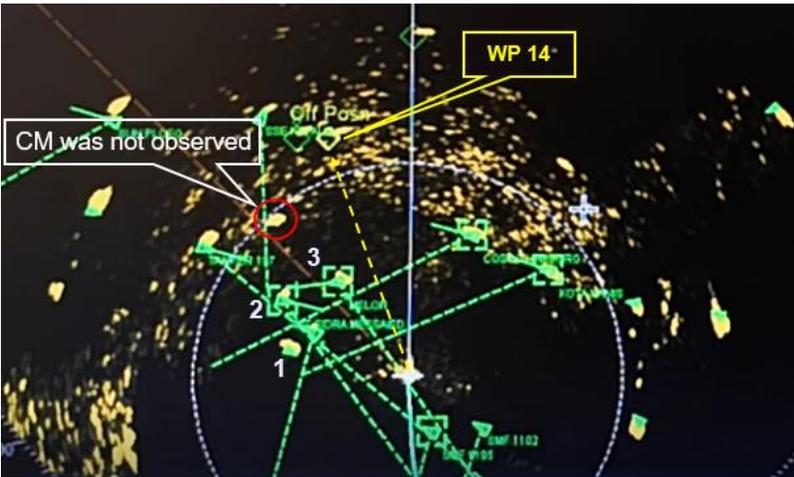
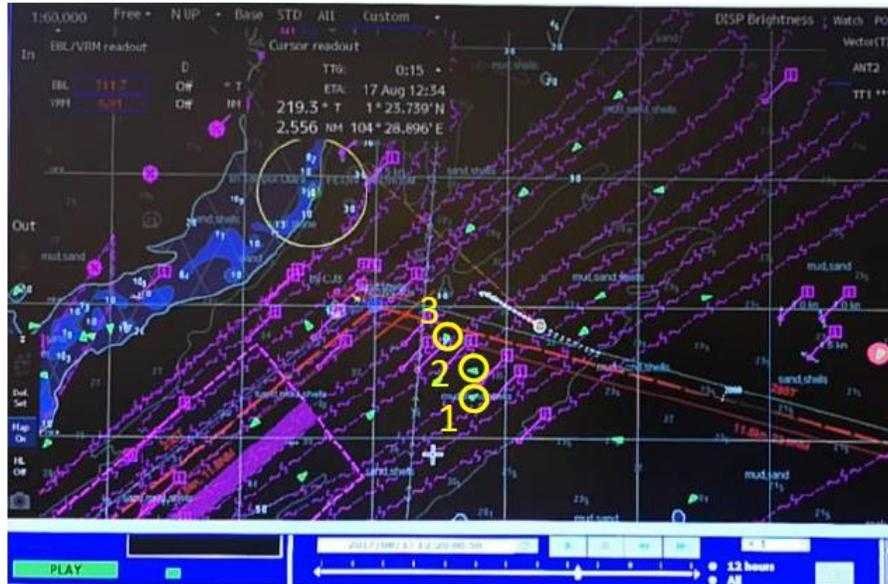
1.3.12 At about 2020H, the Master of SG, altered his vessel’s heading further to starboard from 291°T to 300°T, to increase the passing distance between his vessel and Melor. By this time the other two vessels, i.e. Red Moon and Sidra were passing well clear on SG’s port beam (see **Figure 9 and 9a**). There was no change in SG’s speed.

Figure 9: SG’s X-Band Radar display at 2020H

Figure 9a: SG's ECDIS display at 2020H

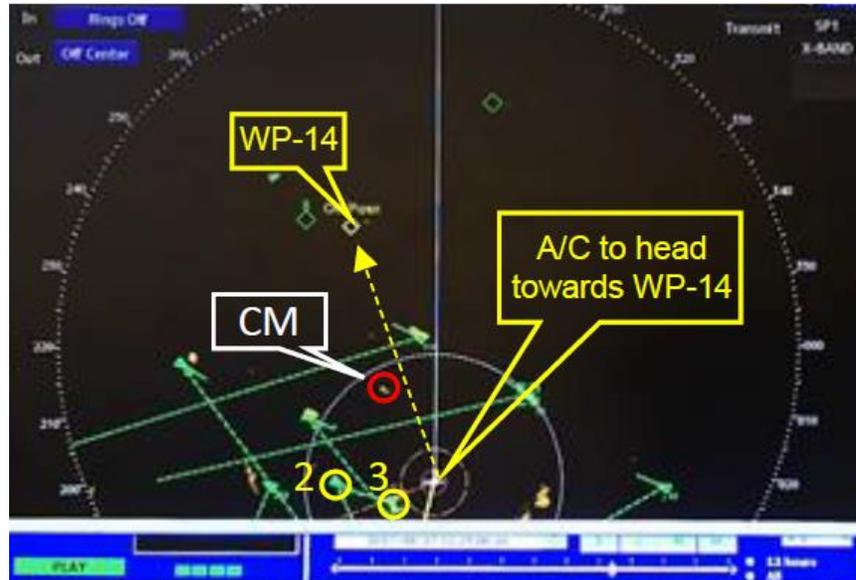
Figure 10: SG's X-Band radar display at 2025H

- 1.3.17 The Master checked the radar and noted that CM had not been acquired and was about 0.8nm away. The Master noting the green sidelight<sup>22</sup> which indicated that CM would likely cross SG's bow, reverted to port 15° helm with the intention to further increase the bow passing clearance and thus to pass starboard-to-starboard with CM. (See **Figure 10**).

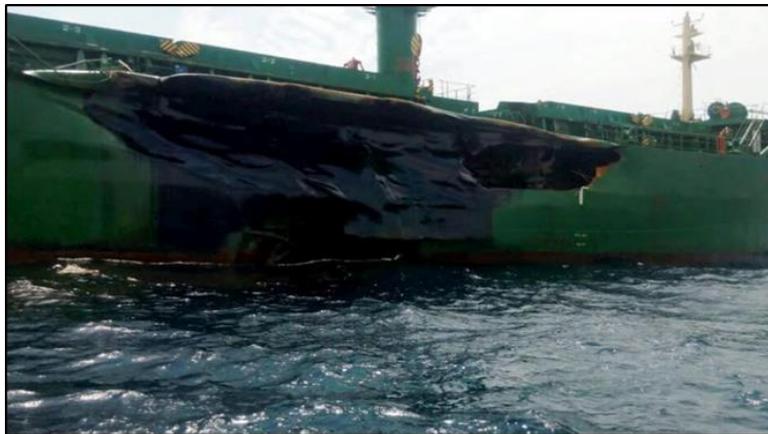
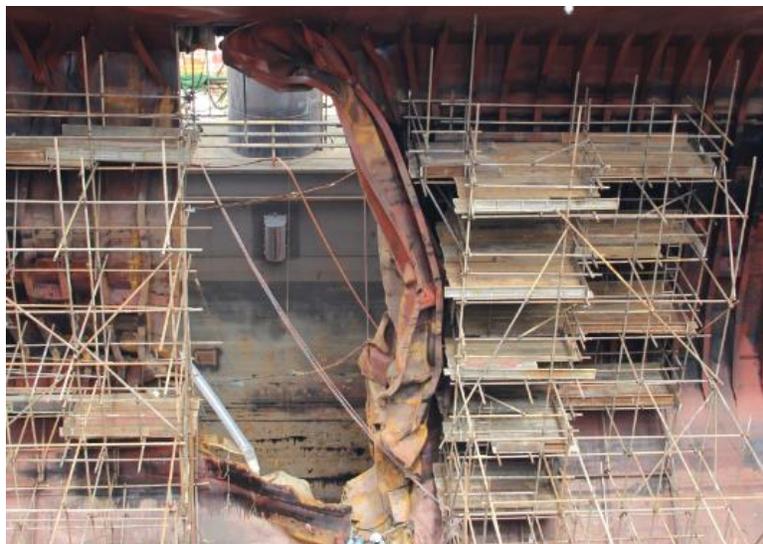
1.4.3 The collision did not result in any injuries on SG, However, SG sustained damages to the ballast water topside tank, bunker tank and water ingress into the cargo hold. In the opinion of the Master, the collision rendered the vessel unfit to continue its passage. (See **Figure 11 and 11a**)

Figure 11: SG's no.2 cargo hold as viewed from water level

Figure 11a: View from inside of SG's no.2 cargo hold
