COLLISION BETWEEN OIL TANKER KARTIKA SEGARA AND SUCTION HOPPER DREDGER JBB DE RONG 19 IN SINGAPORE STRAIT ON 13 SEPTEMBER 2017

MIB/MAI/CAS.025

**Transport Safety Investigation Bureau
Ministry of Transport
Singapore**

7 November 2018

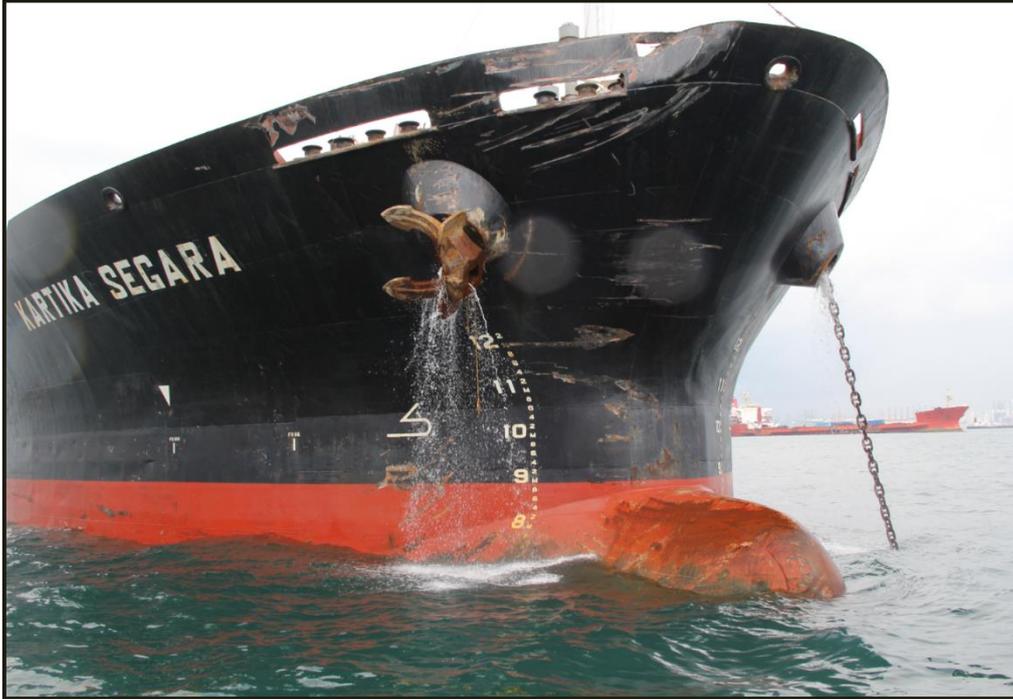
Figure 1: Kartika Segara – Photograph after collision showing damaged bow

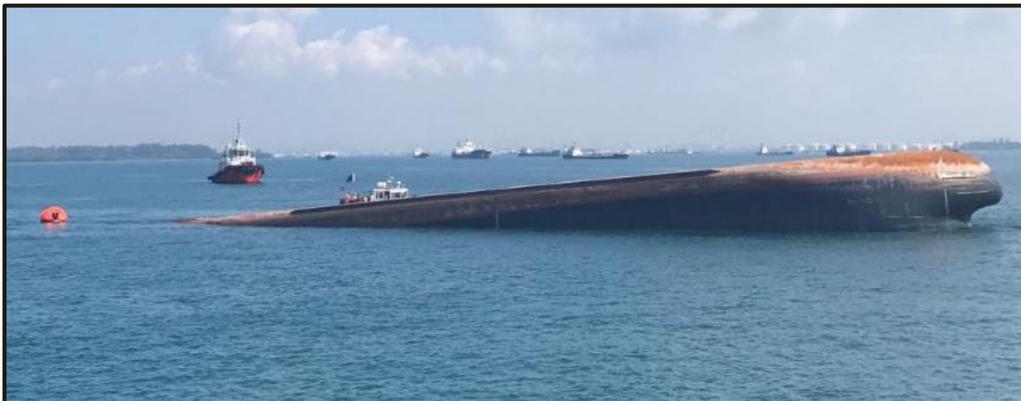
Figure 2: JBB De Rong 19 – Photograph after collision showing capsized and partially submerged in water
(Source: Maritime and Port Authority of Singapore)

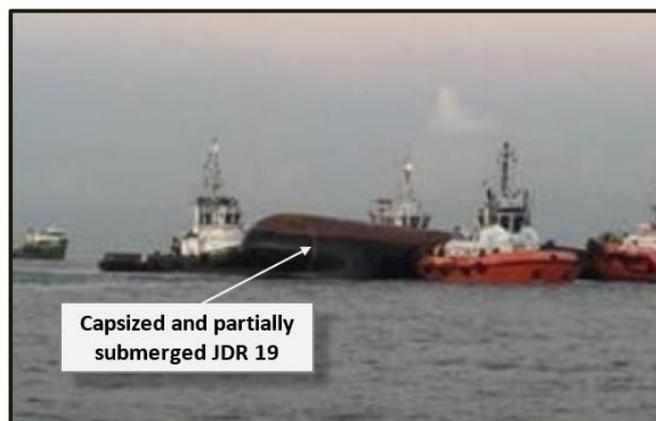
- 1.1.33 At about 0806H, the partially submerged JDR 19 was towed by four tugs (see **Figure 8**) and beached³² off Pulau Senang about 5nm away at the Southern edge of Raffles Reserved Anchorage to facilitate diving operations to search for the missing crew members.

Figure 8 - Capsized and partially submerged JDR 19 was towed by four tugs
(Source: Maritime and Port Authority of Singapore)

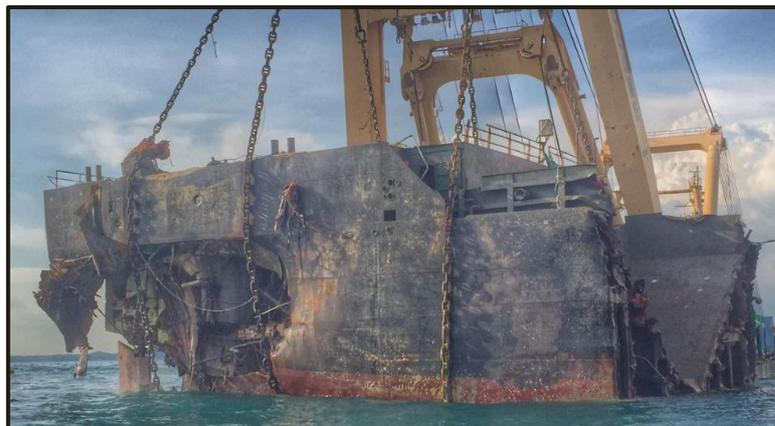
- 1.1.39 JDR 19 was declared as a constructive total loss and the wreck was removed by cutting it into sections (see **Figure 9**).

Figure 9 - The starboard quarter of JDR 19 being lifted out of water showing the angle and location of impact from KS's bow.

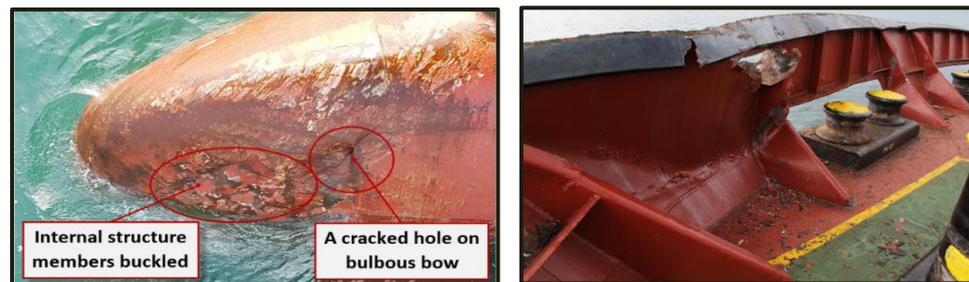
- 1.2.1.1 The internal structural members of the bulbous bow were buckled (see **Figure 10**). Additional damages were noted on the ship's bow and starboard side bulwark at the forecastle deck and a slight indentation to the starboard side shell plate at the area of no. 3 water ballast tank.

Figure 10 – Damage at ship bow areas after the collision
(Source: the ship's manager)

- 1.2.1.2 Surveyors from ClassNK surveyed the vessel and issued a condition of class³⁸ for permanent repairs to be done no later than the next docking survey. Having done the temporary repairs, KS subsequently resumed her voyage to discharge her cargo at the next discharging port of Baubau, Indonesia.

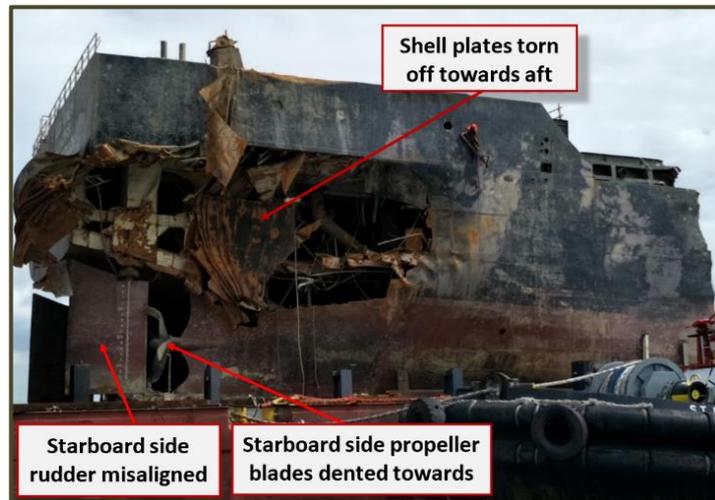
- 1.2.2.1 The damage to JDR 19 was mainly on its starboard side which included tearing of ship's side shell plating at the starboard quarter in way of the starboard auxiliary tank³⁹ below the steering gear compartment, bending of all the four blades of the starboard propeller and misalignment of the starboard rudder (see **Figure 11**). JDR 19 capsized soon after the impact.

Figure 11 – Aft section of JDR 19 after being salvaged

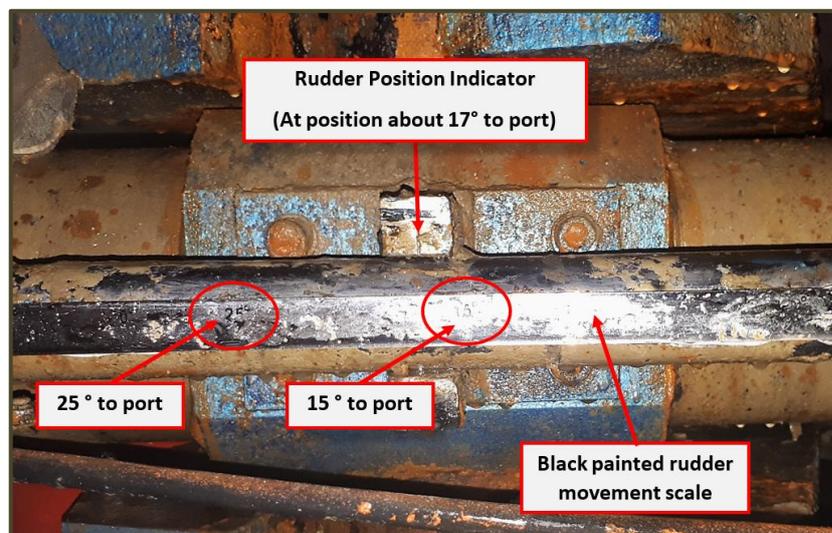
- 1.4.4.1 JDR 19 did not have auto-steering capabilities and had to be steered manually. The engine telegraph was next to the steering console. CO2 had reportedly been steering the ship since taking over watch from CO1 at 2300H.
- 1.4.4.2 According to the Master and both Chief Officers, the vessel did not have any maneuvering difficulties and responded well to helm orders from the bridge.
- 1.4.4.3 A post salvage assessment of the wreck showed that the rudder position was at about 17° to port (see **Figure 17**). This was confirmed as being the helm order given⁶² by the CO2 prior to the collision.

Figure 17 – Physical rudder position indicator at steering gear room on JDR 19

⁶² VDR data of the KS indicated that JDR 19’s heading began to change to port about four minutes prior to the collision.

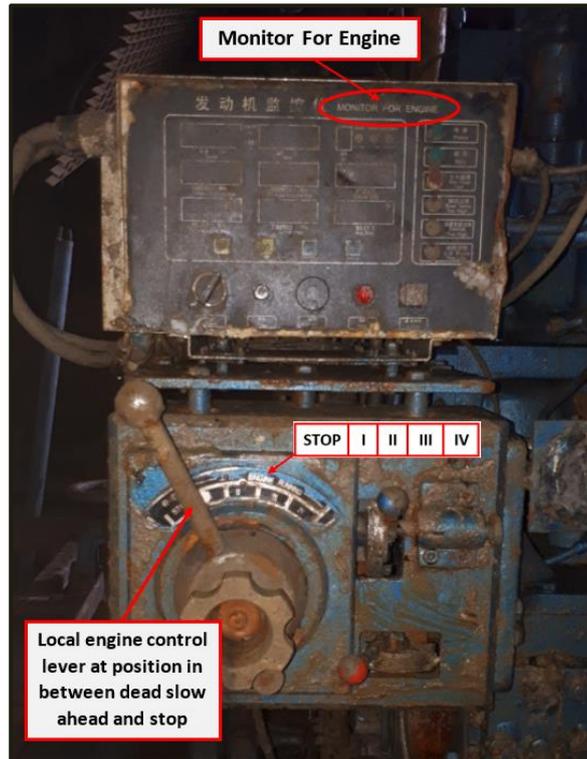
- 1.4.4.4 According to CO2, he slowed the engine telegraph to “minimum” ahead prior to the collision.
- 1.4.4.5 The physical inspection of the wreck showed that JDR 19’s local engine lever at a position⁶³ between Dead Slow Ahead and Stop (see **Figure 18**).

⁶³ CO 2 had confirmed that he had reduced JDR 19’s engine speed about 2 minutes prior to the collision.

Figure 18 – Engine local control lever at position between Dead Slow Ahead and Stop, photo taken in the engine room after vessel was salvaged
