Final Report

COLLISION

**TANKER SHUN SHENG
AND
BARGE KOI 5 (TOWED BY TUG KOI 3)**

MIB/MAI/CAS.060

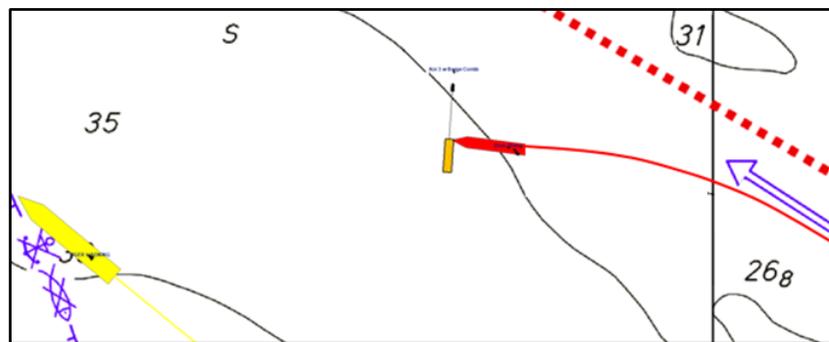
- 1.1.21 At a time recorded as 0454H, SS' bow collided⁴⁷ into the starboard forward section of Koi 5 (see **figure 14** showing the approximate angle of impact between SS and Koi 5).

Figure 14 - The approximate angle of impact between SS and Koi 5 (not to scale)

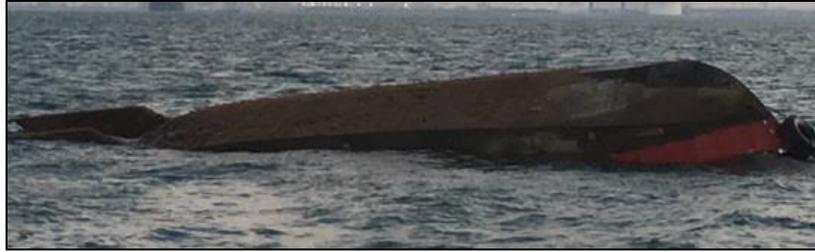
Figure 15 – Image of Koi 3 in capsized position taken in daylight hours
(Source: MPA)

- 2.7.2 Post salvage, the investigation team noted that tug's windows and other openings to machinery spaces were found open and doors were latched in open position. It is likely that when the girting of the tug took place, sea water started to enter these openings and caused a rapid flooding of the spaces, causing the tug to sink almost instantly, giving very little reaction time to the crew who became trapped inside. It is extremely important that the water-tight integrity of vessels is not compromised at any time, as situations can change drastically.

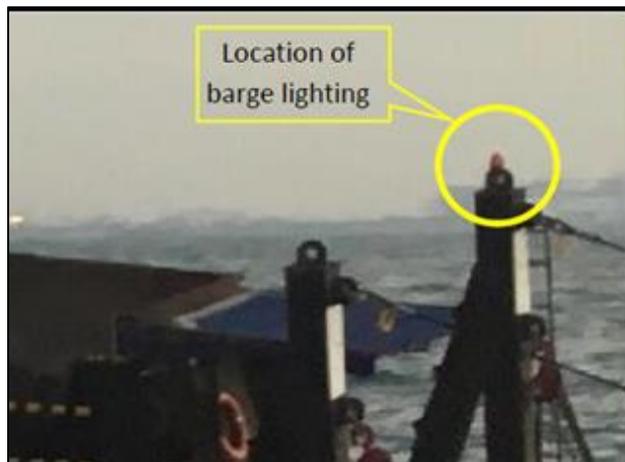
Figure 17 - Close-up view of Koi 5's forward section showing the "Red Light"
(Source: MPA)

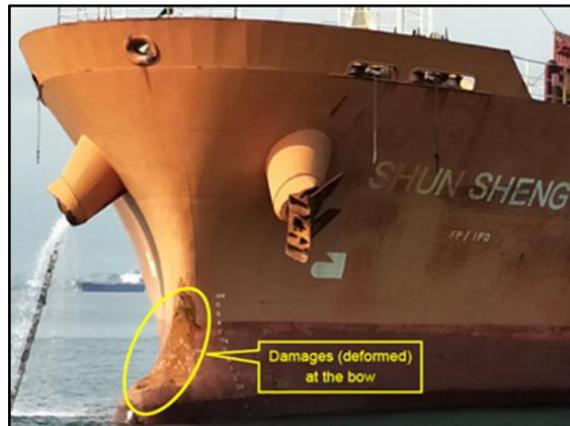
- 1.1.49 Immediately after the collision, the Master came to the bridge and was informed by the CO that SS had collided with something. The bridge team and the Master were unaware of the consequence to the tug at this time⁶⁵. The Master noted that the main engine was '*Stopped*' and the helm, which was at '*Hard to Port*', was being turned back to '*Midship*'.
- 1.1.50 The Master sent the deck crew to the bow to carry out a damage assessment (visual and sounding of tanks) on SS. The deck crew reported that no apparent damage was noted, and the Master instructed the CO to call VTIS West to report the occurrence, who then advised SS to stand-by for further instructions.
- 1.1.51 SS did not sustain material damage from the collision, except for deformation at the bulbous bow (see **figure 25**), and remained fit to continue its passage,

Figure 25 – SS' condition with damaged bow (*Source: TSIB*)

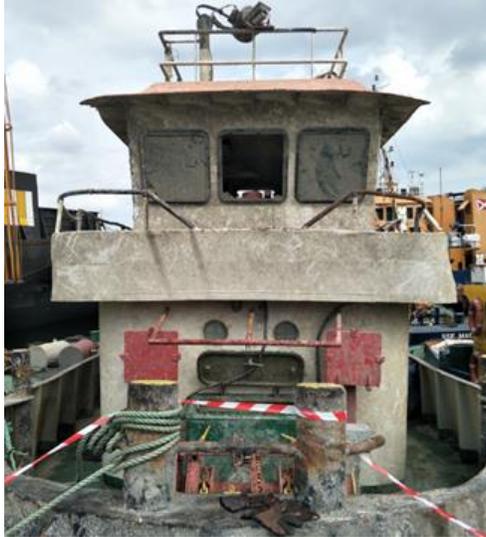
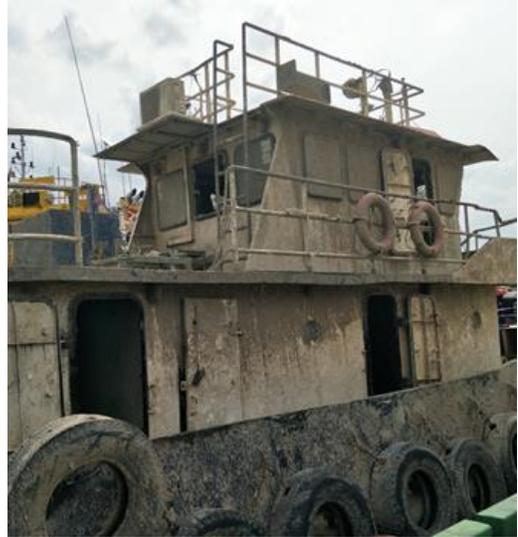
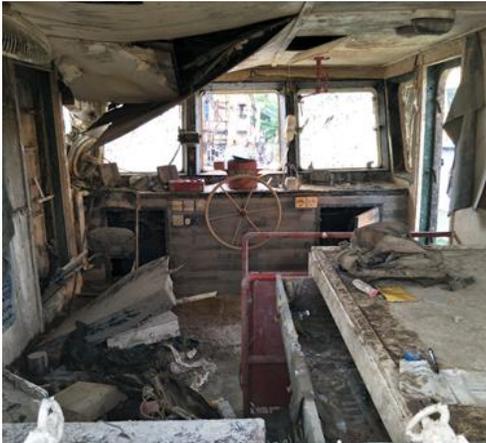
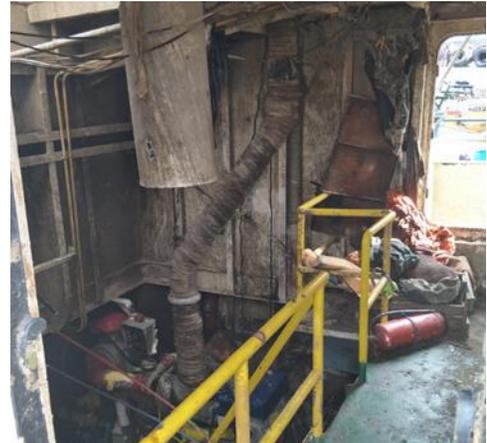
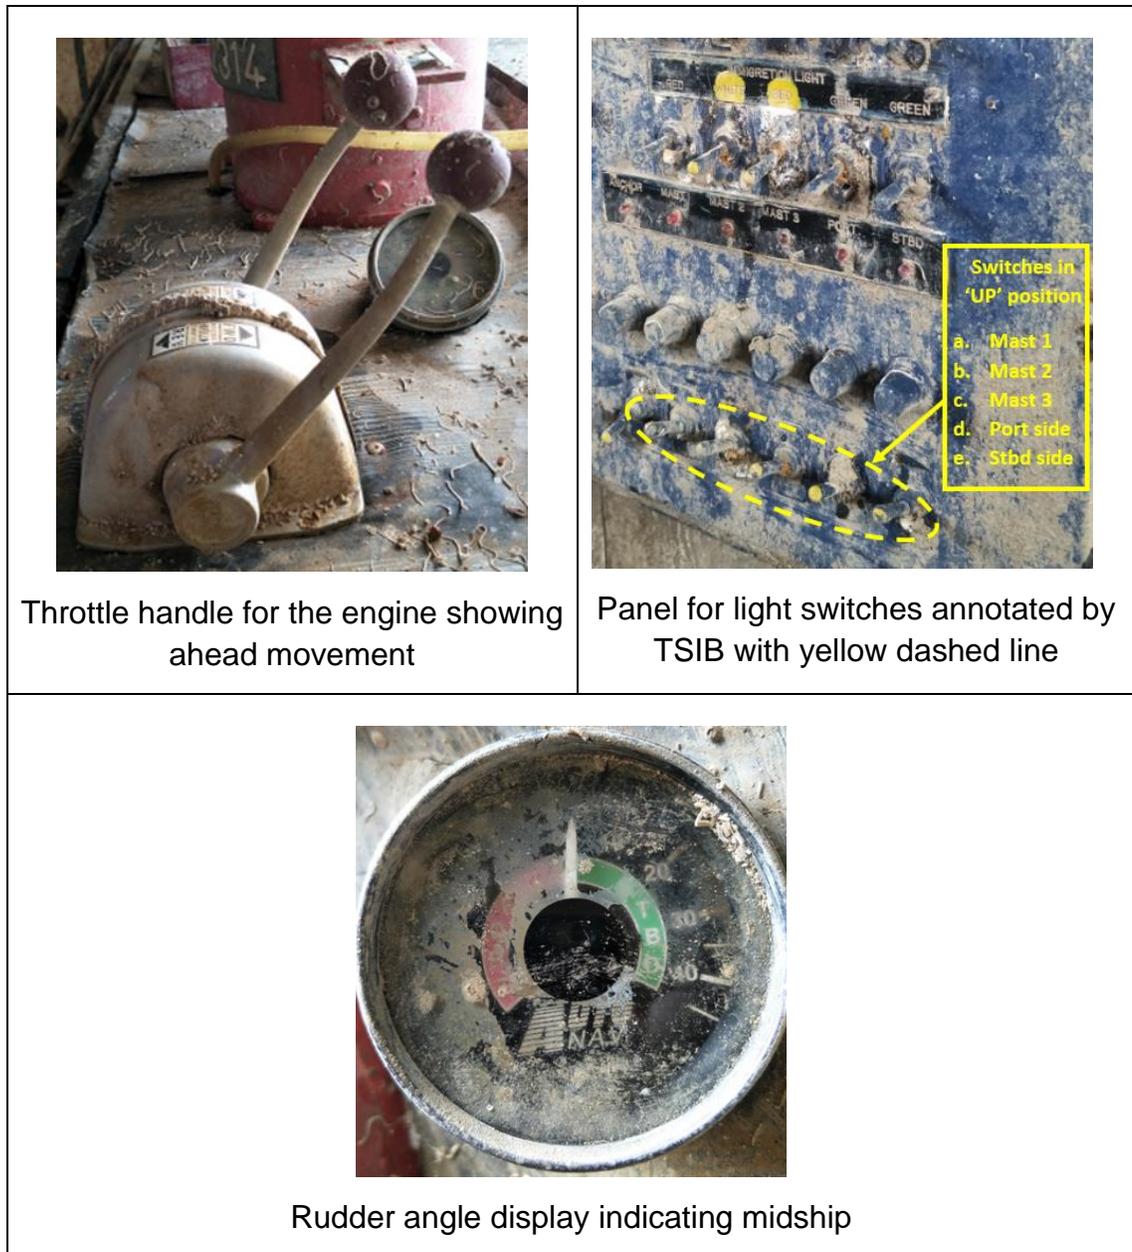
Figure 26 – Relevant photographs of Koi 3 taken after being salvaged
(Source: TSIB)

1.2.2 A summary of the key observations showing Koi 3's condition and some of the equipment⁶⁶ on board (see **figure 26**):

- I. No structural or significant damages to the hull;
- II. Doors and ventilator flaps of the accommodation, machinery spaces and steering gear compartment were secured in open position;
- III. Navigational lights arrangement indicated the tug was fitted with sidelights and stern light. The mast for masthead light was broken, likely as a result of the sinking and hitting the seabed;
- IV. Light switches (annotated with yellow marking by TSIB) on the panel

- V. A search light was fitted on top of the bridge and was capable of being operated from the conning position; and
- VI. The engine throttle handle at the wheelhouse was at "Ahead" position.

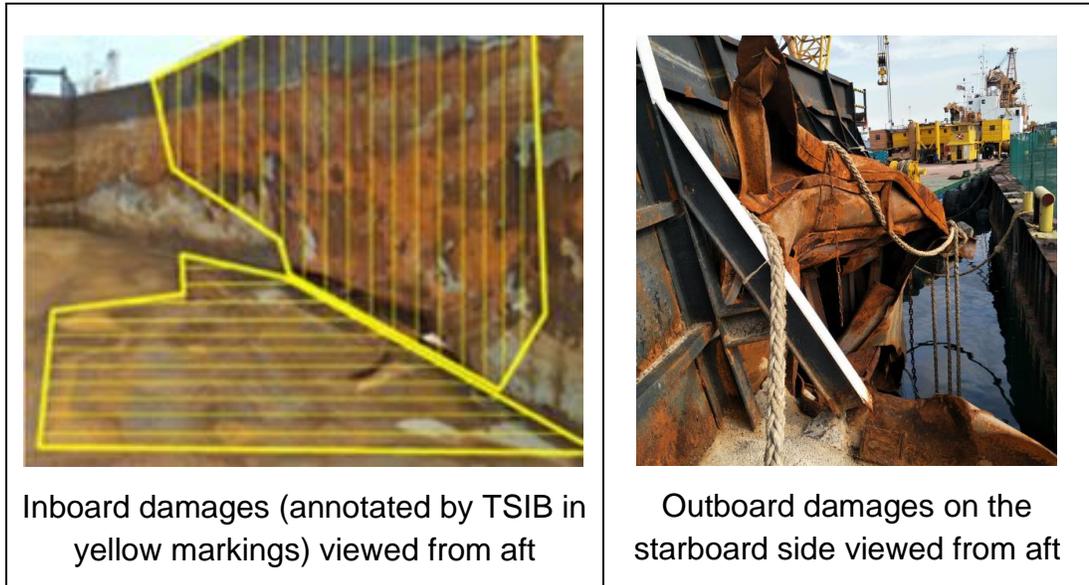
- III. The hull section on the forward starboard side was breached inwards, above and below the water line; and
- IV. There was a small red light fitted at the forward post of the ramp structure. There were no other light⁶⁷ fittings found on the barge.

Figure 27 – Showing damages sustained by Koi 5 (*Source: TSIB*)

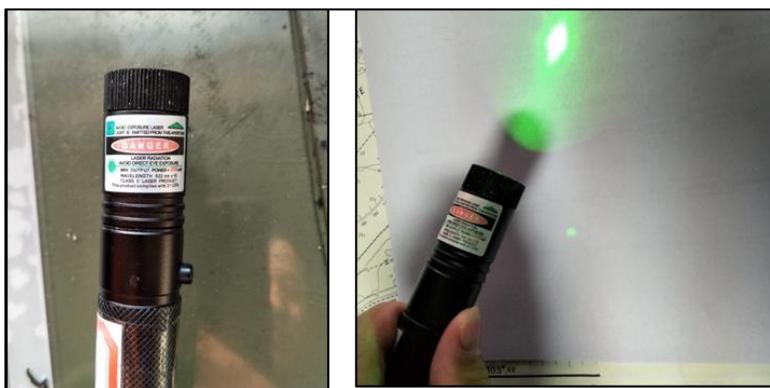
Figure 29 - Laser light used by the bridge team for capturing attention of other ships (*Source: TSIB*)

2.6.1 The investigation team further noted with concern the dangerous practice (see paragraph 1.5.6 and footnote 75) of the SS' bridge team using the green laser beam to scan the horizon and search for the barge.
