Final Report

EUROCOPTER EC135P2, REGISTRATION PK-RJH RUNWAY INCURSION, SELETAR AIRPORT

24 FEBRUARY 2022

TIB/AAI/CAS.203

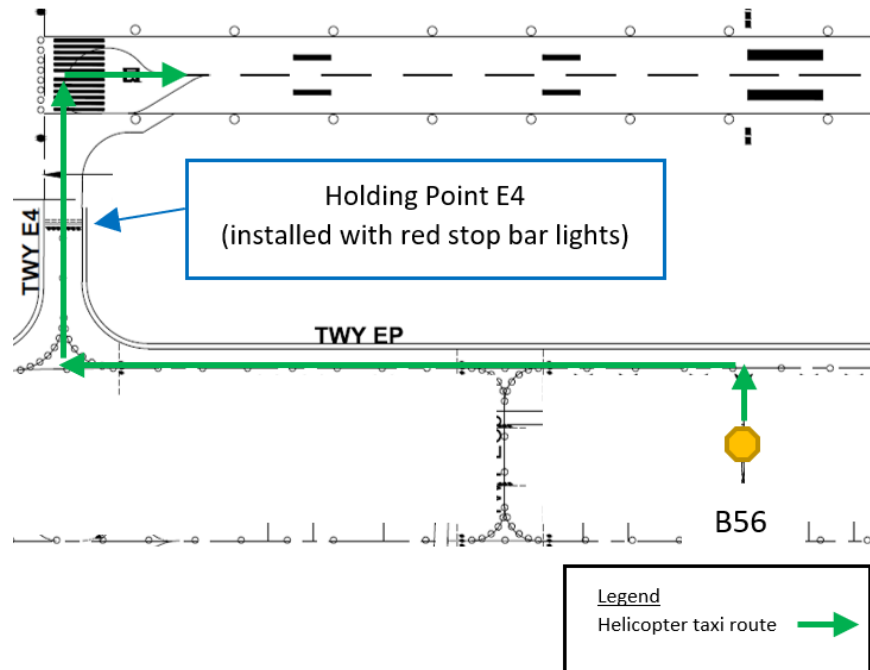
Figure 1: Helicopter air-taxi route

1.1.4 The PIC air-taxied the helicopter from parking bay B56 to Holding Point E4 along Taxiway Echo Papa (EP). However, instead of holding at E4, the PIC continued air-taxiing onto Runway 03, lined up with the runway, and waited for take-off clearance (see **Figure 1**). According to the PIC, before entering Runway 03 he had checked that there was no other aircraft on approach or on the runway.

- 1.1.5 During the post-incident interview by the investigation team, the PIC could not recall seeing, during his taxi, any red stop bar lights, which were switched ON at the time of the incident.
- 1.1.6 The GMC OJT, the OJT instructor and the Runway Controller (RWC) noticed the helicopter had entered the runway without clearance. The RWC asked the GMC OJT to instruct the PIC to contact him (the RWC)¹ over the tower frequency. The GMC OJT did as requested. The PIC contacted the RWC who then informed the PIC that no clearance had been given to enter the runway. The PIC apologised for the mistake.
- 1.1.7 The RWC subsequently issued take-off clearance to the PIC and the helicopter continued its flight without further event.
- 1.2 Injuries to persons
 - 1.2.1 There was no injury.
