FINAL REPORT

FATAL INJURY ON BOARD SG VICTORY IN HULHUMALE, MALDIVES ON 17 MAY 2016

MIB/MAI/CAS.001

**Transport Safety Investigation Bureau
Ministry of Transport
Singapore**

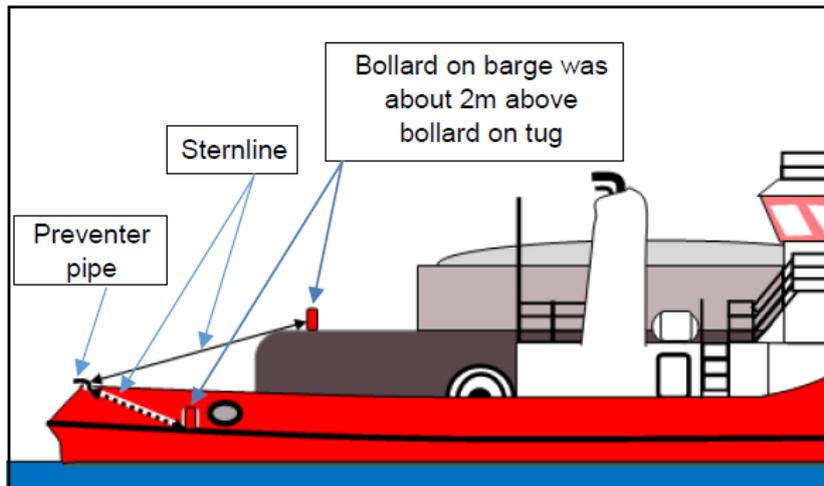
Fig. 3 – Stern line passed via open ended pipe

- 1.1.9 In this occurrence, the head line was passed underneath the forward towing bracket, as in a typical arrangement. The stern line, however, was passed via underside of side guard preventer pipe⁵ located at the port side of the side guard opening (see Fig. 3 and 4). The crew carried out the mooring operations under the guidance of the Chief Officer. It was revealed that the operations were as per past practices.

2.1.1 The occurrence was the result of incorrect and inappropriate lead being used for the stern line by shipboard personnel, i.e. led via the side guard preventer pipe instead of the closed fairlead to secure the barge to the tug.

2.1.2 The preventer pipe was never designed to be used and should never be used as a fairlead. The Chief Officer, and for that matter the Master and all other crew members, ought to have known this, as appropriate use of fairleads constitutes basic seamanship. It had been fortunate that nothing untoward happened when this same practice had been used on earlier occasions, but not this time. The Chief Officer being an experienced officer like the Master, was expected to have sufficient knowledge to realise the danger of using equipment not designed for its intended purpose. This was considered as the primary causal factor¹⁵ to the accident.

- 5.1 To the tug company - To ensure that equipment onboard are used as designed and unsafe acts onboard are reported to the company. The company should take appropriate steps to ensure that the side guard preventer pipe is not used as a fairlead for towing and subsequent beaching operations. The purpose of the preventer pipe should be clearly marked onboard their fleet of tugs. **[TSIB-RM-2017-001]**

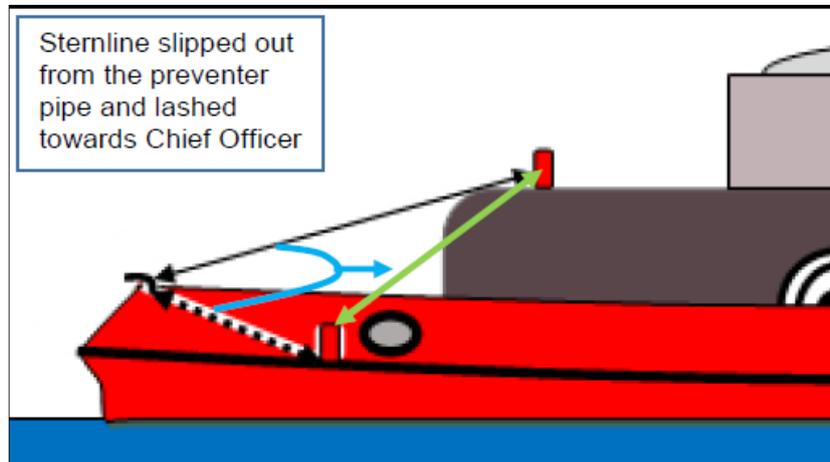
1.1.12 During one of these movements, the stern line slipped out from the side guard preventer pipe (see Fig. 5 and 6), sprang forward and reportedly hit the Chief Officer⁶ at the base of his head as he was walking on the open deck of the tug towards the tug's accommodation.

Fig. 5 – Stern line slipped out from the preventer pipe

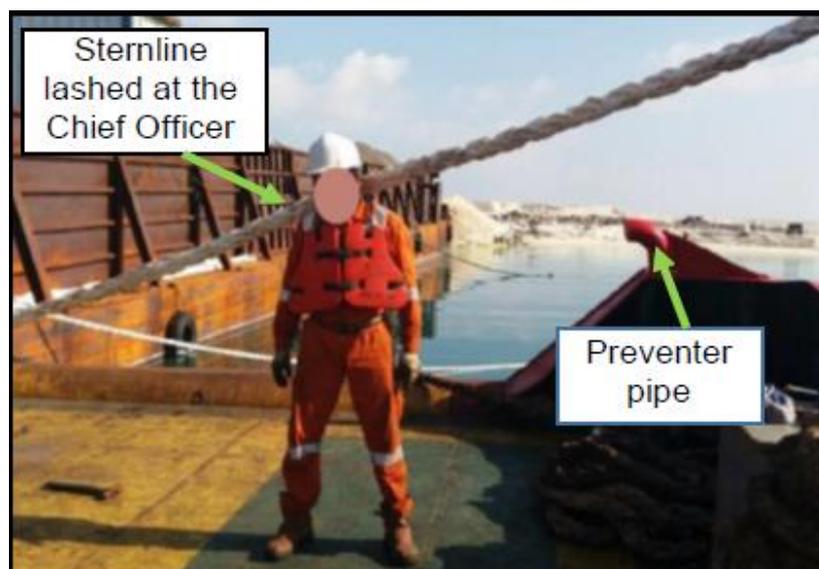
Fig. 6 – Stern line slipped out from the preventer pipe

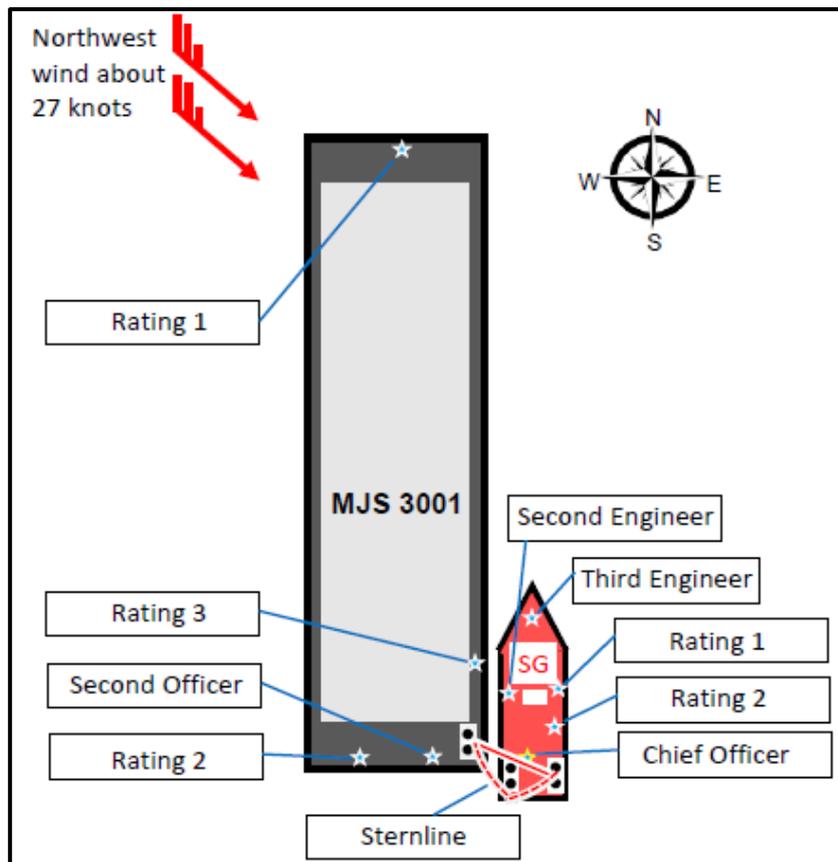
Fig. 7 – Position of officers and crew on board

1.4.4 The dotted red line represents how the stern line was initially moored and the solid red line represents the stern line's position at the time of the accident.
