Final Report

FATAL INCIDENT OF THIRD ENGINEER ON BOARD YUAN SUI HAI AT SEA 25 SEPTEMBER 2020

TIB/MAI/CAS.092

**Transport Safety Investigation Bureau
Ministry of Transport
Singapore**

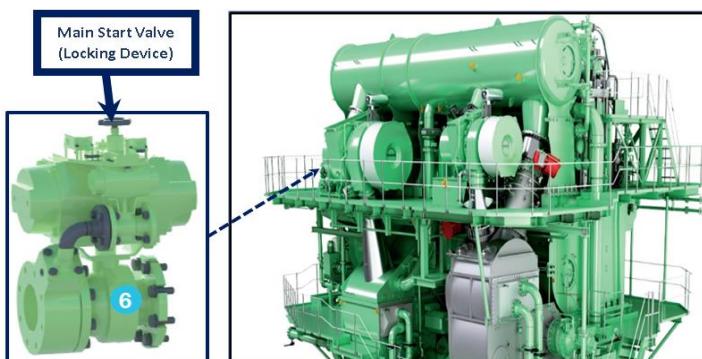
Figure 2: The main start air valve and its locking device, located at the starboard aft of the main engine (middle level) indicated by the dotted blue arrow. (annotated by TSIB)

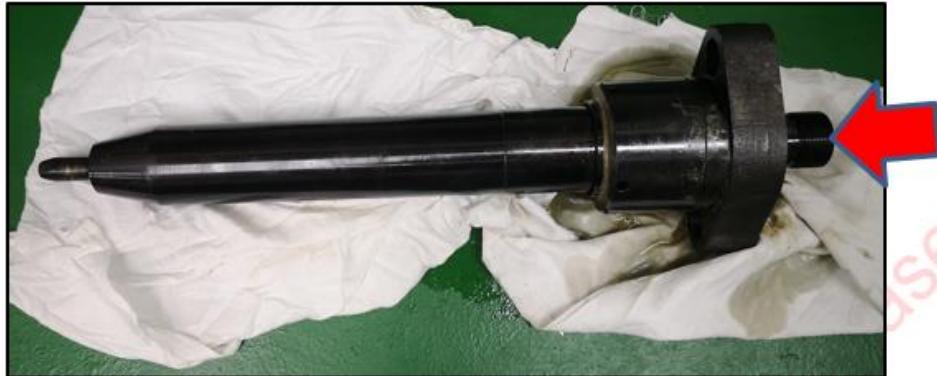
- 1.1.13 The CE rushed over to the 3E and held his head in his arms and noted that the 3E's face was badly injured near the right temple (above the ear and to the right of the eye) and was bleeding profusely with faint breathing. The FOIV from the no.4 cylinder was by the side²¹ of the 3E. The CE assessed that the head of the FOIV (marked in red arrow in **figure 3**) had likely hit the 3E on the face.

Figure 3: The FOIV from the no.4 cylinder of the main engine.
(annotated by TSIB) Source: Engine crew of YSH.

- 3.1 The securing nuts for the FOIV to the engine cylinder cover were found removed after the 3E was hit by the expelled FOIV from the cylinder cover, while the engine RPM was in the process of being reduced but had not reached zero.

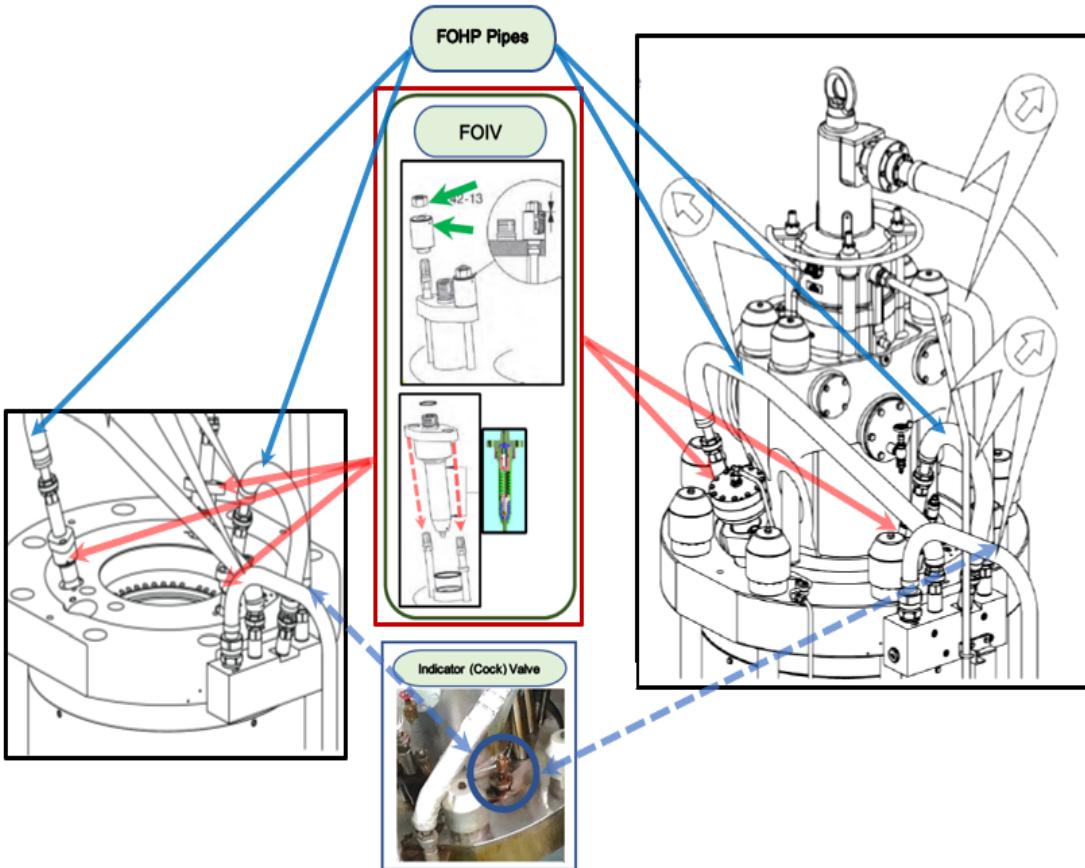
Figure 4: The cylinder cover with the FOIVs, FOHPs and indicator (cock) valve (blue-circled). For the FOIV, the green arrows show the components (spring housing and nut) of the securing arrangements and the dotted red arrows indicate the direction in which the FOIV is fitted to the cylinder cover (annotated by TSIB)

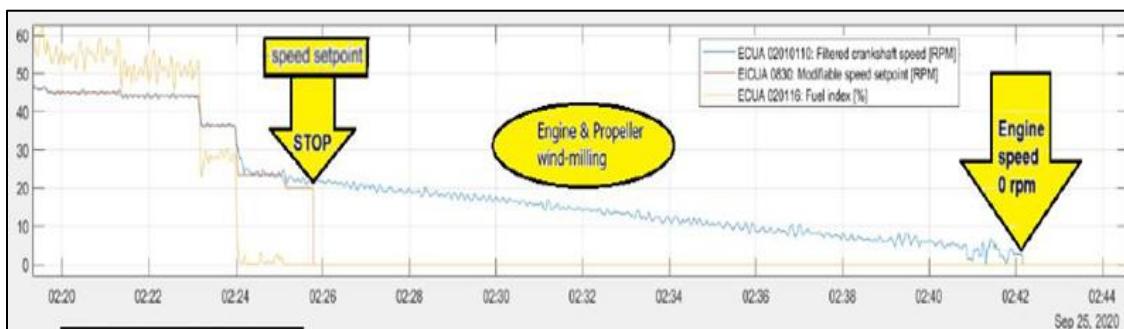
Figure 6b: Graphical representation of Line recorder extract showing speed setpoint stopped, engine & propeller wind-milling³⁷ until 0243H (i.e. when engine RPM comes down to Zero) - (Source: The ED)

- The ED further analysed (see figure 6c) that the pressure in no. 4 cylinder's combustion chamber at the time of the incident (at about 0227H), was estimated to be between 30 and 48 Bar.
- The extracted engine data also revealed that most of the required actions³⁸ of the listed safety precautions from the engine manual (specifically from the specific job card for the replacement of FOHP and FOIV) had not been followed (see **Figure 7**).

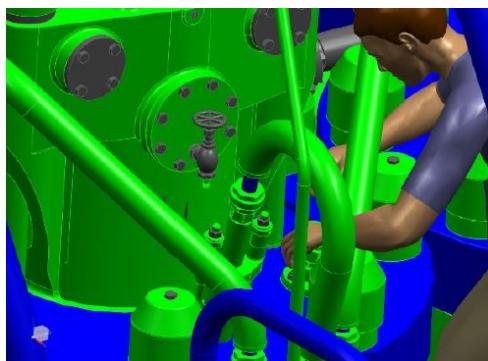
Figure 8: Visualisation of the 3E's probable position just prior to the accident – not to scale.

⁴² The 3E was standing on the pedestal which was below the right-side of the cylinder cover while working on the FOHP and FOIV that were on the left of 3E. This had likely resulted in the injury sustained only on the right of 3E’s face while he was looking and at the same time, loosening or removing the securing nuts before the FOIV expelled.
