# **FINAL REPORT**

## **FATAL INJURY ON BOARD GENERAL CARGO SHIP HAN ZHI AT THE PORT OF SOHAR ON 21 OCTOBER 2017**

**MIB/MAI/CAS.027**

**Transport Safety Investigation Bureau  
Ministry of Transport  
Singapore**

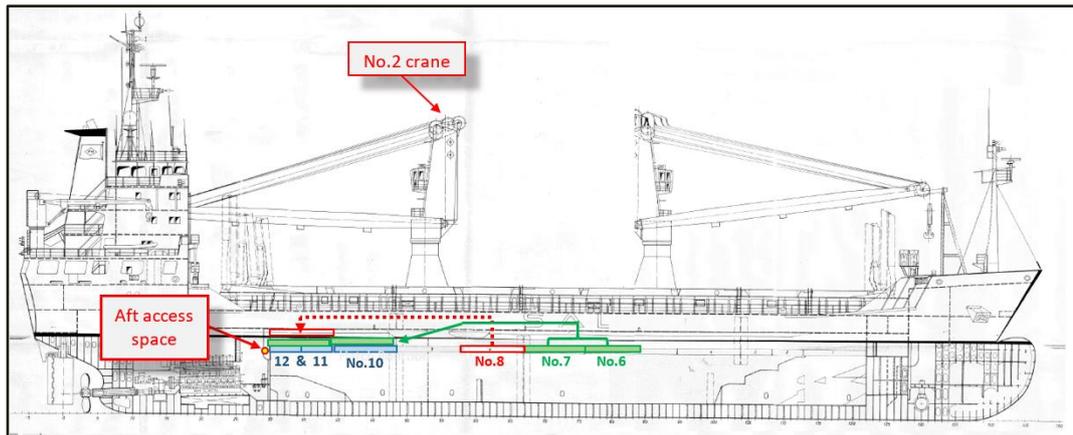
- 1.1.5 At about 0725H, when all the crew arrived at the tween deck, the Chief Officer who was supervising the shifting of the pontoons, briefed them on the shifting plan, i.e. no.6 and no.7 pontoons were to be shifted and stacked<sup>9</sup> as second tier onto no.10, 11 and 12 pontoons which were located at aft of the cargo hold. No.8 pontoon was to be placed as third tier on top of no.7 pontoon (see **Figure 1**).

Figure 1 - Relevant pontoons' locations and shifting plan. Arrows indicate movement of pontoons planned for stacking  
(Source: ISM Manager)

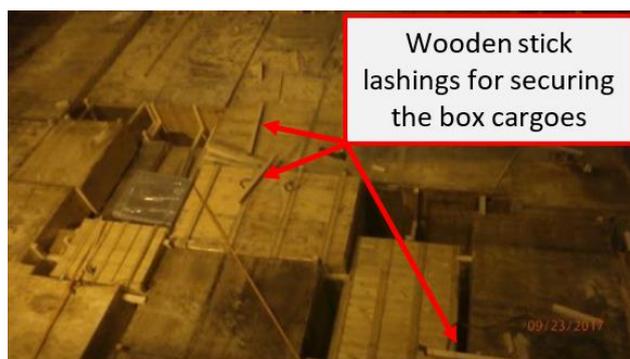
Figure 2 - View of wooden stick lashings  
(Photo source: the ISM Manager)

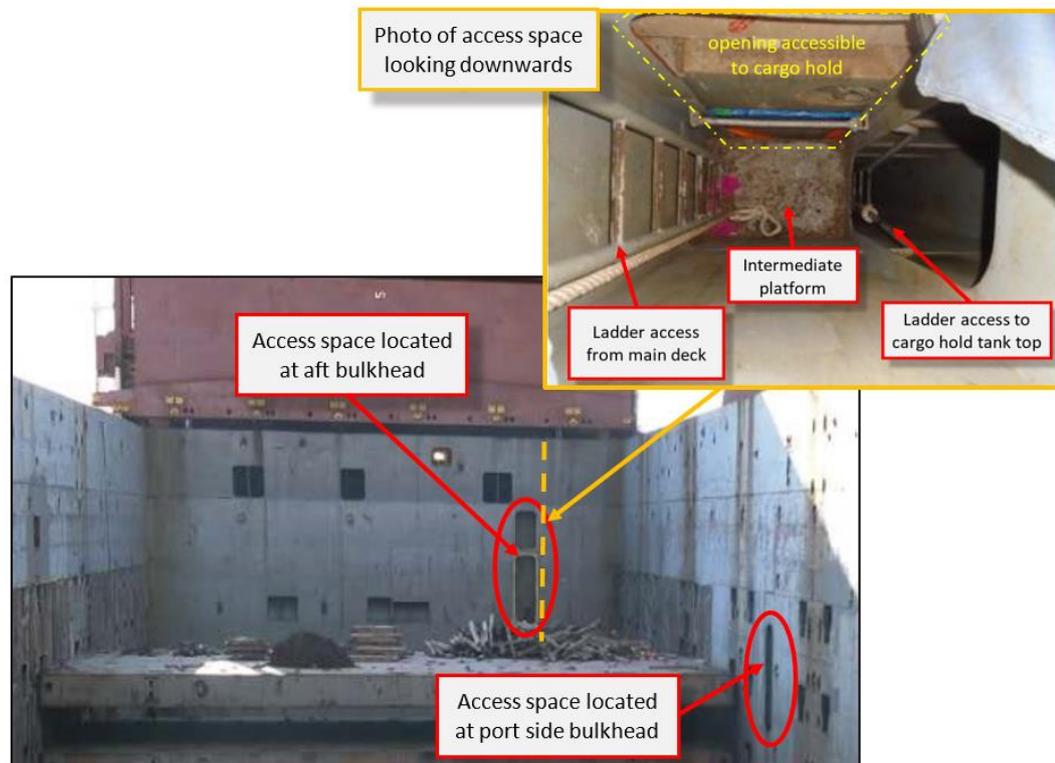
1.2.4 All crew members including the Chief Officer entered the cargo hold from the aft access space (see **Figure 4**). This was the same place where ASD2 and Bosun were positioned prior to the accident.

Figure 4 - Aft part cargo hold showing the two access spaces  
(Photo source: the ISM Manager)

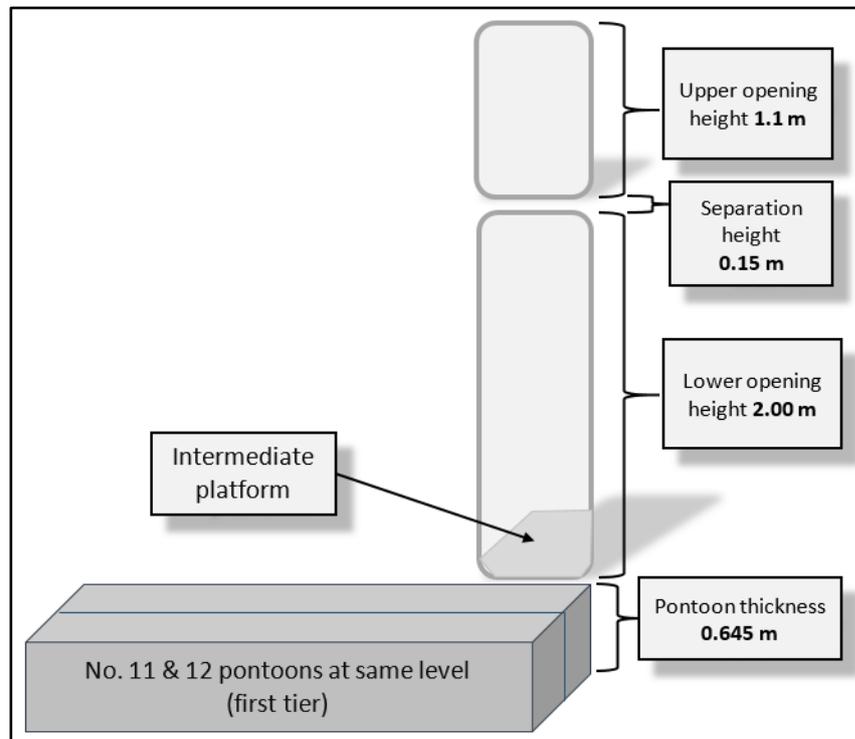
1.2.7 The aft access space consisted of two openings, for accessing the cargo hold, separated by 0.15m. The upper opening had a height of about 1.1m, and the lower opening had a height of about 2m (see **Figure 5**). Ship's crew could enter the cargo hold via the lower opening from the intermediate platform.

Figure 5 - Two openings at the aft access space, intermediate platform and first tier pontoons

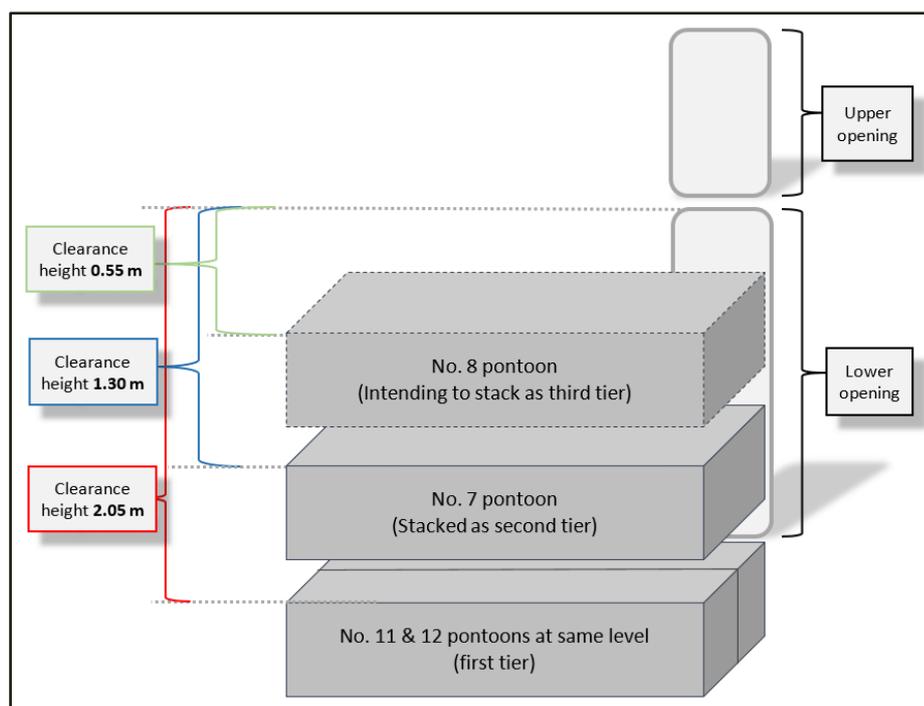
1.3.1 When the tween deck pontoons (in this case no.11 and no.12) were placed next to the aft access space, the top of the pontoons would be at about the same level as the bottom of the lower opening.

1.3.2 Based on measurements and calculations, after no.7 pontoon was placed onto no.11 and no.12 pontoons as the second tier, the remaining height clearance<sup>16</sup> between the top of no.7 pontoon and the top of the lower opening would be about 1.3m. This clearance would be further reduced to about 0.55m if no.8 pontoon was placed on top of no.7 pontoon as the third tier (see **Figure 6**). The upper opening (1.1m) remained unaffected after placing third tier pontoon.

Figure 6 - The clearance of the lower opening after three tiers of the pontoons stacked (*not to scale, for illustration purpose only*)

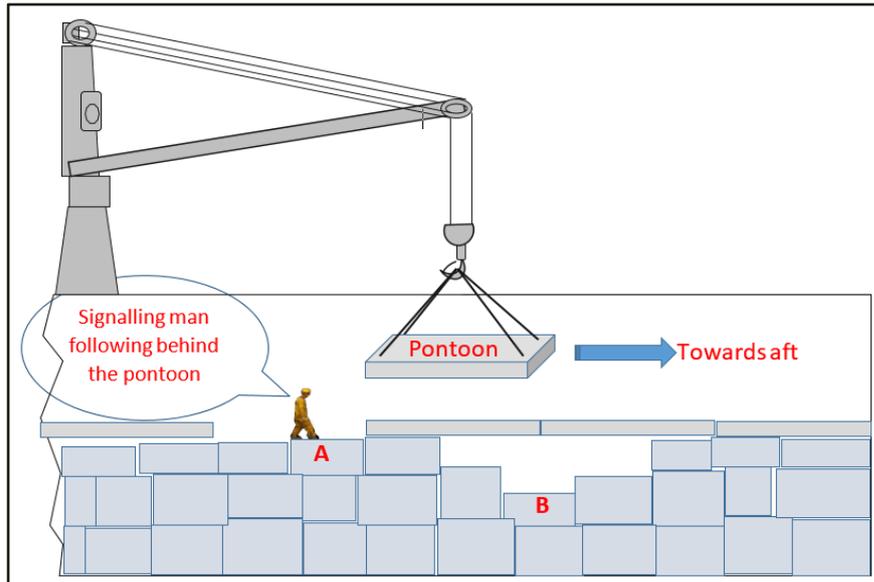
1.5.4 According to the practice on board the ship for shifting of pontoon the signalling man would typically follow the pontoon as it was moved, as long as there were other tween deck pontoons along the path or cargoes of similar level to ensure the crew's path was safe for walking (see position A in **Figure 7**). In cases where the cargo heights were significantly different (see position B) and difficult to walk through, for convenience, the signalling man would typically stand onto the pontoon being shifted. Alternatively, the signalling man could also be positioned on the main deck.

Figure 7 - Position of the signalling man inside cargo hold in relation to the pontoon moving direction (*not to scale, for illustration purpose*)
