FINAL REPORT

FATAL INJURY ON BOARD THE BULK AND CONTAINER CARRIER PAC ALKAID AT THE PORT OF HOUSTON ON 20 AUGUST 2017

MIB/MAI/CAS.022

**Transport Safety Investigation Bureau
Ministry of Transport
Singapore**

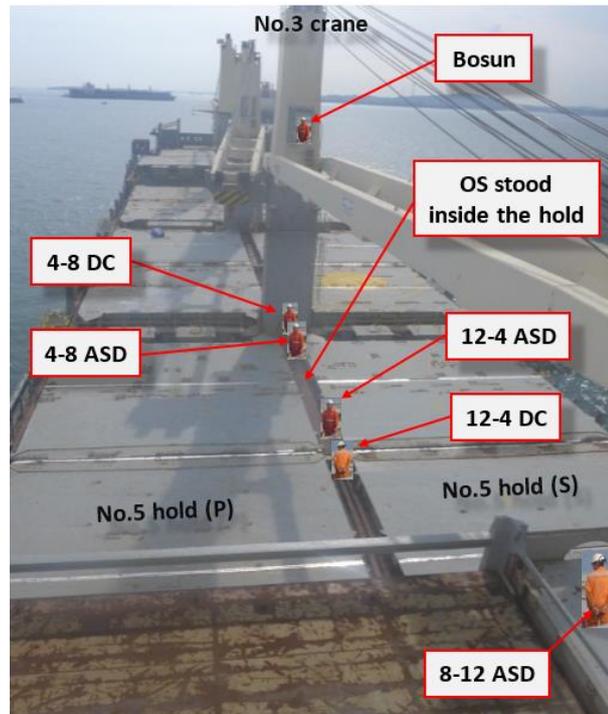
Figure 3 – Positions of persons at the time of accident, no.5 cargo hold hatch covers were in open status at the time (Not to scale - for illustration only)

- 2.4.5 The investigation team also noted that the four crew involved in cleaning of the fallen cargo at the hatch coaming centre beam, which was about 6m high from the cargo level in the no.5 cargo hold, were not wearing any fall prevention equipment. Although the width of the hatch coaming centre beam was about 1.78m wide, it would be desirable for the company to review the risk of falling from height when performing work at the hatch coaming centre beam.

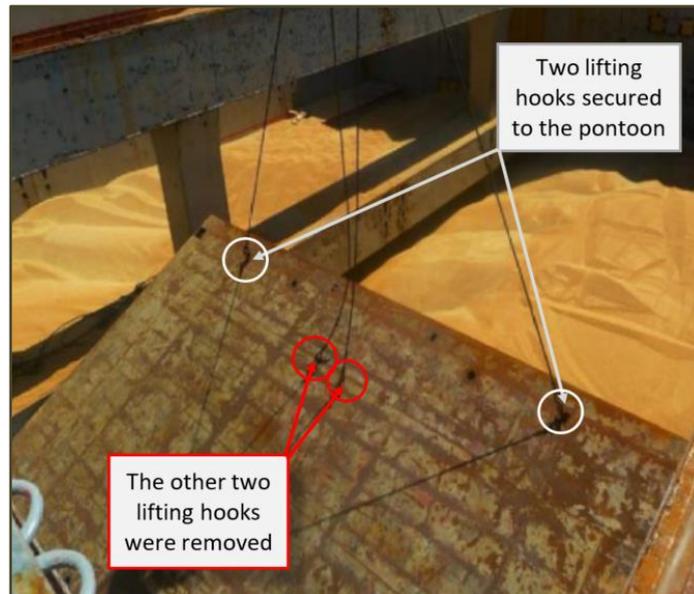
- 1.1.16 Once the lifting wire slings were slackened, the OS removed the two fore end lifting hooks, leaving only two aft lifting hooks secured onto the pontoon (see **Figure 4**). He then positioned himself on the upper tween deck centre beam. This activity was not known to the two Filipino crew members (12-4 ASD and 12-4 DC) who were at the hatch coaming centre beam (above the position of the OS) carrying out their task of cleaning the cargo with shovels.

Figure 4 – View of the lifting hooks arrangement at the time of accident
(Photo source: The ISM Manager)

- 1.1.18 At about 0100H, while the pontoon was being dragged between the ship's side bulkhead and centre beam structure for about 2m, one of the hooks broke while the other slipped out of its securing slot. The pontoon dropped on the grain cargo with a loud noise and the detached slings swung uncontrollably towards the 12-4 ASD who was shovelling at the time on the centre beam. The ASD instinctively grabbed hold of the swinging wires to avoid hitting him and followed the swinging motion. He was swung and thrown towards the starboard side bulkhead at the aft corner.

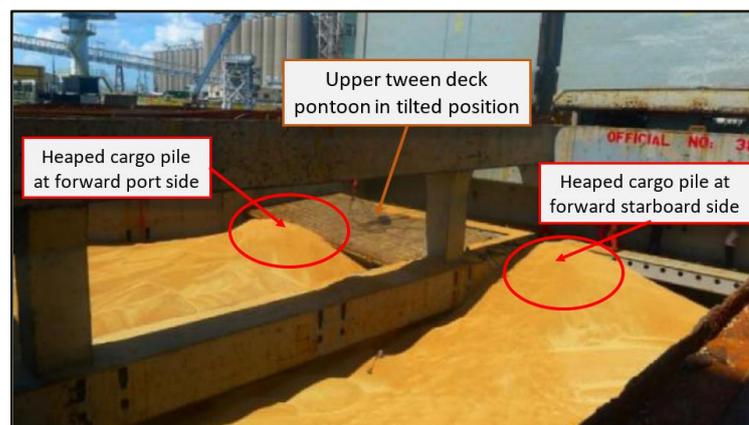
- 1.2.6 The width of the hatch coaming centre beam where the crew stood for cleaning the cargo was about 1.78m. The beam was not designed to have a fixed safety fencing. There was no temporary fencing as safety railing to prevent a fall into the cargo hold when the accident happened. The height between the cargo level and the hatch coaming centre beam was about 6m.
- 1.2.7 Alkaid was loaded with a total of 25,273 metric tonnes of grain cargo separated into four cargo holds (no.2, 3, 4 and 5) and 2,764 metric tonnes were distributed into the no.5 cargo hold which was planned as the last loading hold. On completion of loading in no.5 cargo hold, most of the cargo was levelled except for two piles at the forward end of both port and starboard compartments (see **Figure 9**).

Figure 9 – View of heaped cargo piles loaded in no.5 cargo hold
(Photo source: The ISM Manager)

- 3.1 On completion of loading, the pontoon could not be closed due to piled up cargo in no.5 cargo hold. This was because the reference for loading limit in this hold was not marked and there was inadequate monitoring of the final cargo loading operation which resulted in piling of the cargo. Tasks were not properly planned and prioritised.

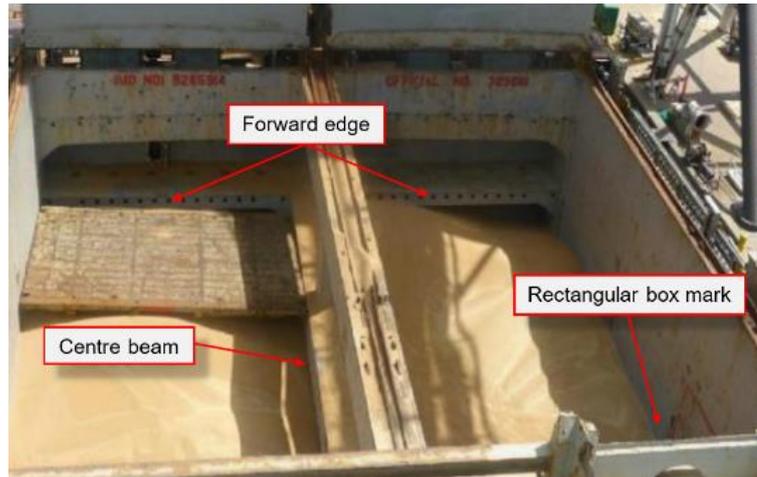
Figure 10 - Loading reference point for no.5 cargo hold in the Chief Officer's cargo loading written instructions
(Photo source: the ISM Manager)

1.4.3 The cargo loading instructions further required the officer of the watch to personally show the shore personnel the reference for loading limit. However, this was not carried out. There was no evidence to indicate that the ship's officers were not able to communicate with the shore personnel during the loading process. In the event trimming of cargo was needed, the Chief Officer would advise the shore personnel accordingly. The instructions also required the duty officers to inform the Chief Officer if they were in doubt or if the loading plan was altered.

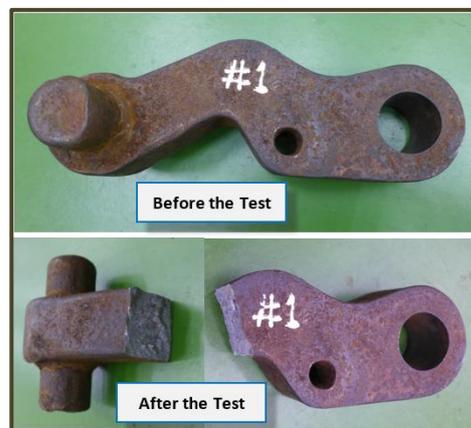
1.11.2 The test result revealed that the lifting hook broke at a load of 353.0kN which was equivalent to about 36 tonnes³⁸ (see **Figure 12**). Visually there appeared no other signs of material fatigue.

Figure 12 – The pontoon lifting hook (before and after the lab test)
