# **FINAL REPORT**

## **FATAL INJURY ON BOARD OCEAN GLORY EN-ROUTE FROM TAIWAN TO SINGAPORE ON 8 JANUARY 2017**

**MIB/MAI/CAS.008**

**Transport Safety Investigation Bureau  
Ministry of Transport  
Singapore**

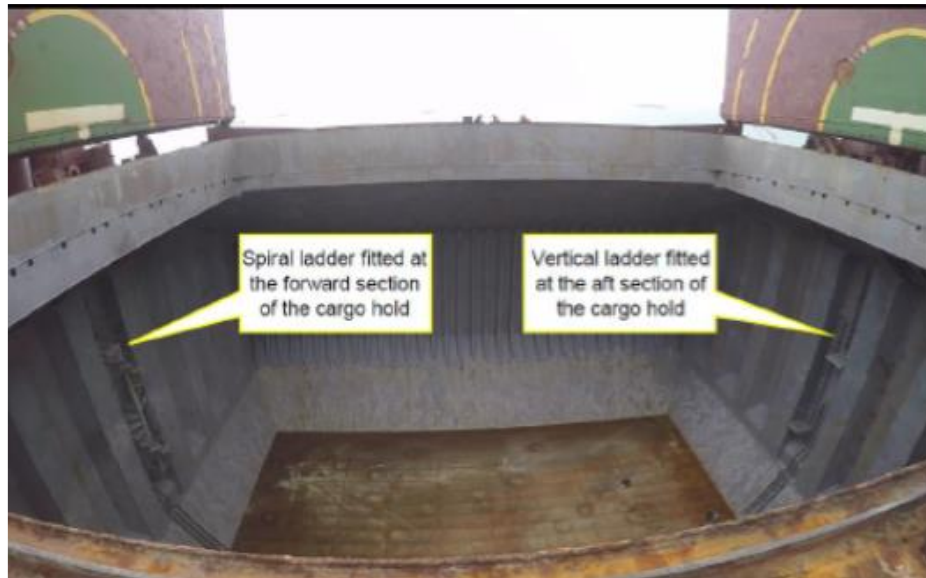
*Fig. 1 - Cargo hold No.3 viewed from vessel's portside*

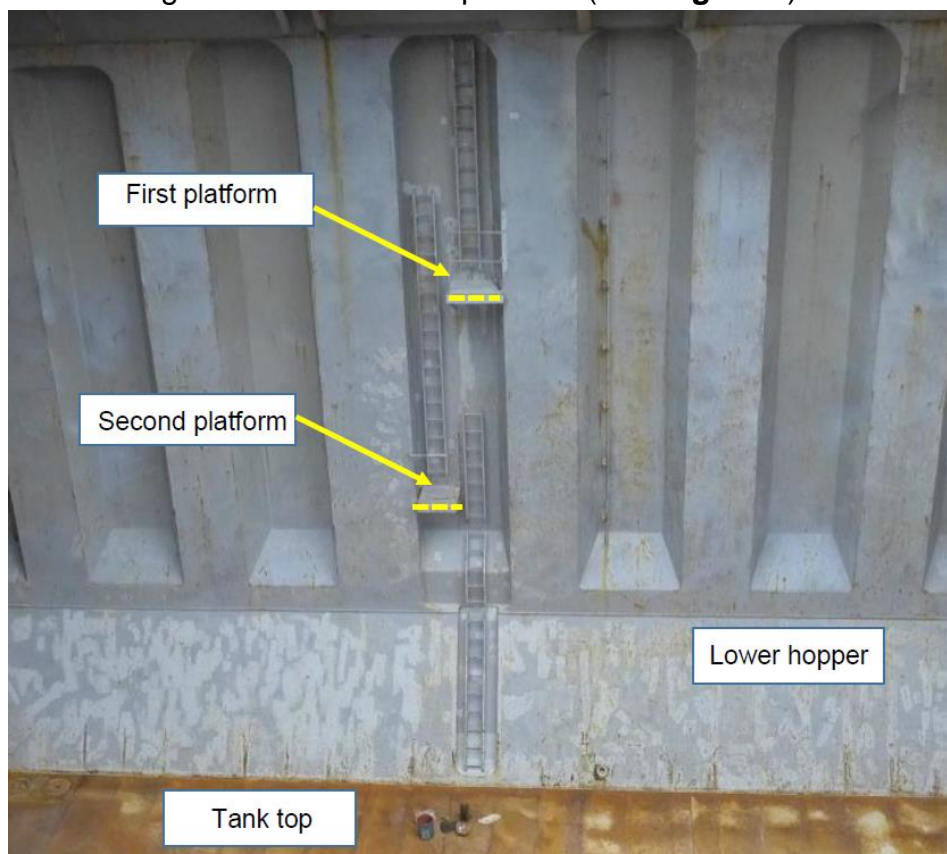
- 1.1.11 Cleaning Group 3 (AB3 and DC) began seawater wash of forward coaming and hatch covers of No.3 cargo hold from the main deck.
- 1.1.12 The Chief Officer was supervising the cleaning operation from the main deck, near the forward section of No.3 cargo hold. At about 0955H, the Chief Officer saw that AB2 had completed seawater wash of the upper aft section of the cargo hold from the first platform (See **Figure 2**).

*Fig.2 – First platform of No.3 cargo hold aft section*

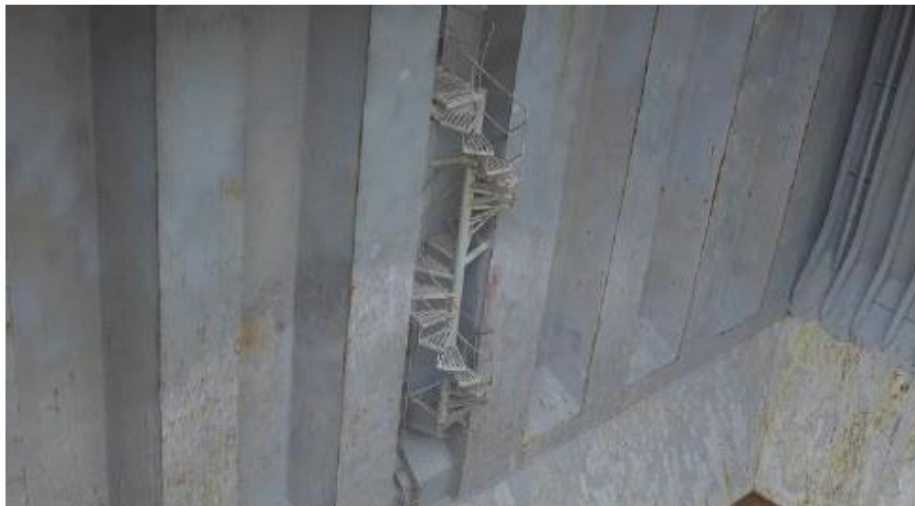
*Fig. 5 - The forward access provided by spiral ladder*

- 1.4.3 The aft vertical ladder has three sections, first platform, second platform and tank-top. The last section between the second platform and the tank top was inclined over the lower hopper. (See **Figure 2**)
- 1.4.4 The intermediate platforms of the vertical ladder were provided with guard rail<sup>18</sup> (railing) with a height of about 1.2 m, to prevent accidental fall into the

cargo hold. The ladder portion was for a typical cargo hold construction and did not have any cage or railings around.

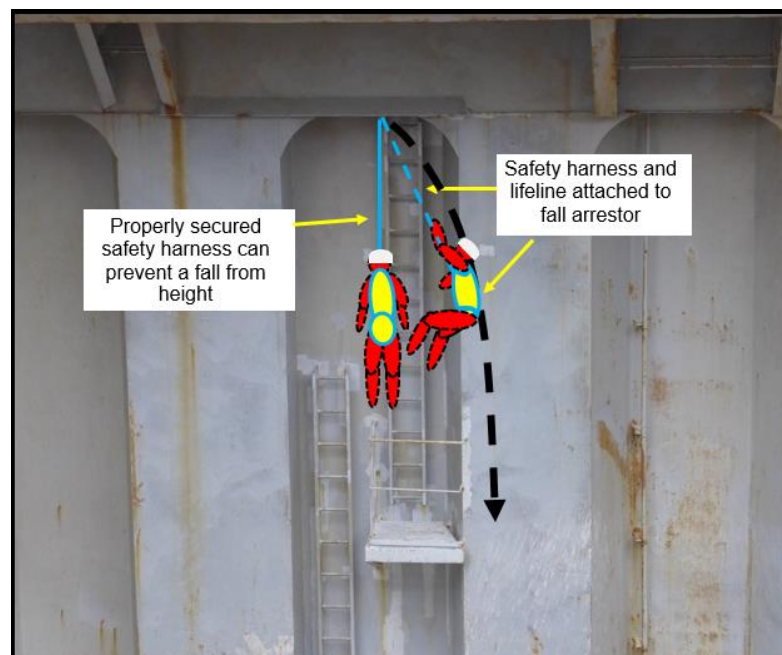
- 2.1.1 When AB2 had completed the seawater wash from the first platform, he proceeded to an unrestricted climb on the vertical ladder. For this, he had detached his safety harness lifeline from the securing point (railing) of the first platform.
- 2.1.2 AB2 most likely had lost his grip during his climb, thus resulting in his fall. The factors that caused him to lose his grip could include; wet and slippery ladder rungs, wet rubber gloves, tiredness as AB2 climbed the ladder after handling a fire hose with seawater for washing the hold, which could be a physically strenuous activity<sup>27</sup>.
- 2.1.3 Had AB2's harness been secured by way of a fall arresting device appropriately attached to the main deck, he would have been suspended with the device even if he lost his grip and thus would not have fallen into the hold.

*Fig. 8 – Illustration if a harness was secured to a strong point*
