Final Report

FATAL INJURY OF CREW AFTER FALLING FROM HEIGHT ONBOARD GLORY CHALLENGER AT SEA 2 MAY 2022

TIB/MAI/CAS.123

Transport Safety Investigation Bureau
Ministry of Transport
Singapore

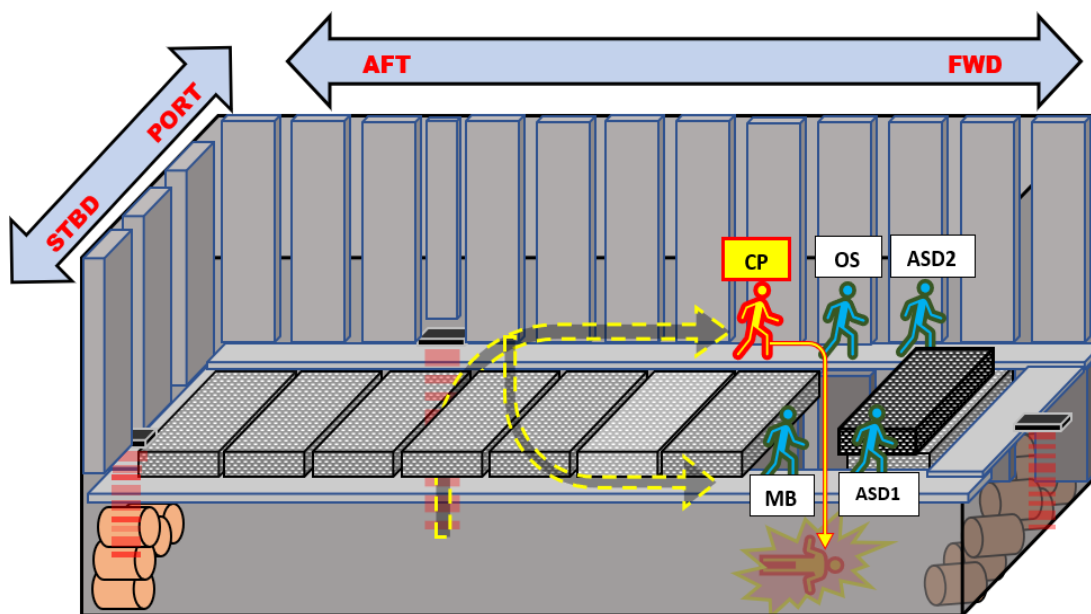
- 1.1.5 Three of them (ASD2, OS and CP) used the port side walkway, while the other two (ASD1 and MB) were on the starboard side walkway. When the crew were about to reach the stacked pontoons, a loud thud was heard. On looking around they saw that the CP had fallen inside the cargo hold and was lying on the tank top (see **figure 1**).

Figure 1: View of cargo hold no.2 from the starboard. The dark-shaded block shows the (second) pontoon that was stacked on the first pontoon. The dashed arrows show the route taken by each group towards the stacked pontoons. – *Illustration not to scale.*

- 2.1.4 The investigation team opined that the CP had likely walked near the edge and missed a step and fallen about 7.40m into the cargo hold. The fall was fatal after he fell into the lower hold.

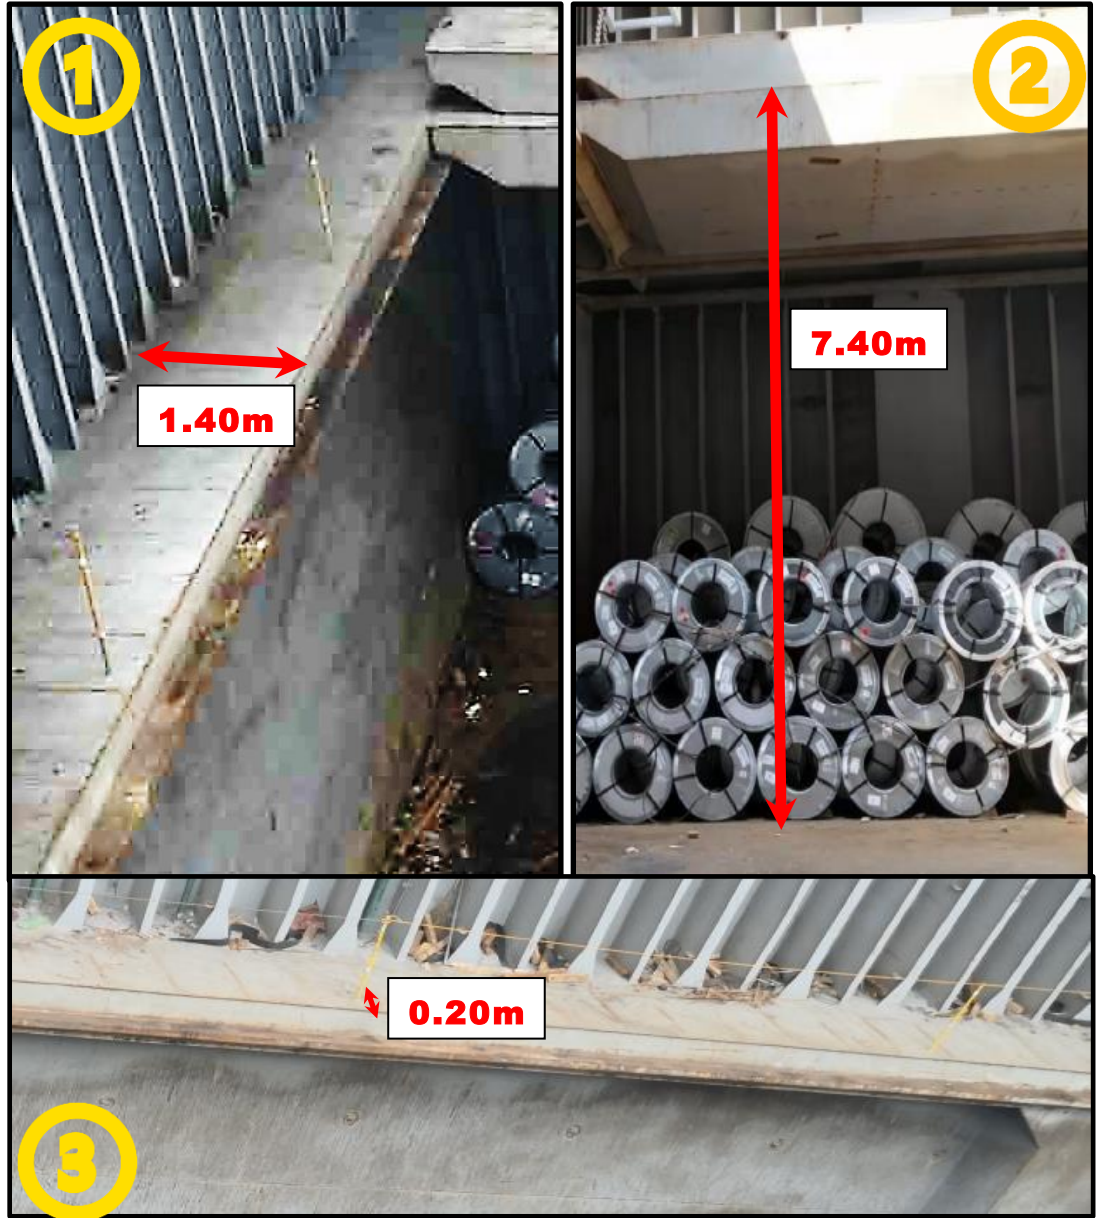
Figure 2: Cargo Hold No.2.

- 1.3.1 GC was constructed with a tween deck for each of the two cargo holds, separating each cargo hold into upper and lower decks. The tween deck for cargo hold no. 2 had nine steel pontoons of the lift-off type, each with the same length but of different widths. The first five pontoons were about 15.37m in length and width of 3.31m each while the other four pontoons were about 3.70m each.
- 1.3.2 The height from the tank top in the cargo hold to the tween deck pontoon (measuring from the upper surface¹⁸) was about 7.40m. The width of the port and starboard walkways from the bulkhead to the edge of the pontoons was about 1.40m. When the safety railing (yellow stanchions) is rigged, the distance between it and the edge of the pontoon is about 0.20m, leaving about 1.20m of walking space (see **figure 2**).

Picture-1 shows the approximate dimension of the portside walkway.
Picture-2 shows the approximate height from tank top to the tween deck.
Picture-3 shows the typical safety cordon comprising yellow-coloured stanchions with a single wire.

- 2.1.2 In spite of a noticeably wide walkway (1.40m), the risk of falling from height into the lower cargo hold exists, each time the pontoon(s) is removed from the tween deck. Established risk mitigation, which was the rigging of the safety railings when a part of the tween deck was left open, was not carried out on the day of the occurrence.

- 4.2 The SMS also included a new instruction with regards to the requirements to cordon any opening of the pontoon(s) on the tween deck with the stanchions and wire-cable, to prevent person(s) from walking too close to the opening, aside from the existing requirement only for cargo work.

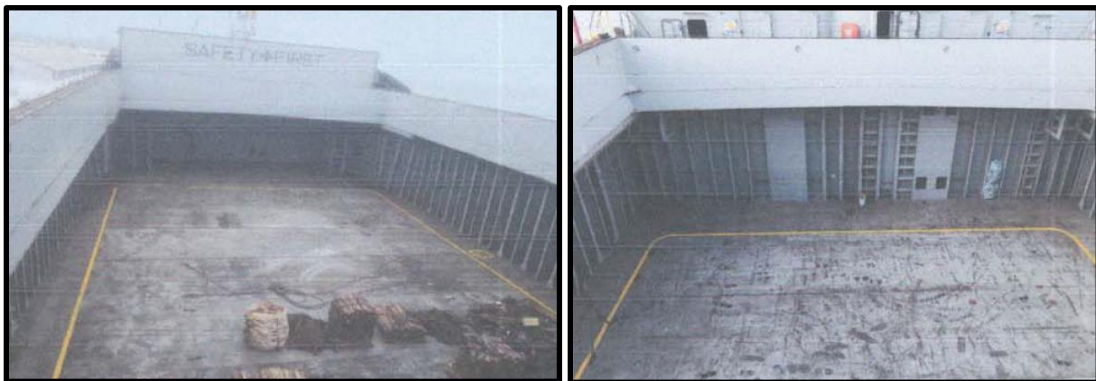
Figure 4: Painted markings on the perimeter of the tween deck pontoon edges.

- 4.3 The Company promulgated to the fleet of the new requirement to paint the surrounding perimeter of the tween deck (pontoon) openings with yellow paint, for visibility to person(s) walking near the edge (see **figure 4**).
