FATALITY OF CREW AFTER FALLING OVERBOARD FROM EPIC BORACAY IN SOUTH ATLANTIC OCEAN, OFF BRAZIL 10 JUNE 2021

TIB/MAI/CAS.113

Transport Safety Investigation Bureau
Ministry of Transport
Singapore

5 April 2022

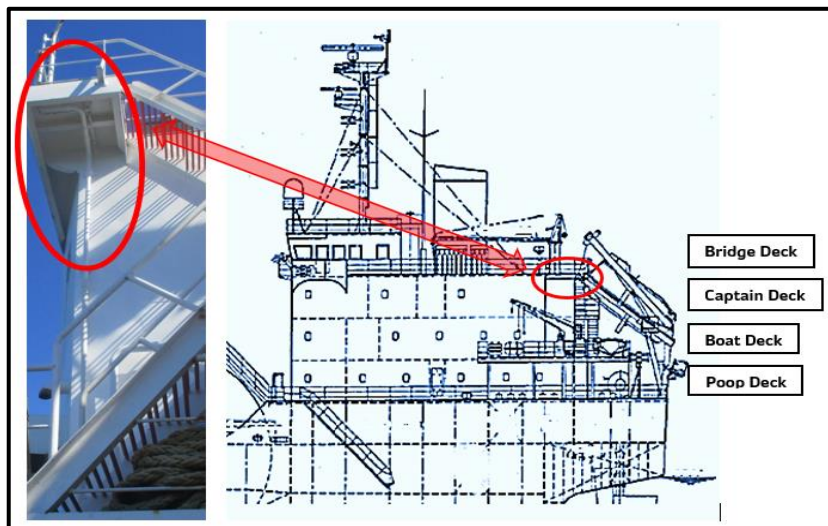
Figure 1: General Arrangement of EB indicating the deck layout and the external stairway landing which the ASD-3 was assigned to paint (circled in red) – not to scale. (annotated by TSIB)

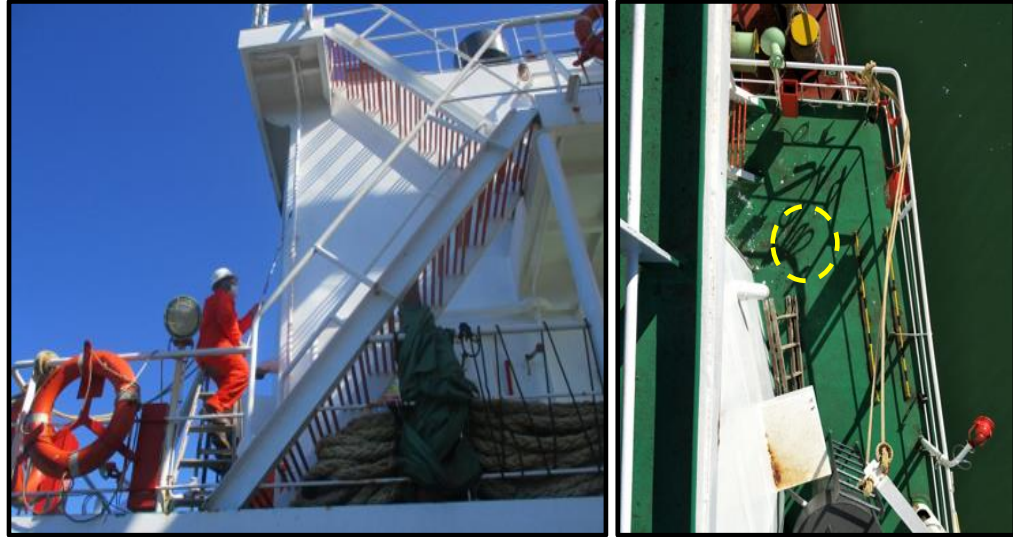
- 1.1.6 At About 0925H, while the ASD-1 was in the midst of the painting job, he recalled seeing the ASD-3 coming up from the poop-deck via the starboard side, carrying a portable A-frame ladder and going to the port side. The ASD-1 did not query the ASD-3 but when he turned his attention towards the port side, he saw the ASD-3 sitting on top of the ladder and painting the stairway landing (see **figure 3**).

Figure 3: (Left image) Enactment of ASD-3's position when seen from the stern. (Right image) – Plan view from the Bridge wing, of the approximate position (yellow-dotted circle) of the ladder.

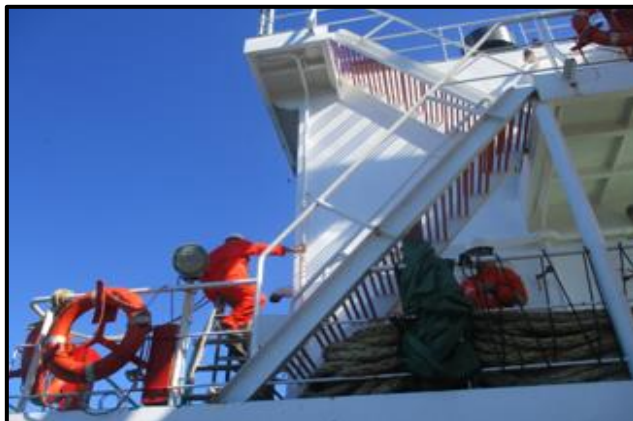
Figure 4a: Enactment of ASD-3's position at the time of the first roll.

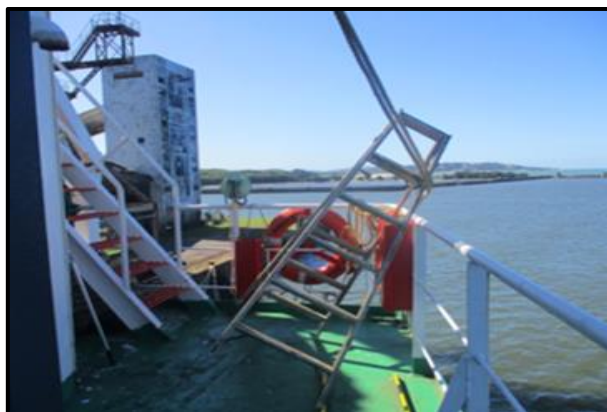
- 1.1.7 At about 0926H, according to the passage plan, the 3O commenced a starboard alteration of EB's heading to about 187°(T) using the auto-pilot. While turning, EB began rolling with the swell (see section 1.6).
- 1.1.8 Around the same time, the ASD-1 recalled seeing the ladder tilt towards the sea with the ASD-3 holding on to the drainpipe under the stairway landing, with one hand (see **figure 4a**) to balance the ladder and himself. In quick succession, as a result of a successive roll, the ladder tilted again and this time, both the ASD-3 and the ladder went overboard (see **figure 4b**).

Figure 4b: Approximate angle when the ladder tilted towards the sea – view from forward, towards the stern.

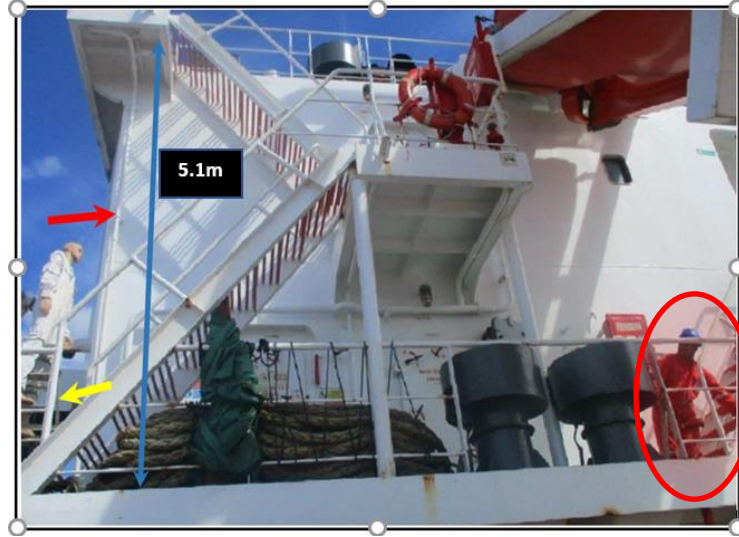
- 1.5.9 From the recount of ASD-1, the ladder was placed such that its legs (i.e. steps) were perpendicular to the fore-aft centreline of EB. **Figure 7** shows the positions of ASD-1 and ASD-3 and **figure 8** shows the height of the ladder when fully extended and the approximate distance of the ladder from the safety railings.

Figure 7: Viewed from the stern, depiction of the erected A-frame ladder's position (yellow arrow) on the portside of the boat-deck. Red arrow points to the drainage pipe. ASD-1's (circled in red) back was facing the ASD-3.

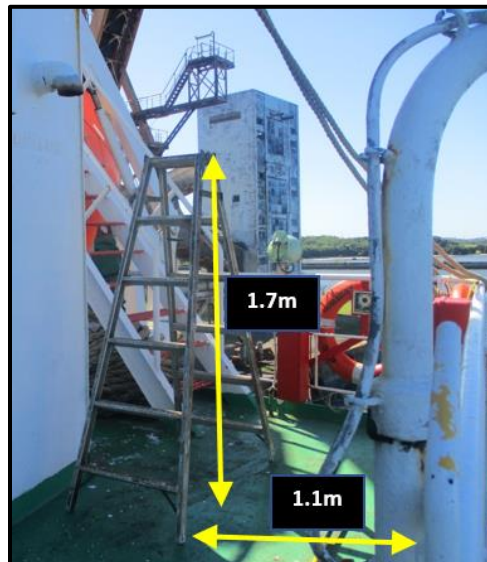
Figure 8: Height of the ladder and approximate distance of the ladder to the safety railings.

- 2.1.5 The ASD-3 had likely not considered the potential of the ladder to sway sideways while the vessel was underway and the consequent risk of falling overboard, given the proximity of the ladder's position to the safety railings.

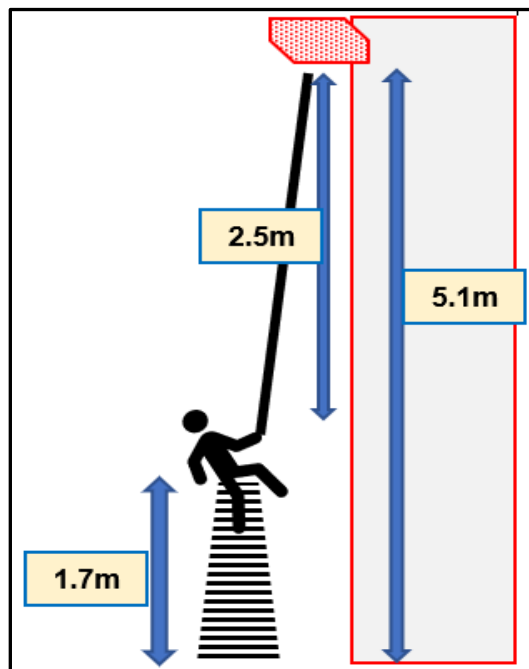
- 2.1.3 It was established that the ASD-3 had used the portable A-frame ladder in the past for work. By sitting on the portable ladder (which was 1.7m high), it reduced the upward reach to the underside of the stairway landing (which is at a height of about 5.1m from the boat-deck) to about 2.5m (i.e. minus the height of the ladder 1.7m and about half the physical height of ASD-3 when seated on the ladder, i.e. 0.85m) as compared to 3.5m by standing on the boat-deck and reaching upwards with a telescopic rod (see **figure 9**).

- 2.1.4 The investigation team opined that the ASD-3 may have considered the painting work to be less strenuous sitting on the portable ladder as it reduced the reach to the underside of the stairway landing.

Figure 9: Illustrating the reach in metres to the underside of the stairway landing when seated on top of the portable A-frame ladder by a person of the same height as the ASD-3.
